CHEMICAL ACCIDENT PREVENTION & PREPAREDNESS

Major accidents having significant impact to the environment

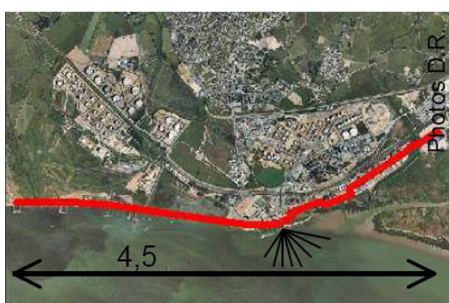
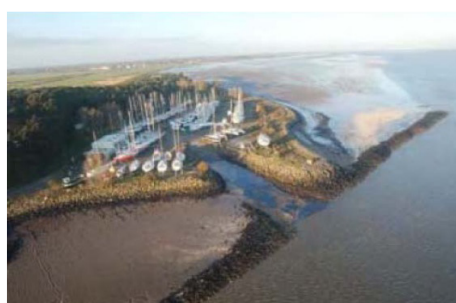
While loading an oil tanker at the refinery wharf, a corroded pipe began to leak and 478 t of cargo fuel oil spilled, of which 180 t flowed into the nearby river. A presence of hydrocarbons on the water surface was observed by a person on a barge who triggered the alarm. The leak itself was only detected 5 hours later by a rounds man who identified and isolated the leak at 500 m upstream from the point that the hydrocarbons were detected. As a precautionary action, subsequent to the spill, public access restrictions to several beaches and fishing prohibition in the river estuary were issued. Over 750 people were involved for three and a half months in cleaning up the 90 km of polluted banks (6170 t of waste was recovered and stored on-site before disposal).

The defective pipeline, 12 inches (~300 mm) in diameter and lined with thermal insulation, forms part of a pipe-rack composed of some 20 pipes on two levels. An examination of the defective pipe section revealed the presence of a longitudinal crack approximately 16 cm long by 1 cm wide adjacent to the observed local corrosion underneath the thermal insulation lining. Water flowing from a perforated pipe, positioned vertically above the fuel oil pipeline, infiltrated under the leaky thermal insulation layer, first causing the steel to corrode and then perforating the pipe.

The unit involved in the accident (source: ARIA No. 34351 and Gendarmerie Nationale)

- The last inspection of the leaking pipeline dated back 4 years prior to the accident. Inspection and monitoring of the pipeline should have been carried out more frequently.
- No visual surveillance or regular sampling of the water and/or the surrounding area was executed which might have been effective to detect hydrocarbons release in due time before the accident occurred.
- There was no safety barrier installed that could have blocked or slowed down the intensity of the hydrocarbons flowing towards the river.
- Operators in the control room should be sure that what is being sent to the tank is actually going into the tank (e.g. a level control system).

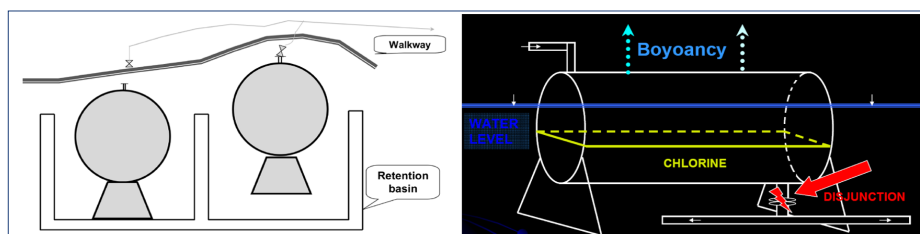
The release

Large flooding of Vltava River in August and the beginning of September in 2002 inundated the premises of the Spolana chemical plant. As the site became flooded, water entered into two different establishments and inundated the emergency retention sumps, in which were located liquid chlorine storage tanks. As a result, chlorine was released to the air and water.

The containers were lifted by the force of the flood, which led to a burst in the piping and detachment of the socket on a tank. The tanks in the chlorine storehouses contained different amounts of chlorine. Some contained only gaseous chlorine as a residue after discharging, some were filled up to 20% of the capacity and one tank was practically full. After being flooded with water exceeding the 'hundred year water level' by 1.3m, the empty and lighter tanks were lifted by buoyancy forces and displaced from their normal positions. The buoyancy forces were so strong that their action deformed and lifted the walkways situated above the tanks (see above). The closing valves in the full tank got caught by the walkway and were completely torn off as the walkway kept moving upwards. As a consequence of the valves being torn off from the full tank, a massive leakage of chlorine occurred.

- The storage tanks/containers were not fixed to the ground, therefore they could be lifted by the flood water. Storage tanks/containers encompassing dangerous substances should be fixed to the ground.

- The walkways were attached to each other, therefore once one container was lifted, it also lifted the adjacent container too. To avoid this kind of chain reaction, the walkways should be segmented.
