CHEMICAL ACCIDENT PREVENTION & PREPAREDNESS

Natech Accidents

Summary

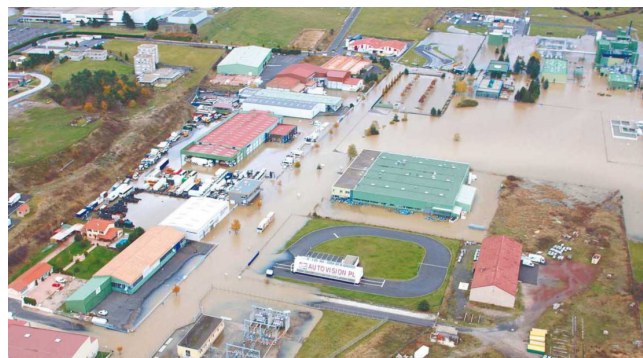
Figure 2: The affected site (Source: ARIA No .35426)

The torrential rains during the previous days resulted in the flooding of the site. The zone was not located in an easily flooded zone but since the site was located in a natural depression, it was flooded even though the platform was raised from 0.8 to 1.5 metres at the time of construction of the site. The flood occurred due to insufficient draining of the water from the catchment area housing the industrial zone given the torrential downpour over a short span.

- The zone was not classified as flood-prone zone, even though less intense showers had been experienced five years before the incident. The water level then had reached 662.2 metres (site platform stood at 662.5 metres), whereas on the date of the event the water reached a level of 663 metres.

- Flooding can occur even in a zone that is not classified as flood-prone; therefore, early warning is crucial to put together the crisis management units and organise all rescue operations.
- There was significant damage to some equipment. Hence, it is important to prevent crucial instruments or laboratory equipment from coming into contact with water. In addition, chemicals that violently react with water should be stored at a height above the maximum water level for all flooding scenarios or be protected by dams.
- Operators should be prepared for a possible inundation of the plant in case of heavy rainfall. There should be a deliberate effort to maintain awareness of historic extremes of flooding in and around a site. Even areas that are not labelled as flood-prone can become inundated when rainfall is extremely heavy.

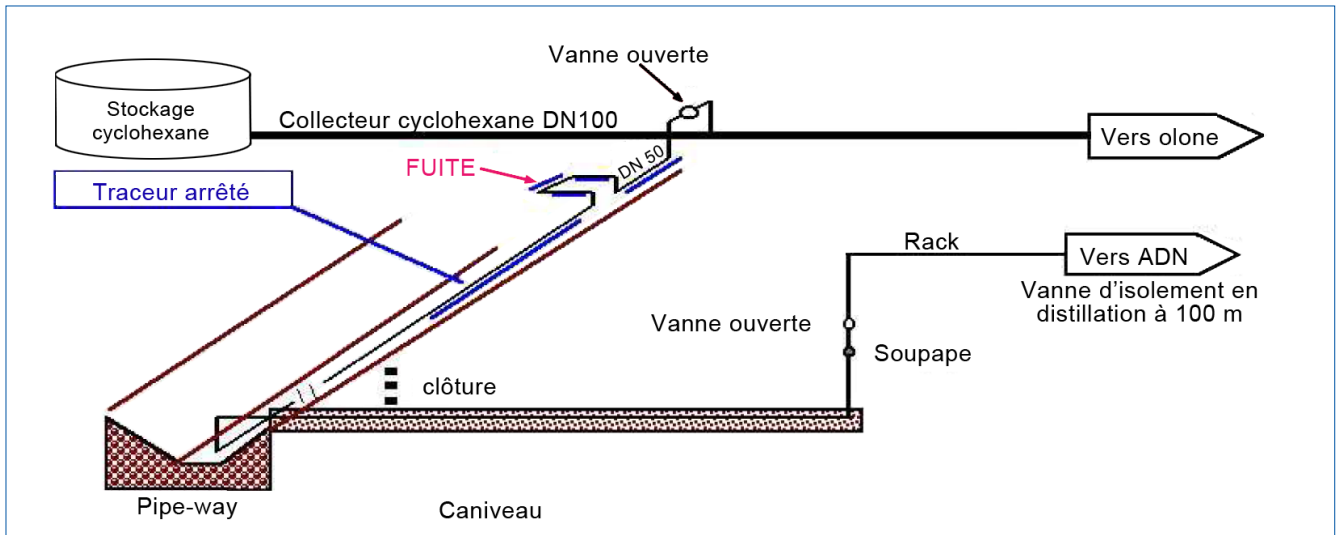
The temperature varied greatly over the weekend of mid-December. Lacking a functional temperature control, the varying temperature in the pipe caused the cyclohexane to expand and contract. A malfunction of the pipe heating device ($T < 6.5^{\circ}\text{C}$) led to the formation of the blockages in the pipe canal. Ultimately, the DN 50 mm branch pipe ruptured at the expansion loop, creating a hole about the size of the palm of one's hand. The expansion loop was the part most exposed to the changes in temperature because of its shape and position up above the pipe-way, (the trench holding the pipework)(see Figure 3).

- In early December 2002, freezing temperatures caused the cyclohexane to solidify in the manifold. The large variation in the temperature caused an expansion/contraction of the cyclohexane which contributed to the rupture of the pipe.
- The DN50 mm manifold was permanently open even in the event of non-use and only the adiponitrile (ADN) production unit admission valve was closed.
- The location of the released cyclohexane was found by its odour, indicating that no monitoring technology had been implemented on the pipe.

Figure 3: The affected process (Source: ARIA No. 23839)

- Operators must be aware of the physical characteristics of the dangerous substances, on site such as their tendency to solidify in extreme cold temperature. These factors should be included in the HAZOP or other hazard identification studies for the affected chemical process (See also Chemie-Pack accident at http://www.onderzoeksraad.nl/uploads/items-docs/1805/Rapport_Chemie-Pack_EN_def.pdf). Also, where significant variations of outside temperature can be expected, operators should identify possible hazards that might be triggered.
- The cyclohexane spilled was revealed by its odour. Relying on odour alone for detection is not a recommended practice on sites where large volumes of dangerous substances are stored. Proper detection in case of release of dangerous substance is crucial to enable staff to act immediately in case of an emergency.

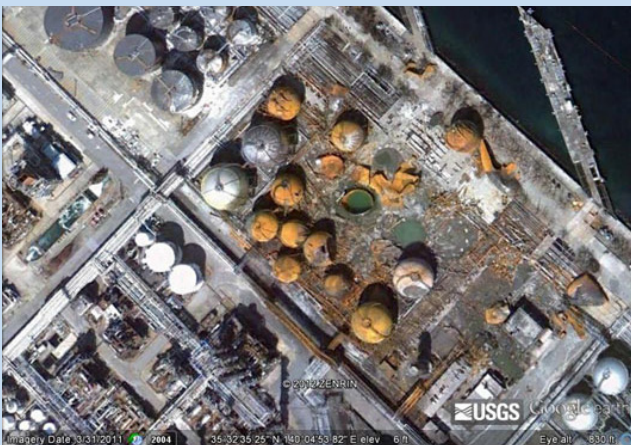
During a severe earthquake that hit a large chemicals facility, acrylonitrile was released to the atmosphere from a failed tank roof, and into containment dikes from two other tanks which suffered pipe breaking at the tank base. A significant amount of acrylonitrile overflowed the containment dikes and was lost in the ocean through the drainage channel as surface runoff. With the concrete containment dikes having been cracked by the earthquake, a considerable amount of substance leaked into the soil and reached the coastal aquifer below the site.

Figure 4: The LPG tank farm at the Chiba refinery after the earthquake-triggered fires and explosions (2012 Google, ZENRIN)

- In natural hazard prone areas an installation's emergency plan needs to consider the risks of natural hazard impact. This includes the preparation of stand-alone emergency plans that do not rely on the availability of offsite utilities and response resources.

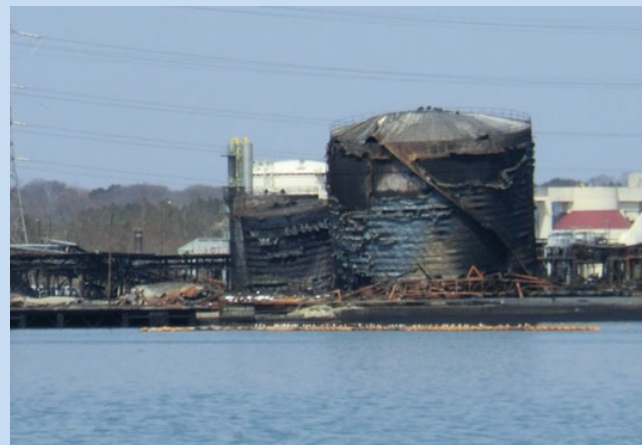
A major tsunami caused multiple pipe breaks and many small hydrocarbon spills from pipe connections when it hit a refinery located at the coast. The releases ignited, causing a major fire that involved three tanks filled with sulphur, asphalt and gasoline, and which destroyed a significant part of the refinery.

Figure 5: Burned tanks at the Sendai refinery hit by the tsunami (Photo Credit: C. Scawthorn)

- Where land-use planning restrictions are difficult to implement for existing installations, supplementary prevention and preparedness measures are required to protect hazardous facilities from tsunami impact.
