Mutual Joint Visit Workshop for Seveso Inspections SAFETY CULTURE, LEADERSHIP, AND ENFORCEMENT 16-18 September, 2015, The Hague, The Netherlands

### Inspections following major accident in a chemical establishment: management perspectives and repercussions on company safety culture

#### Background: the accident profile (eMARS database – Major Accident Reporting System)

- Location/Date/Time of Major Occurrence
  - Lombardia Region north of Italy; 10/09/2013; h. 4.00
- Accident title
  - Flash-fire during upload of DMC (Dimethyl carbonate) under vacuum condition
- Accident type
  - Major Accident, reported under Seveso II Directive
  - Seveso II status of the establishment: art. 9 upper tier (SR
    - Safety Report)
- Industrial Activity
  - General chemicals manufacture
- Reason for Reporting (Annex VI of Seveso Directive)
  - Injury to persons: 1 death

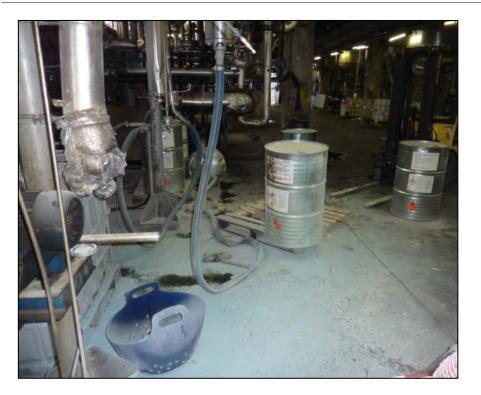
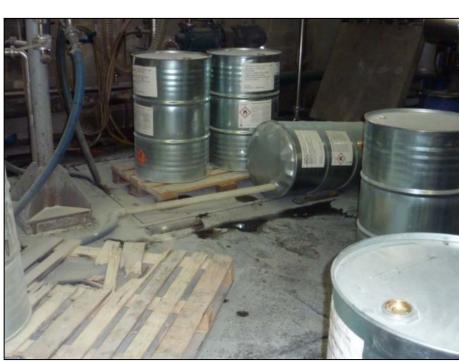
# The connection system: the reactor – the flexible hose – the loading nozzle – the drum

- The cause of the fire triggering is reasonably to be found in the accumulation of electrostatic charges on the hose and nozzle, both in plastic material, following the repeated insertion and removal of these same in the drums (final phase of the loading operations)
  - Such material is not compatible with the manipulation and handling of flammable substance (dielectric properties)
- The procedure for handling flammable, in effect at the time of the event, gave general indications about the chemical compatibility and the grounding system and the correct identification of the specific equipment to be used
- According to interviews with some workers, there was not a specific training on the handling procedure

- Using nozzles of stainless steel and conductive pipe that are chemically compatible with the specific loading raw materials
- Loading possibly from the foot valve of the container in order to avoid turbulence
- Do not exceed the loading speed of 100 lt./min (av. speed of 1 m/s)
- Loading possibly by vacuum produced in the container in which the raw material loading is carried out
- Loading the raw material in exact order as described in the manufacturing process
- Checking the correct grounding system in case of conductive equipment (stainless steel nozzle and/or conductive pipe)
- Check regularly the electric continuity of the "nozzle + conductive pipe" equipment (electrical bonding) - every 6 months
- Do not climb on wooden pallets
- Keep the packed containers separated from each other

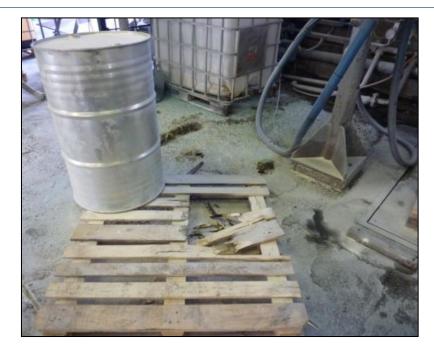
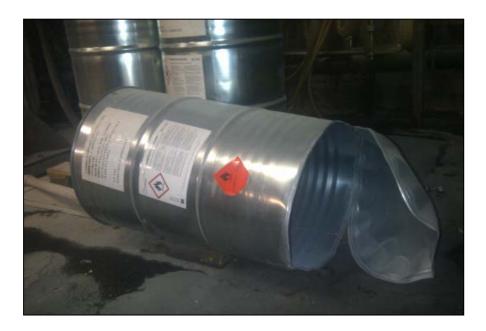
#### Damage to the installations and equipment (1/2)

Pallet damaged area by the exploded drum The exploded drum

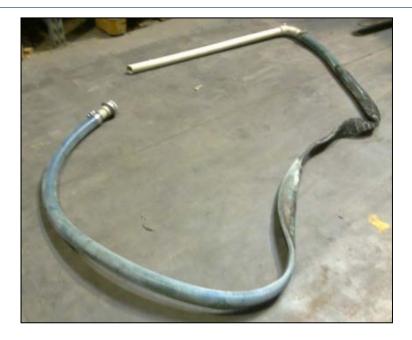
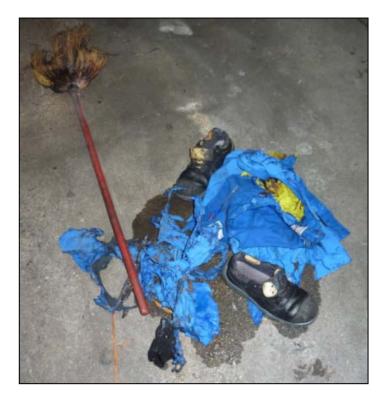
#### Damage to the installations and equipment (2/2)

The flexible hose and the loading nozzle  The remains of Personal Protective Equipment (PPE)

- Replacement of all nozzles for the flammable transferring with loading nozzles of stainless steel and conductive pipe
- Medical interviews of the workers with psychologists of the department of clinical psychology hospital about Post-Traumatic Stress Disorder (PTSD)
