On Cosmo Oil Refinery, Ichihara, Chiba

Ahmed Farag
Anirban Chakraborty

What happened on **March 11, 2011**
at the **Cosmo Oil Refinery**, Ichihara, Chiba ?

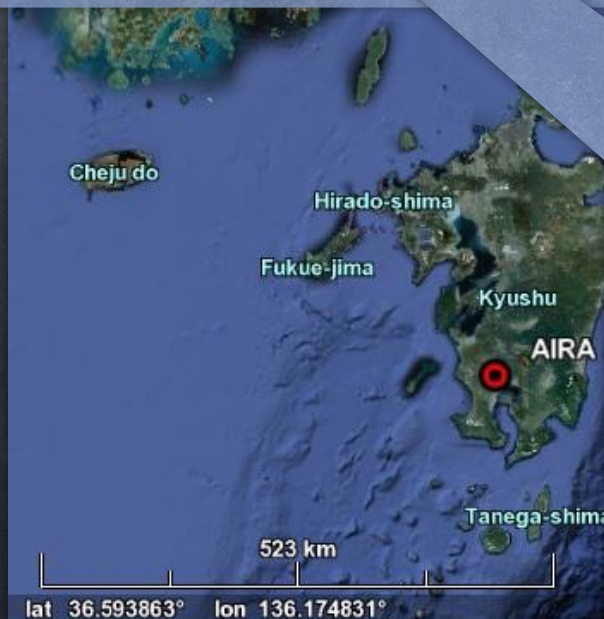
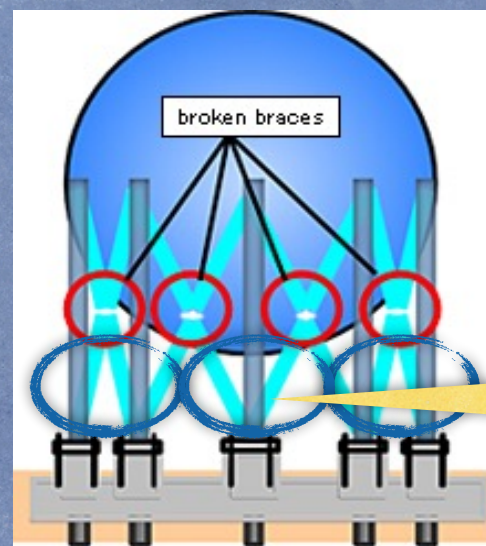
AFTERSHOCK

The legs failed and the tank collapsed

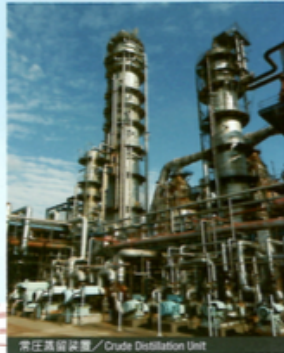
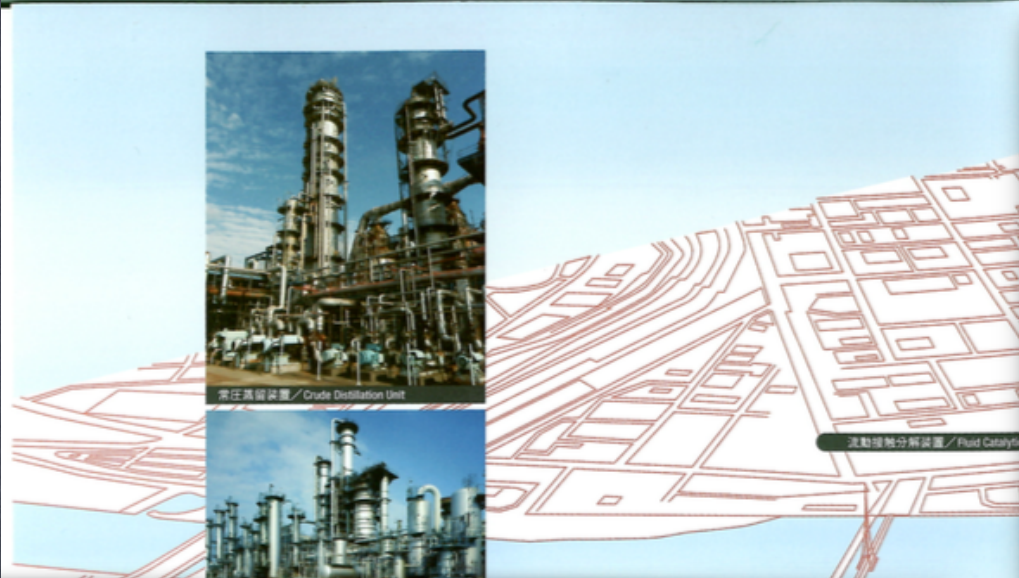
Maruzen Corporation

Vapour cloud floated over and triggered a fire

Another fire burnt the operator room

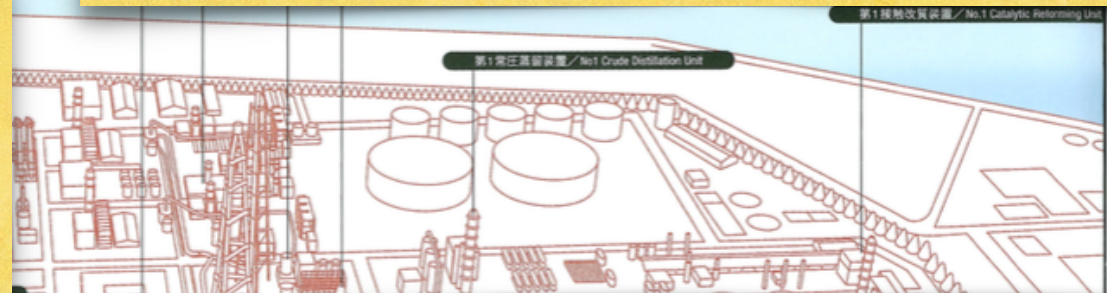
Asphalt Tanks (Cosmos Oil)

Debris affected nearby asphalt tanks

Some asphalt was released into the ocean.
