# Explosion and fire in a chemical plant

- Chemical plant; upper-tier establishment,
- Production of fertilizers,
- Ammonia production unit, heat exchanger (HE)
- Substance involved: H<sub>2</sub>

# Heat exchanger

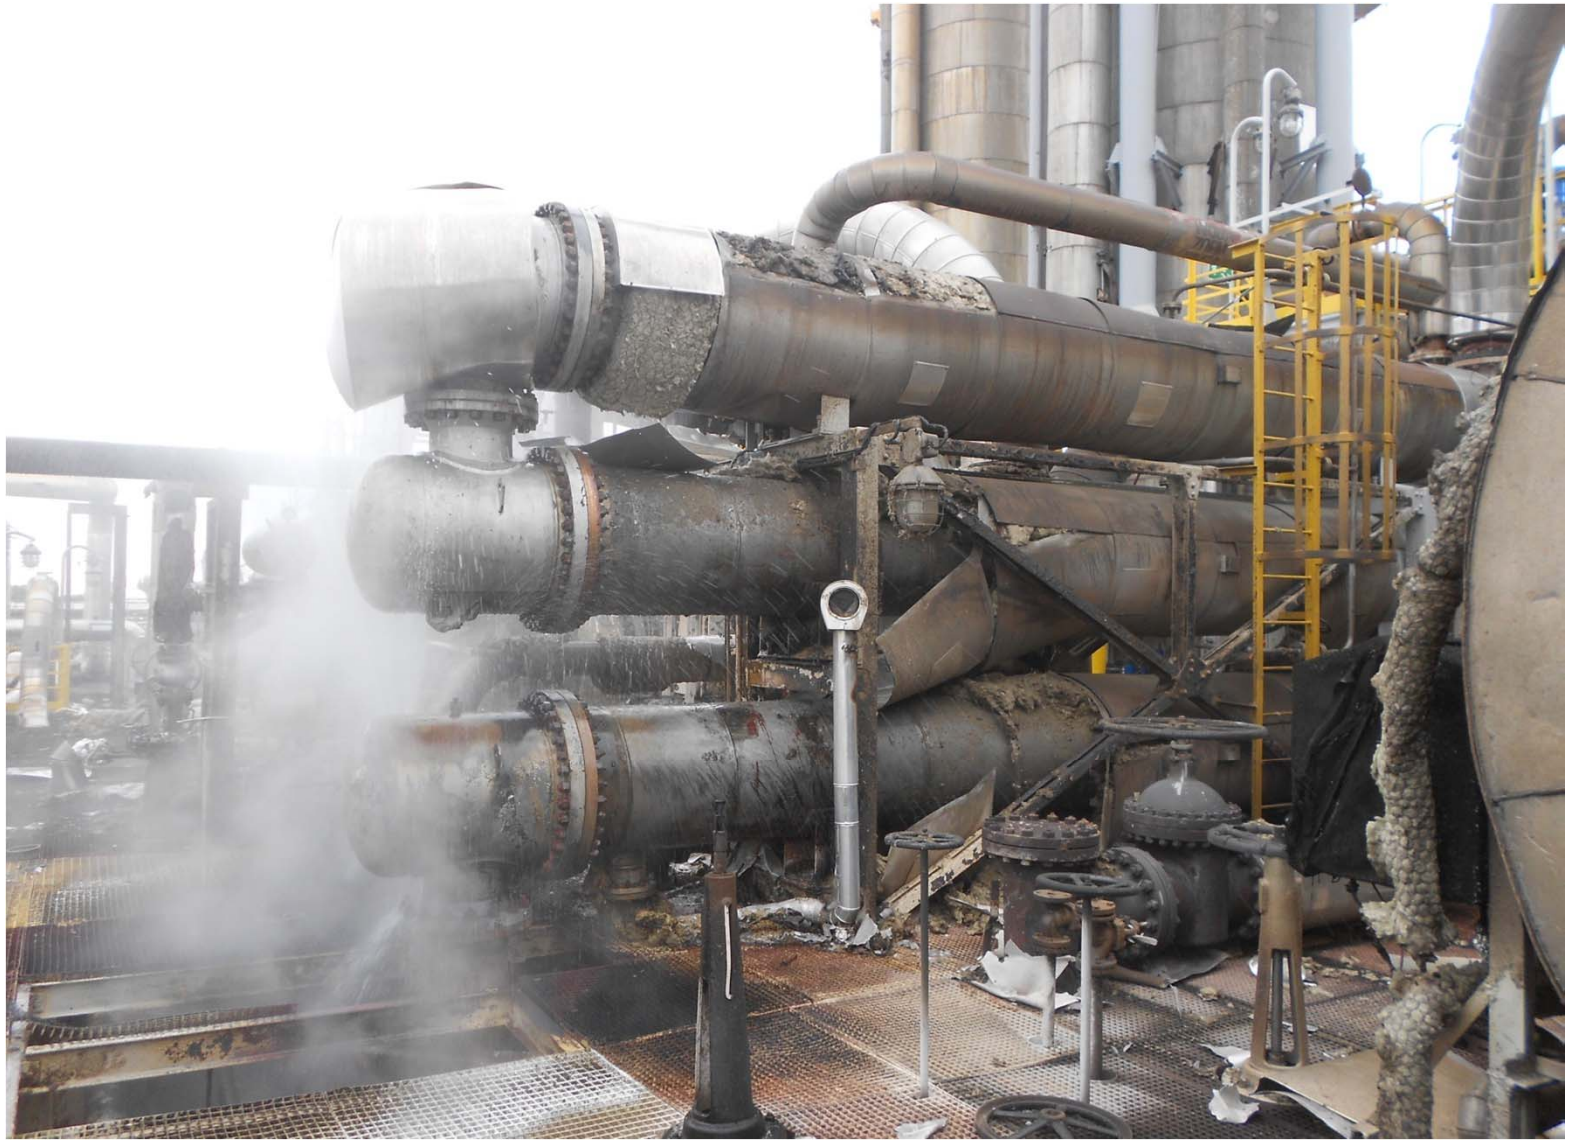
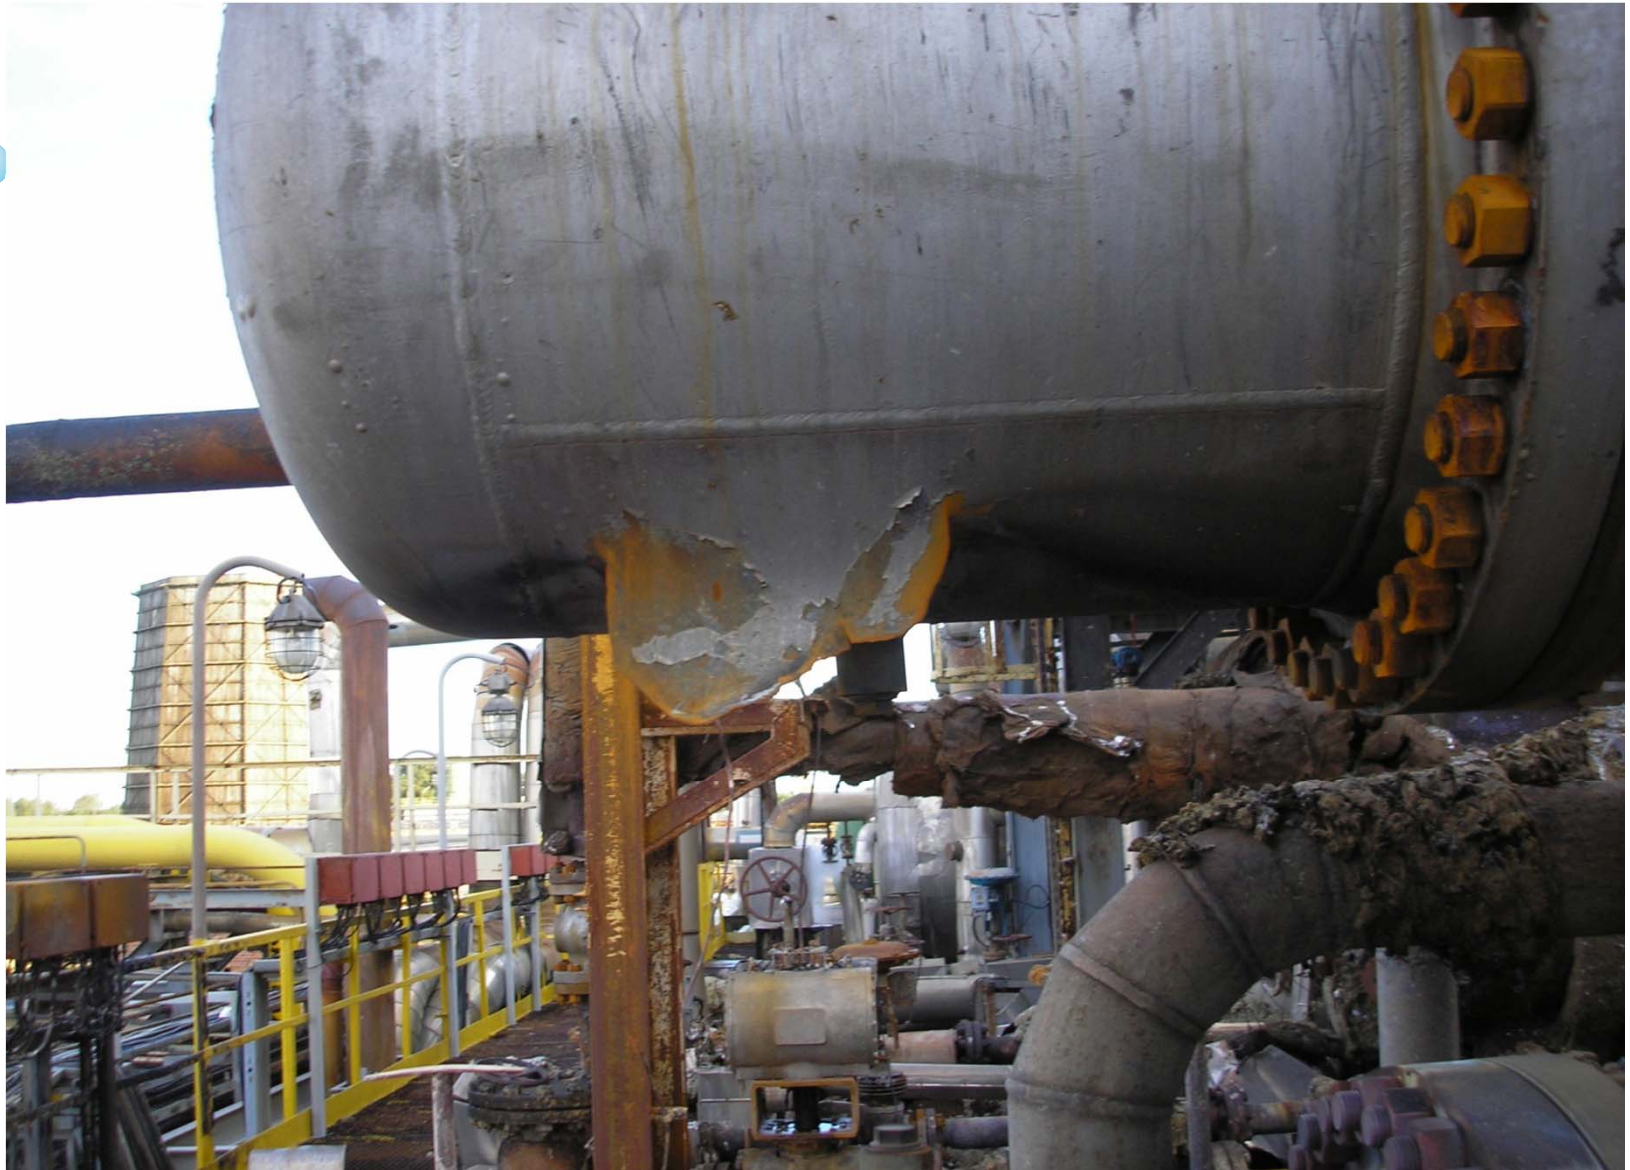
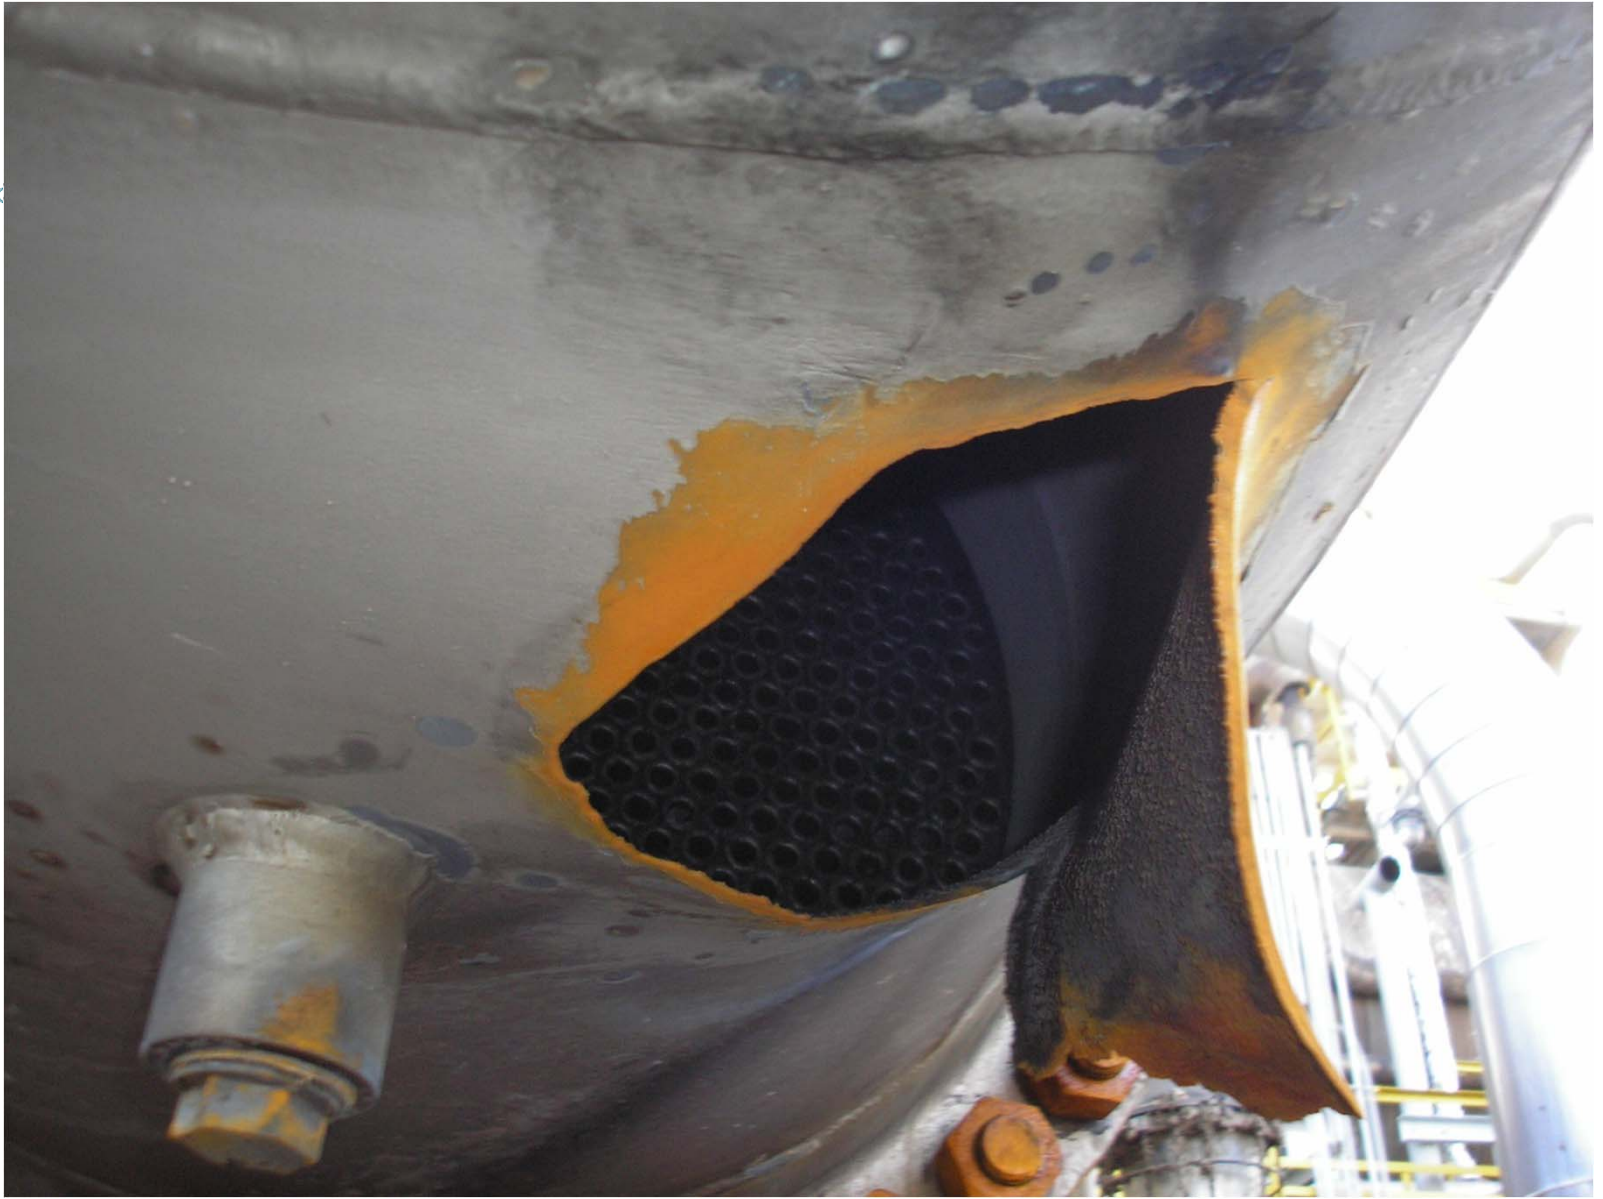
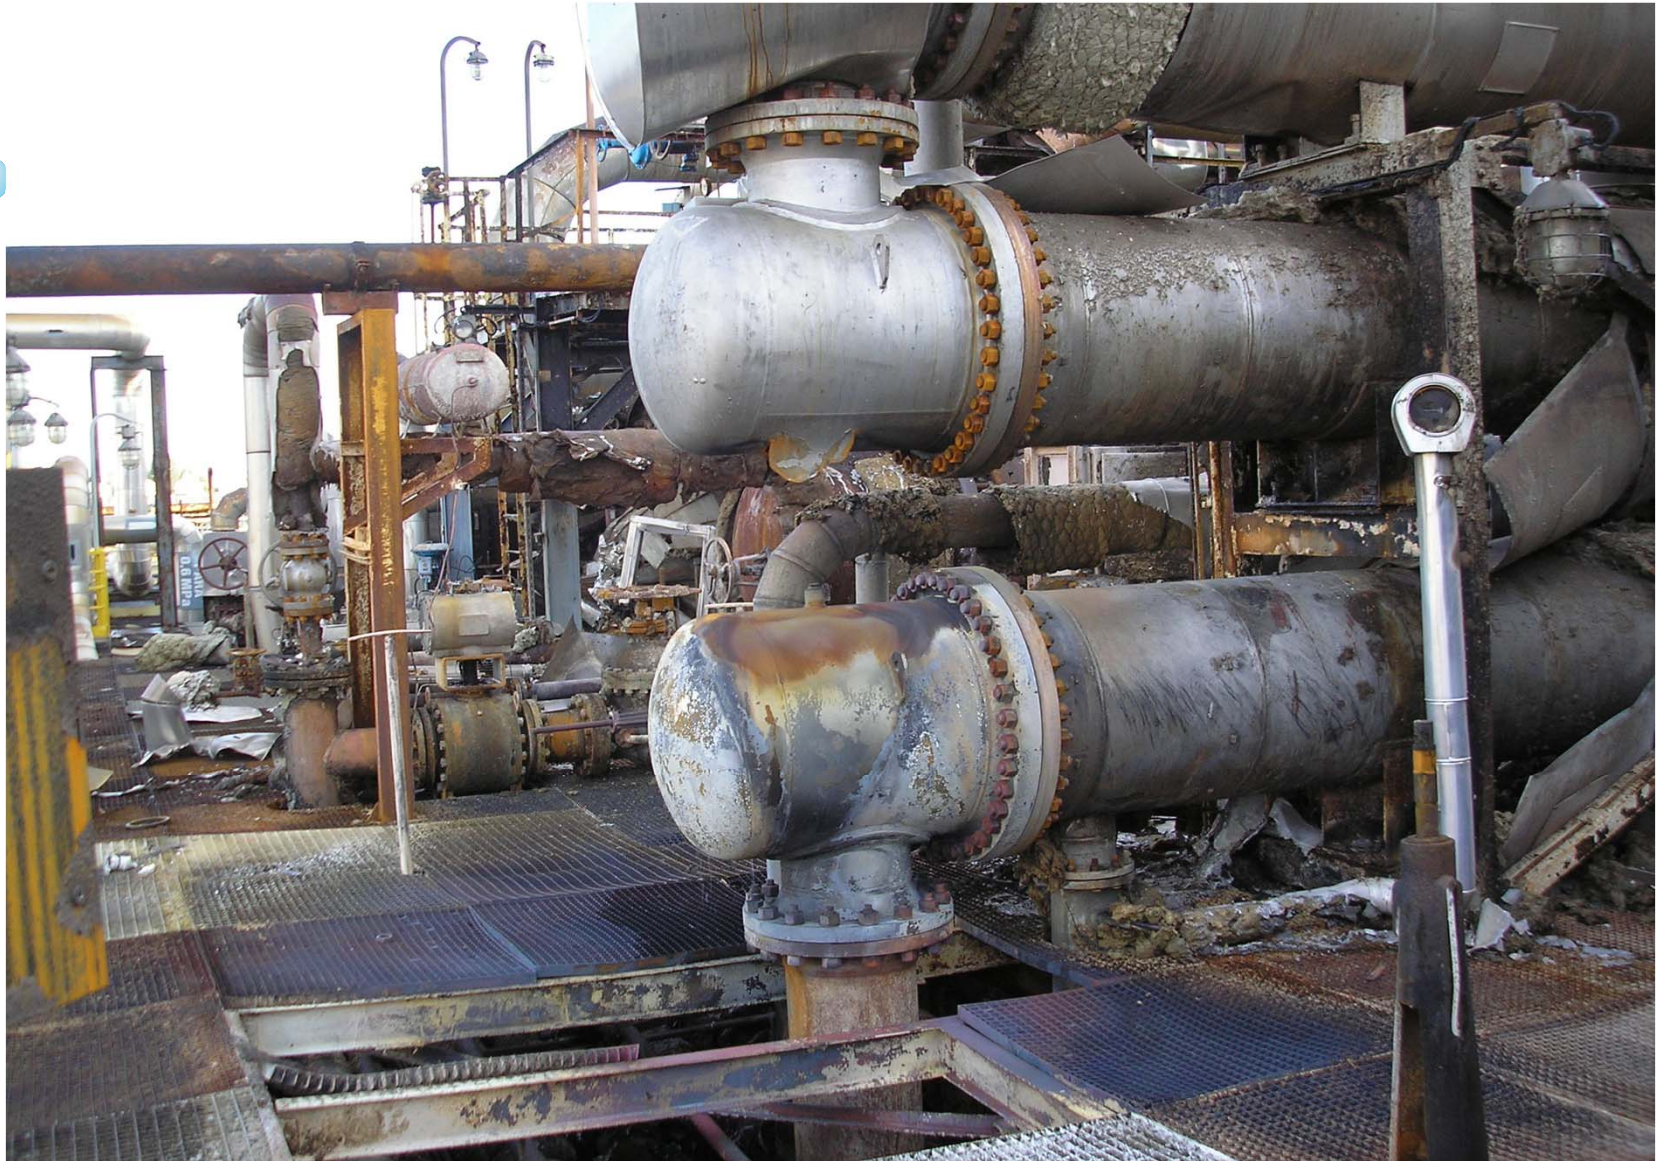
- Rapid expansion of the process gas with hydrogen at a pressure of approximately 3.0 MPa
- The gas stream from the ruptured cover bursts asymmetrically down the structure towards the concrete substrate at level 00.
- Process gas with a majority of hydrogen, despite very low activation energy, does not ignite and does not explode due to the accompanying water vapor and carbon dioxide (typical extinguishing agents).
- The phase I period lasts about 10 seconds (according to the witnesses).

- Spatial hydrogen explosion in the air (characteristic flash and noise).
- Wave of overpressure of the explosion makes a loss in the radius (150 m) – smashed glass and falling out of windows.
- The detonation wave (pressure-sound) hits the nearest adjacent objects at the epicenter of the explosion.
- Estimated time of rapid linear pressure drop from 3 MPa to near atmospheric pressure is approximately 20 seconds.

- Free, limited, jet fire of the remains of the hydrogen in the installation
- Addition of nitrogen to gas to extinguish the "burner" which causes a gradual decrease in the burning intensity and flame length.
- Estimated volume of process gas outflow 15 000 m<sup>3</sup>, including about 10 800 m<sup>3</sup> of hydrogen.
