Chemical Accident Risks Seminar

Ageing of hazardous installations as a potential contributor to major accidents: some events occurred at chemical and petrochemical Italian establishments

Ing. Romualdo Marrazzo

ISPRA - Italian National Institute for Environmental Protection and Research

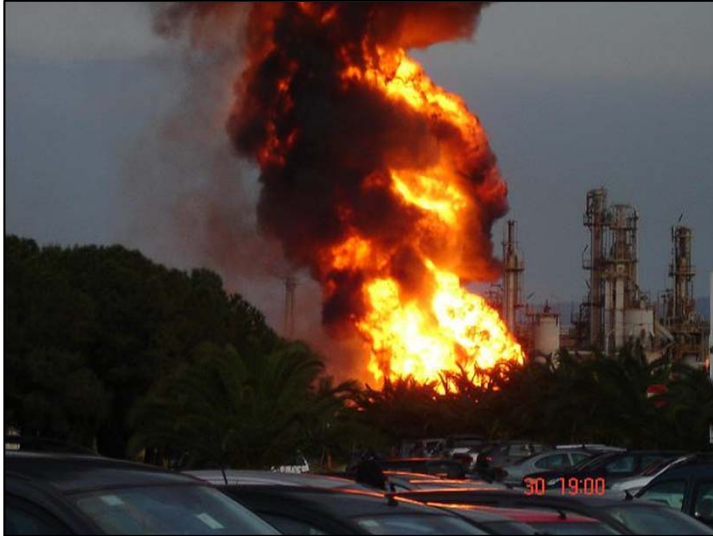
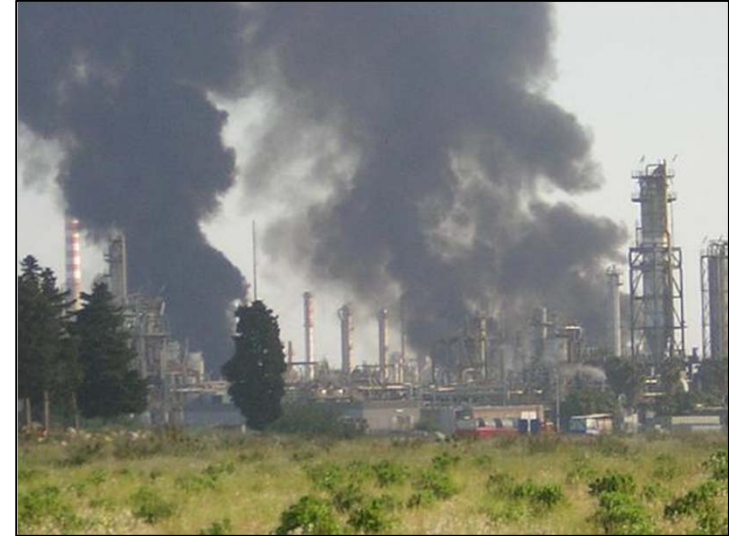
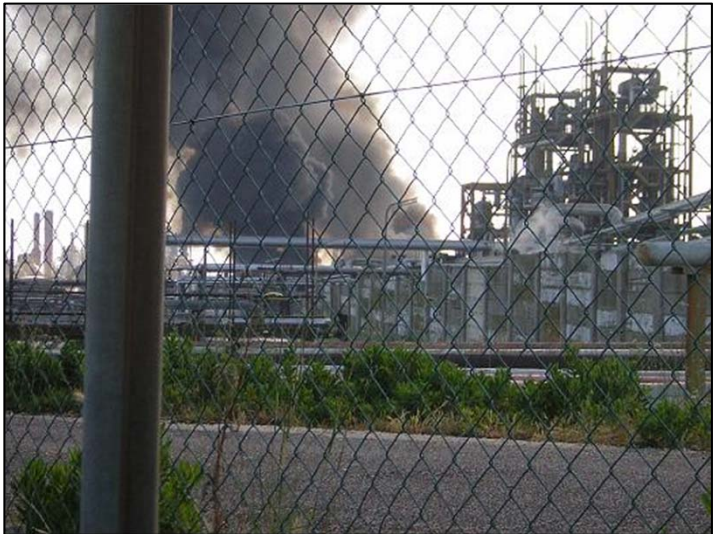
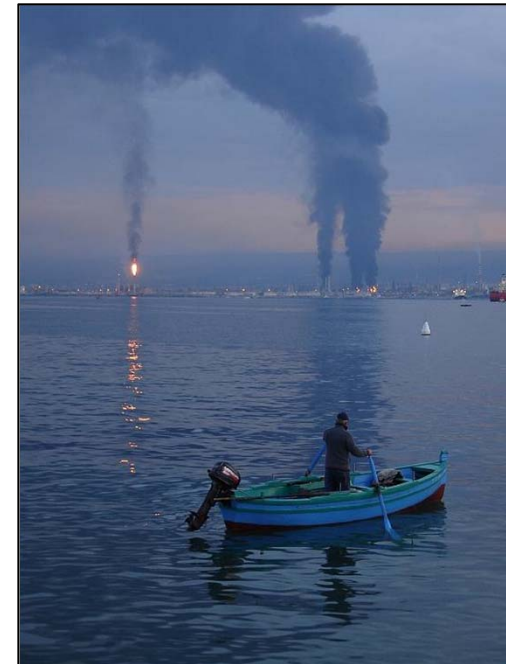
Date: 30/04/2006		Title: Fire and explosions in piping	
Synthetic description: Release of crude oil from transfer pipe in the underpass of the road that crosses the plant, that developed a fire by accidental triggering which subsequently involved the adjacent piping and then a series of explosions			
Causes: Age (over 25 years) and state of preservation of the pipe in relation to the progressive corrosion phenomena, which led to the pipe drilling			
Organizational factor / Description		Actions taken	Expected / Planned actions
Emergency planning - Consequences analysis, planning and documentation		Internal emergency plan activation with major risks emergency forwarding. Intervention of refinery and neighboring establishments fire departments and local Fire Brigade	Internal emergency plan check
Identification and evaluation of major hazards – Planning for plant and management compliances to risk reduction and updating		Investigation to find out the causes of the accident. Visual inspection and basic design of corrective actions. Necessary reconstruction activities	Specific risk analysis. Planned and/or required compliances following CA examination. Check of the pipeline inspection plan

Fires and explosion at the refinery plant

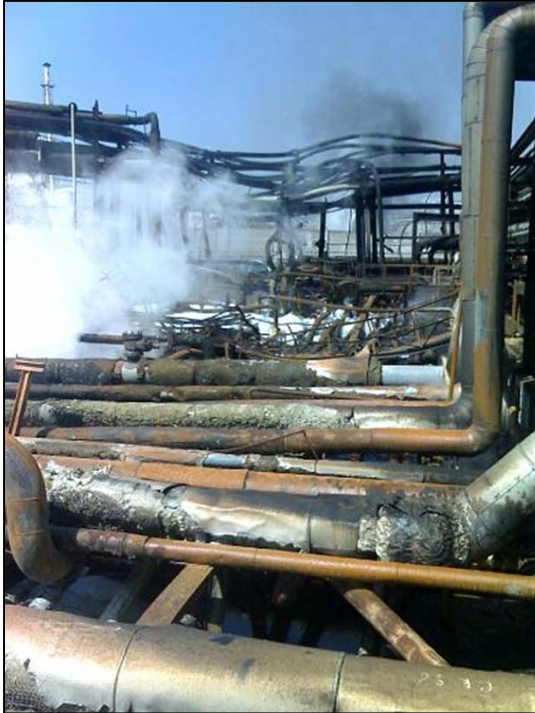
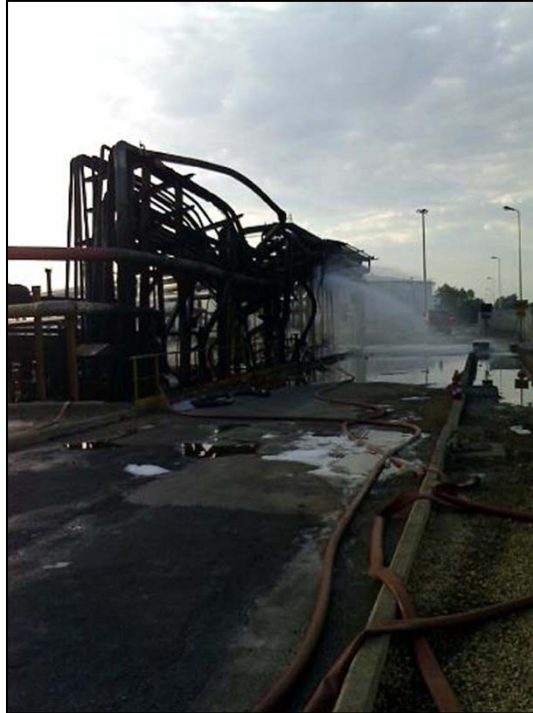
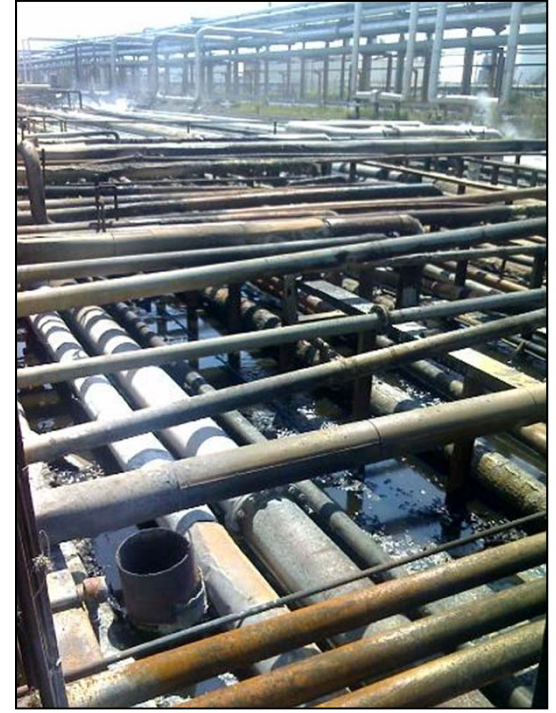
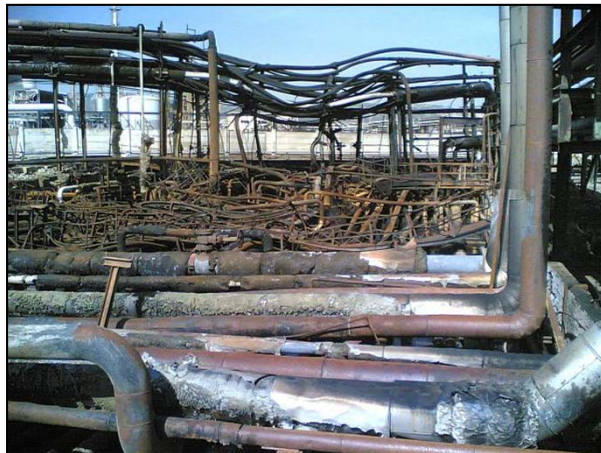
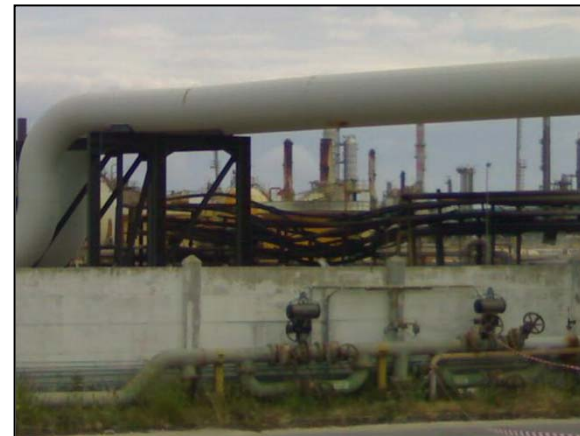
The pipeline rack after the event

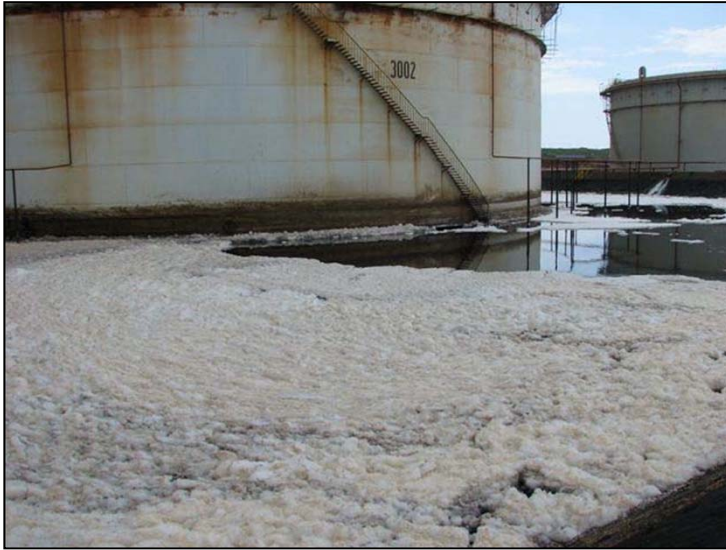
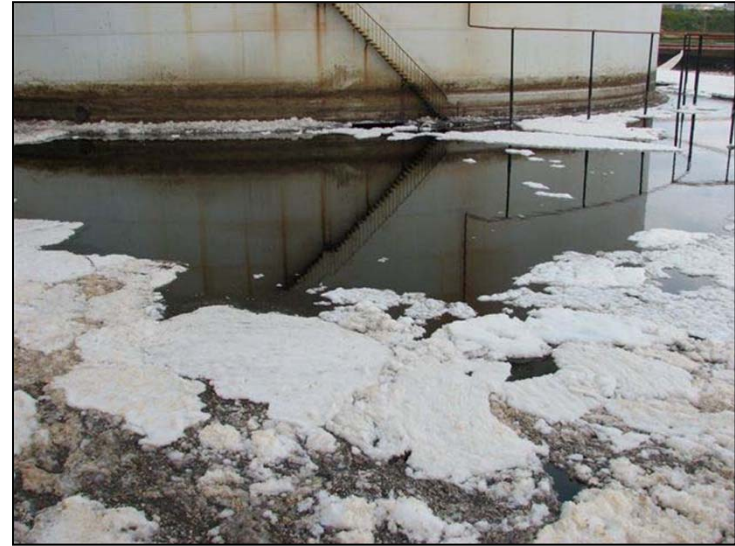
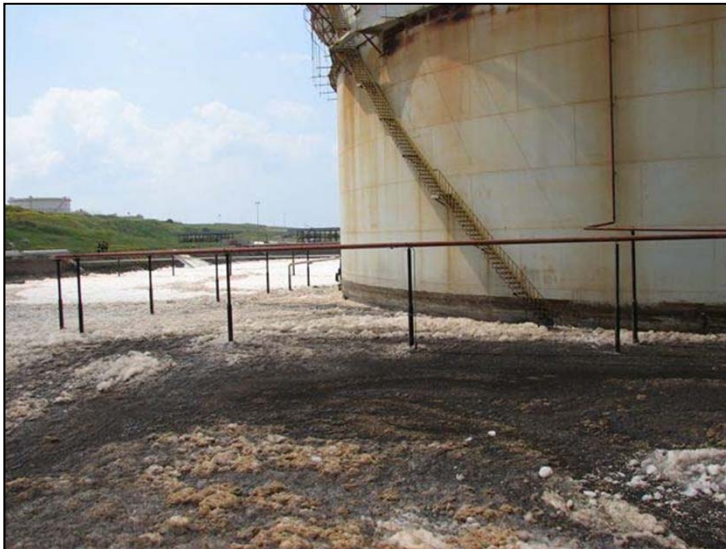
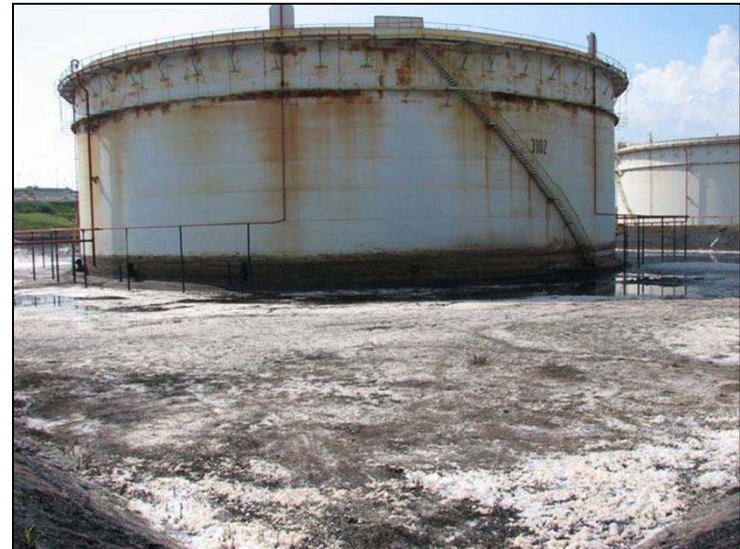
Date: 01/05/2006	Title: Leakage through the tank bottom		
Synthetic description: Leakage of oil through a large lesion at the bottom of a floating roof tank and subsequent release of a significant amount of oil inside the containment basin			
Causes: High corrosion and deteriorated area			
Organizational factor	Description	Actions taken	Expected / Planned actions
Operational control - Identification of installations and equipment subject to maintenance plans	Release of oil inside the containment basin	Tank insulation. Covering the spilled oil with foam to limit the vapor emission. Transferring the product to another tank with temporary pipes	Tank out of service. Carrying out the remediation and maintenance of the basin and the tank. Double bottom insertion

The containment basin after the event: the rupture area

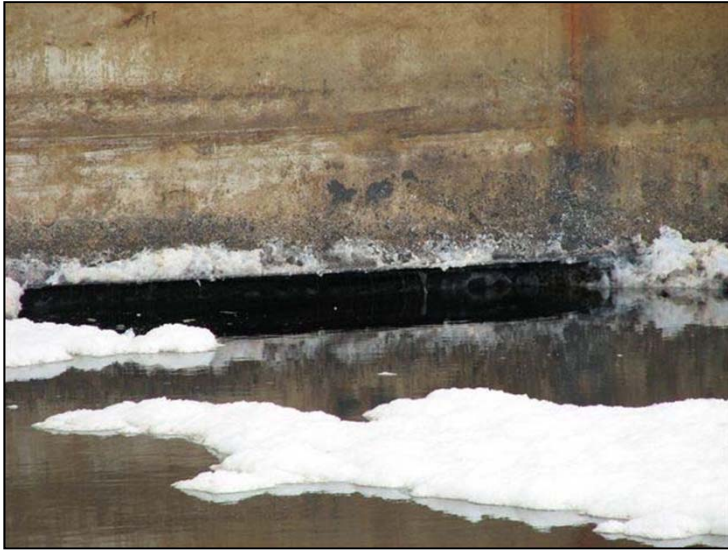
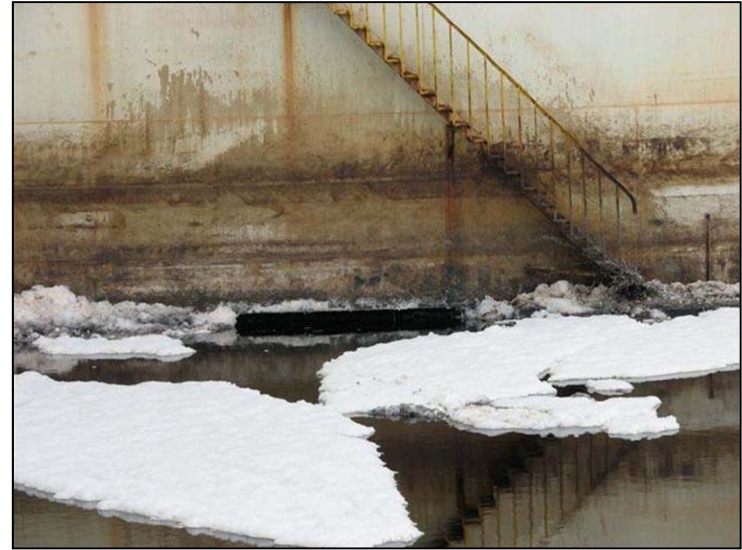
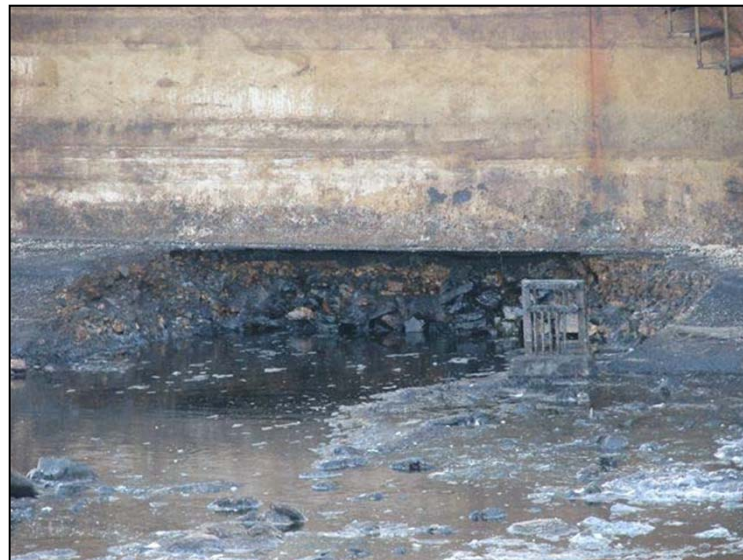
The lesion at the tank bottom
