Ministerie van Sociale Zaken en
Werkgelegenheid

Mutual Joint Visit 2016 - Workshop on Explosives and
Pyrotechnics

S.E. Fireworks

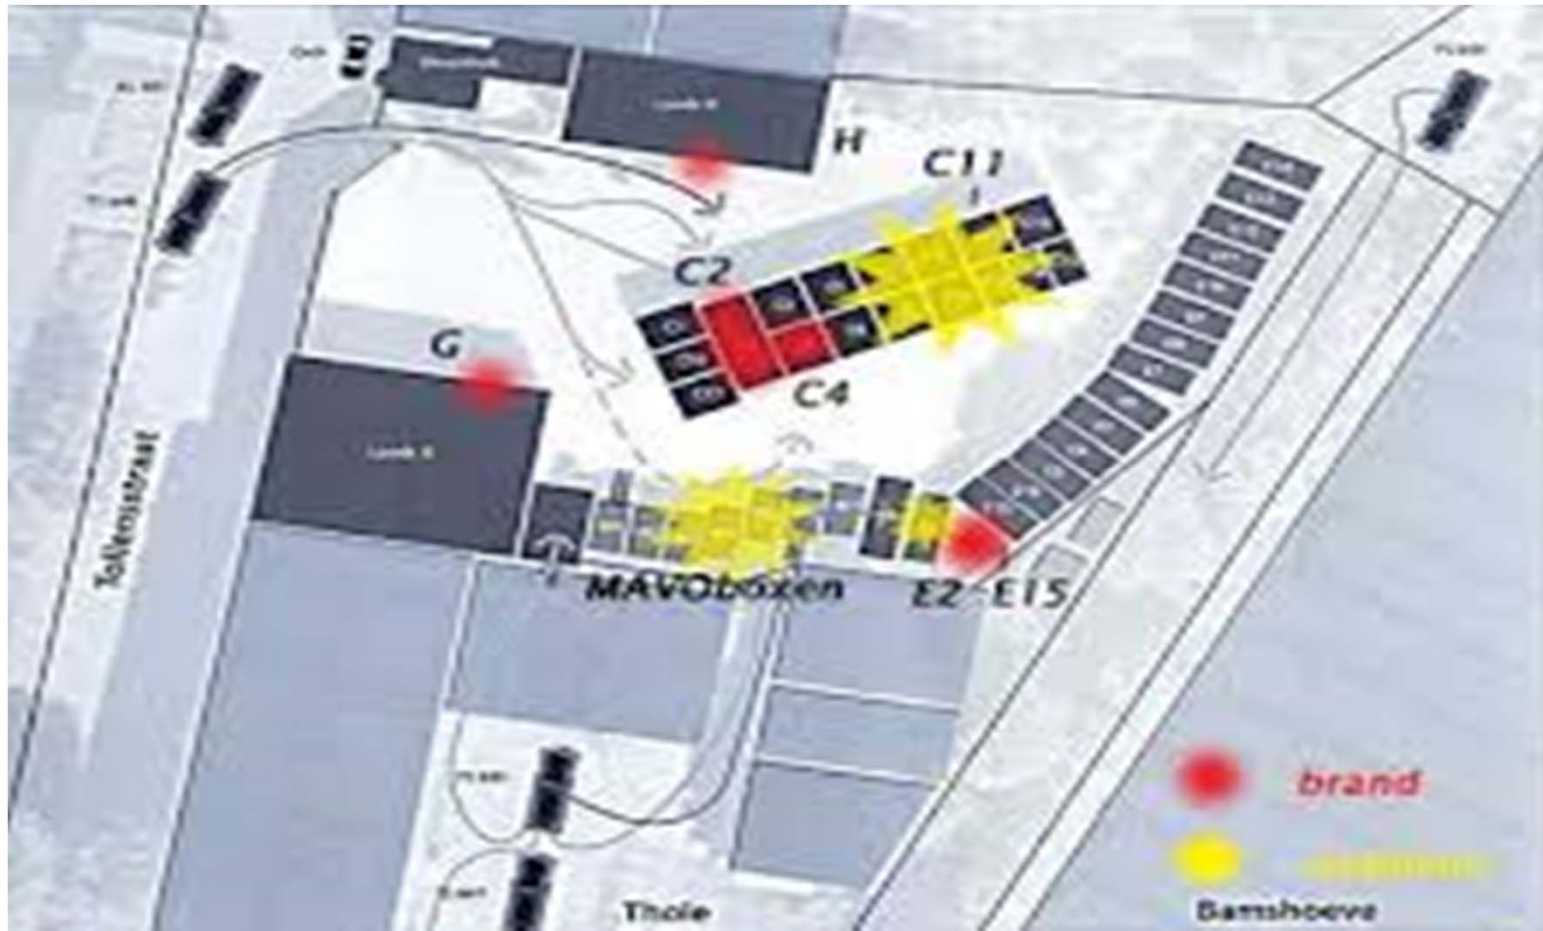
Site lay-out during the incident

- 15.28 Fire in 2 containers E2 and E15
- 15.30 Fire is several places
- 15.34 1st explosion in container E2 en more fireworks is shot from C4
- 15.34 Garage boxes explode quickly one after another
- 15.35 explosion in C11 followed by the rest of the bunker and other containers
- Fireworks and debris is spread over the area and hundreds offires start

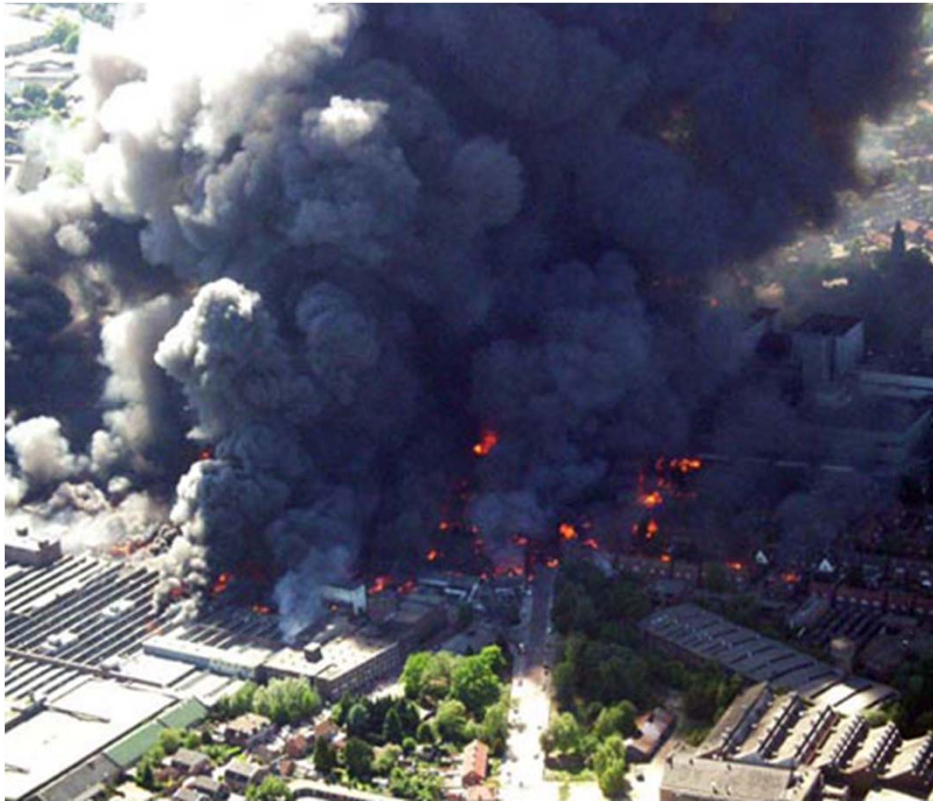
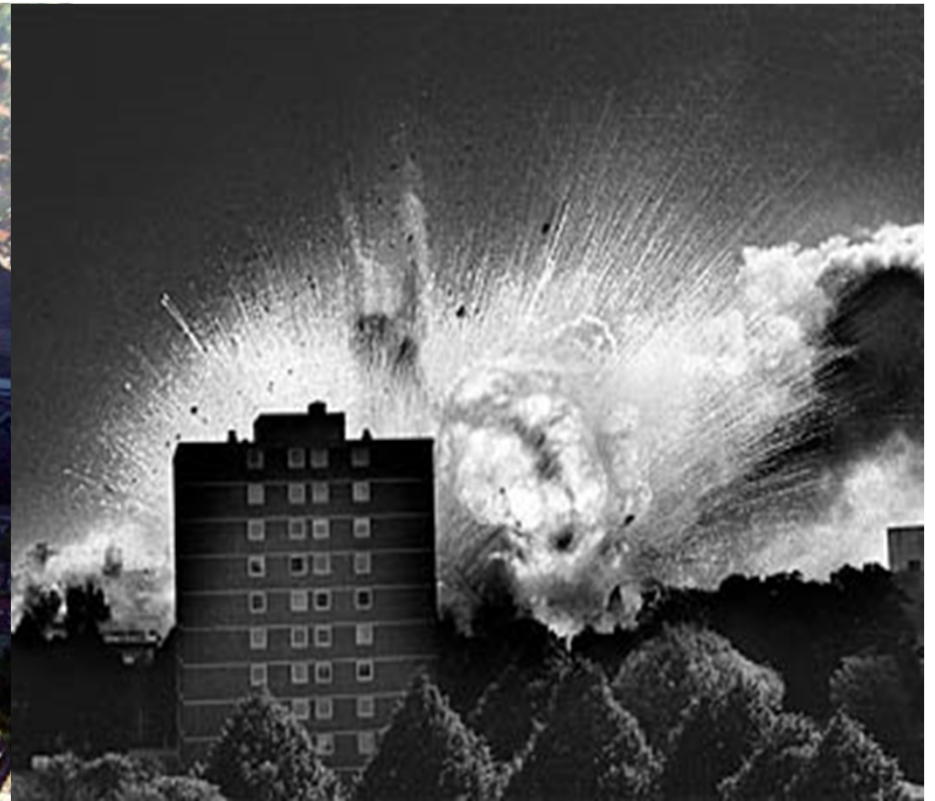
The incident

- 23 people died (including 4 firemen)
- 947 injured (525 hospitalised)
- 42 hectare was ruined
- 200 houses were completely destroyed
- another 282 damaged in the direct area
- 1500 more outside the area
- The costs were around 1 billion Euro
