# **Series of mass explosions in a fireworks plant 25th July 2013 - Città Sant'Angelo (Italy)**

**Eng. Fausta DELLI QUADRI**

**ISPRA – Italian National Institute for Environmental Protection and  
Research Industrial Risk Service**

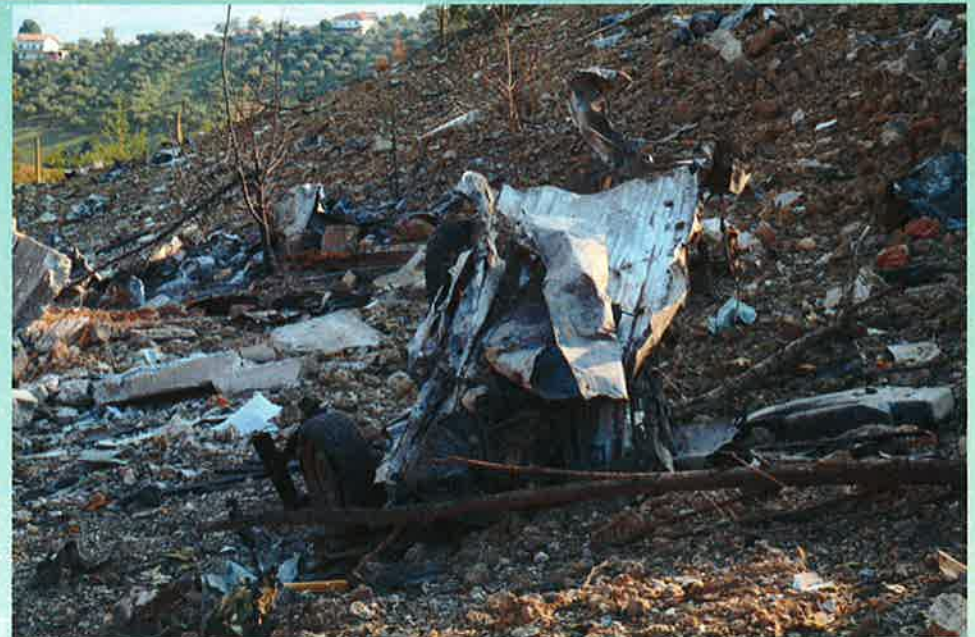
Remains of the plant  
after the accident

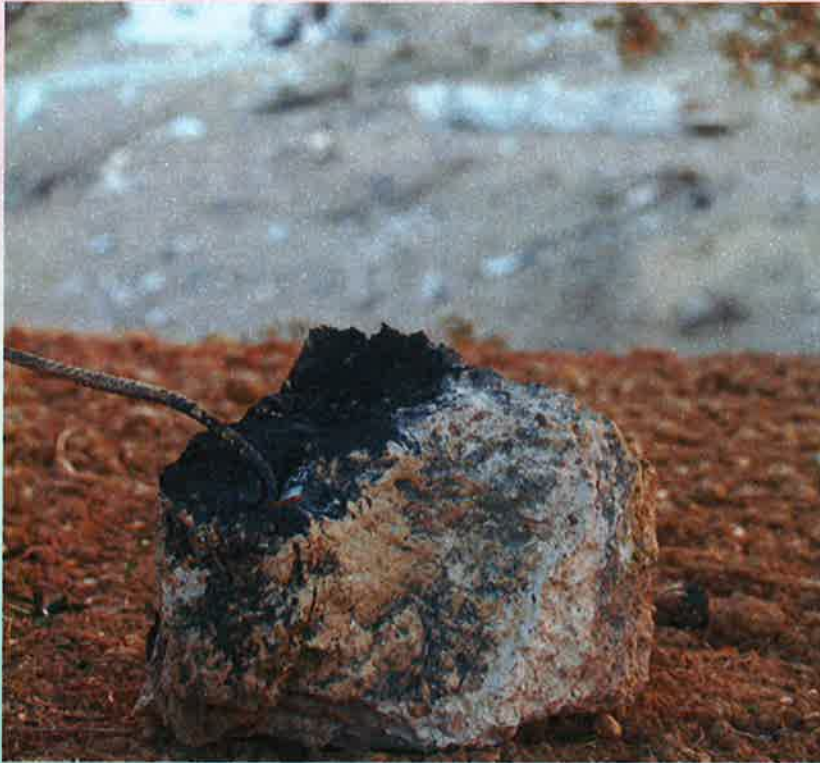
Piece of concrete found more than 900 m away from the plant

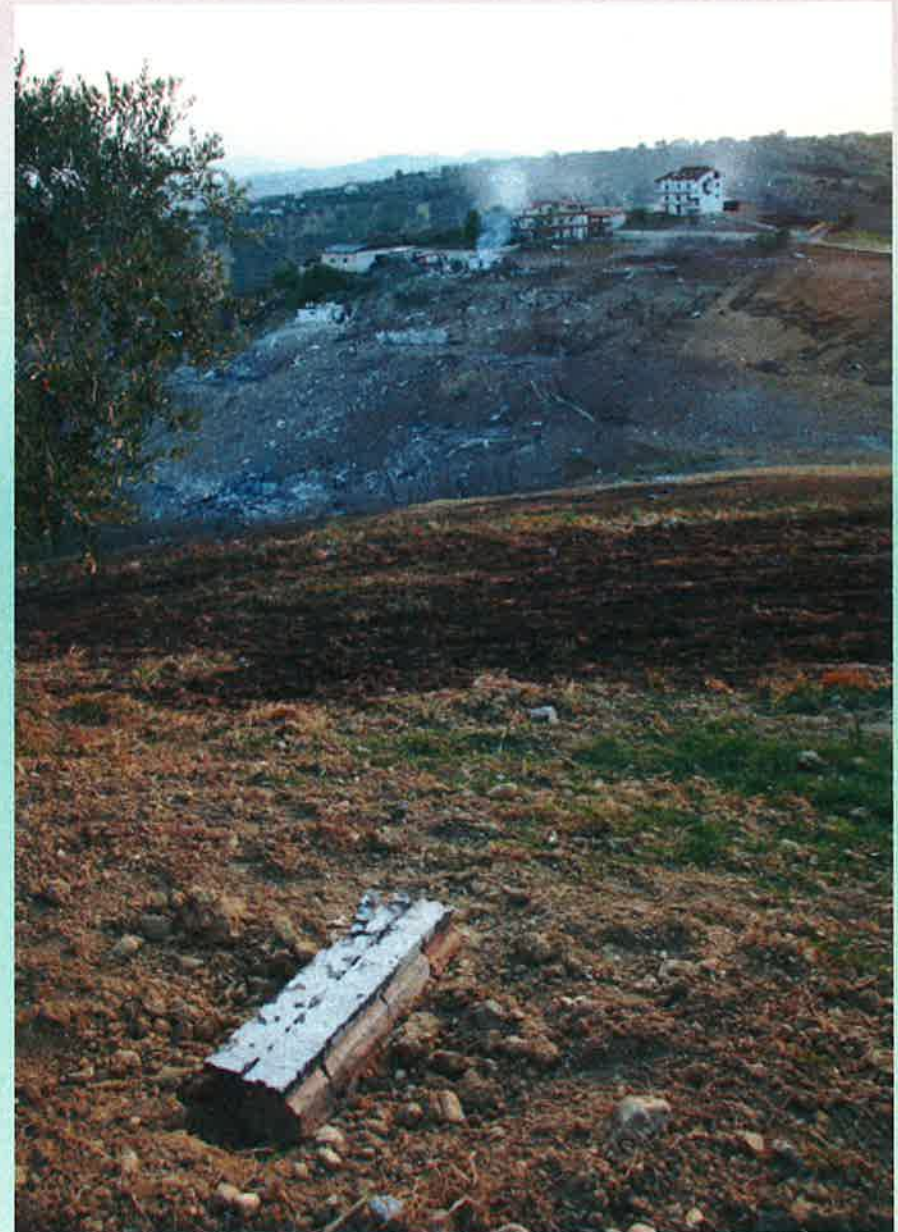
Debris projected by the explosions

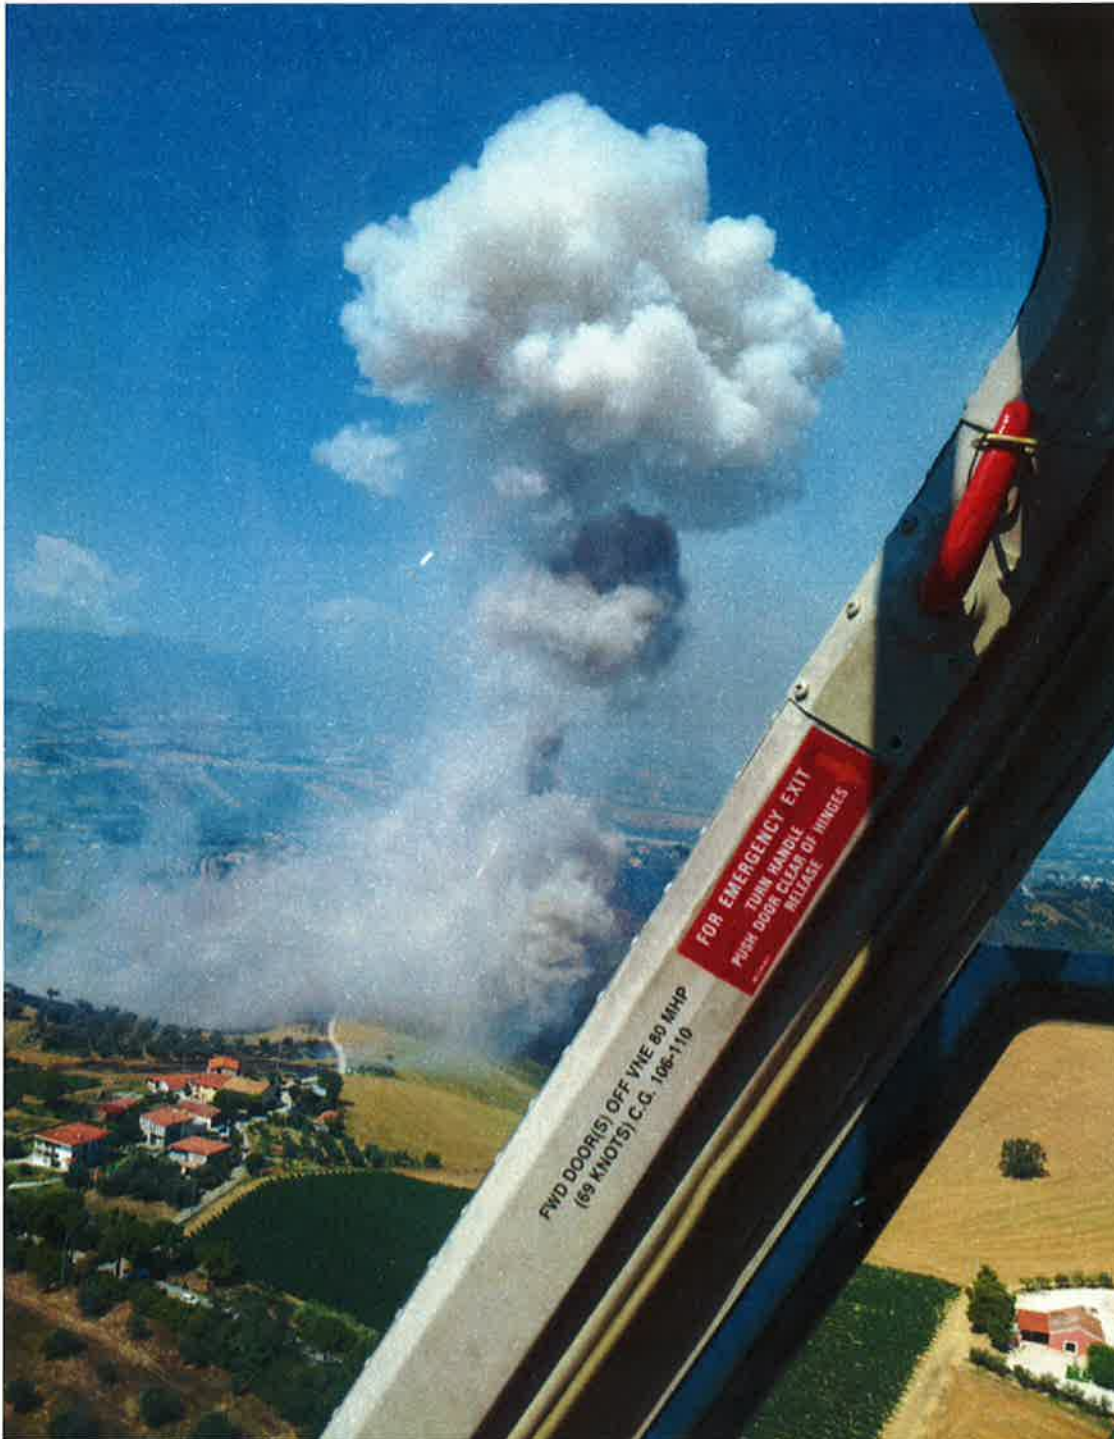
Toxic cloud emitted to the atmosphere

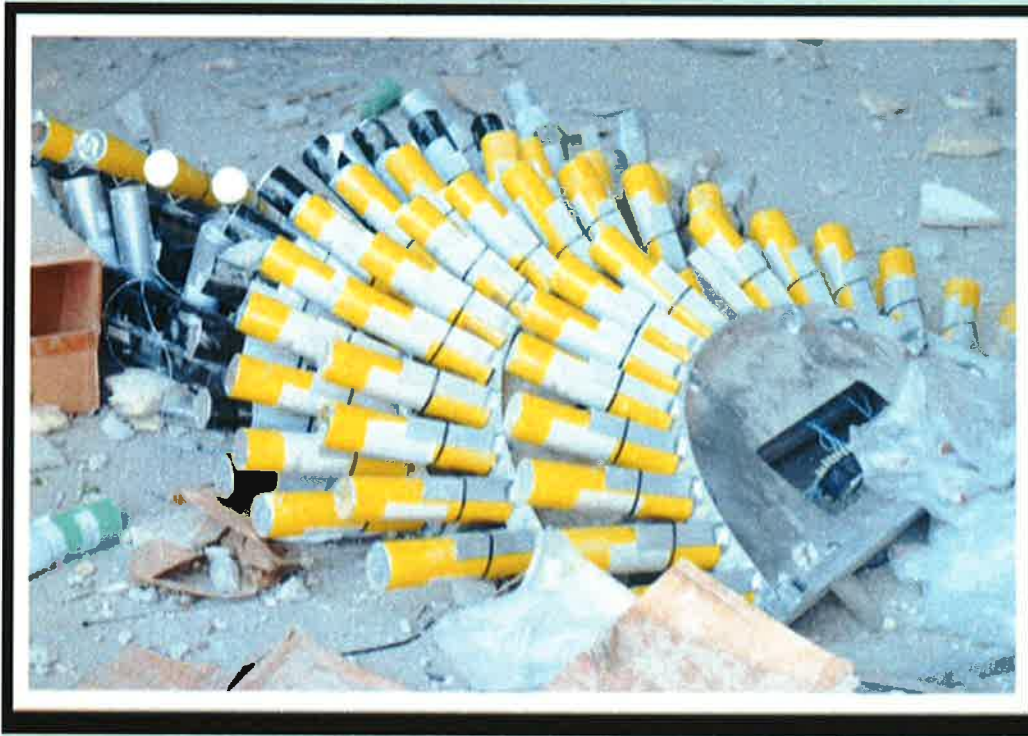
- After the accident, discovery of fireworks already “armed” with an inflammator within the remains of the plant and in the trucks parked just outside of the premises.
- According to Italian regulation, fireworks should always be assembled directly at the location of the pyrotechnical performance, and never in the production or storage facility.
- **Because of the dangerousness of assembled fireworks, there is not doubt that the transfer operations in front of buildings 4 and 5 were the trigger of the explosions.**

Assembled fireworks

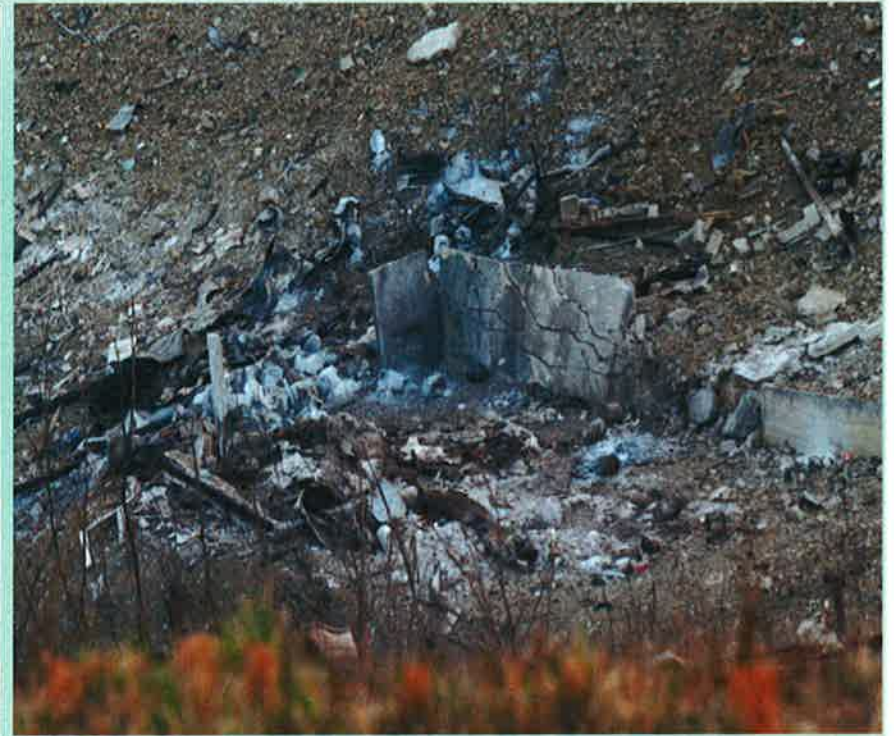
Complete desintegration of the storage buildings and their protection walls :

- evidence of a “mass explosion”
- further proof of the presence of dangerous assembled explosive products at the moment of the accident

Damages caused to the buildings and their protection walls
