The Buncefield Incident – 7 Years on: Could It Happen Again?

Colin Howard

istech Consulting Ltd, Middlesbrough, UK
istech@colizhoward.plus.com

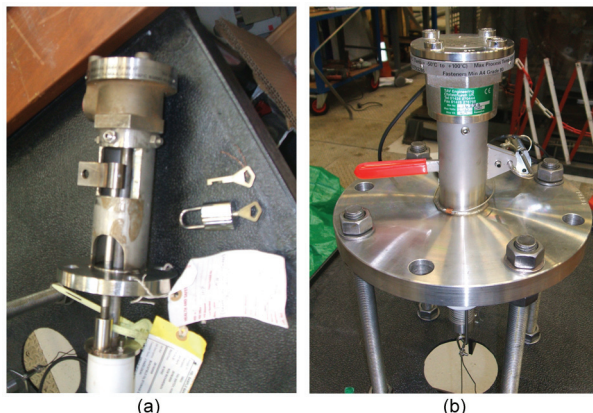
In 1987, TAV Engineering Ltd (TAV) produced their first range of checkable switches (*Figure 1(a)*). At the time, this was a good concept for high-level protection, with an in-built test mechanism, but it could not test for a sunken floating roof or a damaged float or displacer if this sensing option was

To operate the checking feature, the switches were fitted with a small plate forming a handle that could be rotated by 90° out of a rebate or detent in the switch's upstand and lifted to test the high-level switch function within the device. (Where a separate reed switch was fitted for a low-level application, the plate could be lowered to test the low-level function.) The small plate used to test the switch was provided with a padlock to lock it in its 'home' position within the rebate when the switch was in normal use; the hole was large enough to take a standard 'lock-out tag-out' padlock. As long as the plate was returned to sit in the rebate, the padlock provided additional security; it would have been difficult for the plate to have rotated out of the rebate and then moved up or down on its own. The design also provided for different cut outs in the upstand depending on whether the application was for activation on high or low level. *Figure 1(a)* shows a switch designed for a high-level application.

In 1996, TAV developed a modified design of the check mechanism by providing a larger, more easily accessible, lever mechanism (*Figure 1(b)*). A driver for this was to reduce the number of parts required and to simplify the manufacturing process. This lever was also to be locked in its normal operating position with a padlock, which could be removed to test the switch, by raising or lowering the lever, in a similar manner to that described above. This switch, however, differed from the original design in that the lever did not rest within a rebate in the upstand and was held in its normal, horizontal, operating position, at right angles to the main body of the switch, solely by use of the padlock. If the padlock was not fitted, then the lever would be readily pulled into the downward position by the effect of gravity and the attached weight of the sensing mechanism.

The fitting of, and the make and hasp size of, the padlock was critical to the correct functioning of the switch in normal operation. This essential

Figure 1. TAV checkable switch comparison: (a) original and (b) new

requirement was not, however, made explicitly clear in any of the manufacturer's documentation where the padlock continued to be referred to as being for 'security' purposes. Many users interpreted this as an anti-tamper feature, and considering their installation to be on a secure site, did not fit the padlock until advised to do so in the aftermath of the Buncefield incident.

Despite a direct instruction to relock the check lever, there is no indication of the padlock's safety critical function. The manufacturer had carried out a number of studies to verify that the functionality of the modified checkable switch range had not changed from the original intent, but crucially, they did not do a full failure mode and effect analysis (FMEA) study and consider what would happen if the padlock was not fitted or the switch was maloperated.

Following the Buncefield investigation, the manufacturer has fitted a pin through the upstand to prevent the lever falling down, even if the padlock is not fitted.

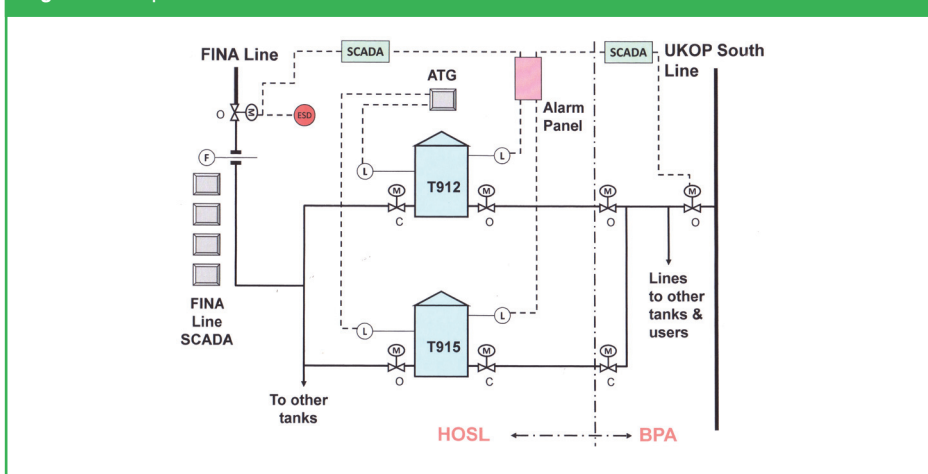
At the time of the Buncefield incident, the key features of the monitoring and control arrangements for the HOSL facility in relation to the tanks primarily involved (tanks 912 and 915) are shown in *Figure 2*. The things to note are the following:

- Four Visual Display Unit (VDU) screens for monitoring and control of the FINALine.
- Full control by the HOSL operators of the FINALine, all the way from the refinery.
- Direct measurement of the flow being received by HOSL from the FINALine.
- Only one VDU screen for monitoring the tank ATG system (20+ tanks) (if display of more than one individual tank was required, it would be 'nested' on the screen).
- Output of the independent high-level switches from the alarm panel routes through supervisory control and data acquisition (SCADA) system controlled by the programmable logic controller (PLC) to remote-operated shut-off valves in the pipeline, rather than being directly hardwired.
- Emergency stop in the control room only operates on the FINALine.
- UKOP remote isolation valve is upstream of the offtakes to other terminal users (BPA and British

Petroleum (BP)) who may not be affected by a requirement to shutdown initiated from the HOSL site, for example, a spurious trip initiation. Similar shutdown arrangements for the UKOP North line are not shown in the diagram.

- Emergency shutdown of the flow from the UKOP lines from the HOSL control room initiated by telephone call to the BPA Kingsbury terminal in the midlands.
- No direct flow measurement of the flow received from BPA.

There is no evidence that the changes to the control room arrangements in the mid-1990s had been subject to a formal review or management of change

Figure 2. Simplified overview of fuel transfer

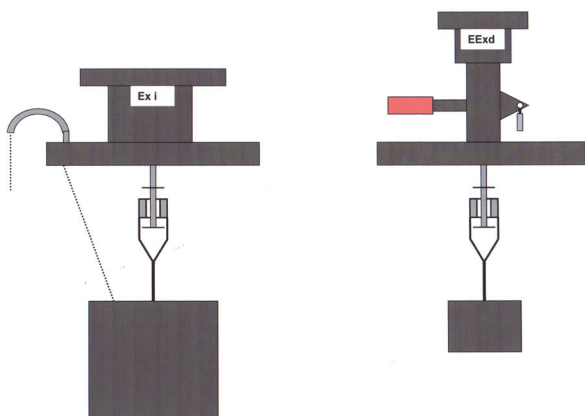
A final opportunity to identify that the replacement was not 'like for like' came with the actual installation (*Figure 3*). The switch removed from tank 912 was clearly different from the one to be fitted, most notably in the large displacer rather than the small weight and the different checking mechanism. At some stage during the installation process, the padlock was removed from the new switch and not replaced; its vital importance to the safe operation of the new switch was not recognised.

Figure 3. Like for like replacements?
