## Ethylene release in LDPE plant and the effect of aging design

TWG2 Webinar – 8. February 2022  
Vibeke Henden Nilssen

# Release of ethylene gas - September 2021

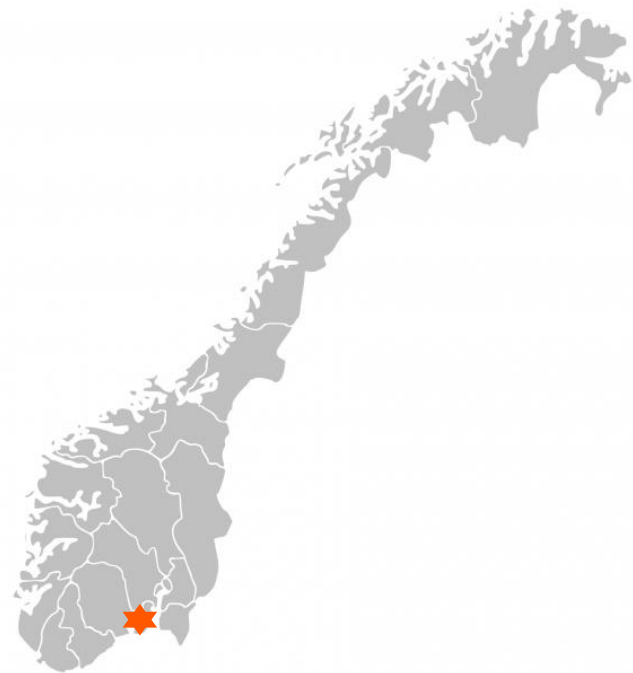
- LDPE plant (Low Density Polyethylene) – lower tier Seveso site - located in the south of Norway
- Construction period 1973-1977
- Norwegian oil and gas company as the original operator
- With shifting ownership through the years, the site today consists of one LDPE plant
- During normal operation, an ethylene gas leak occurred from a manual valve on the bottom outlet line on a high-pressure vessel

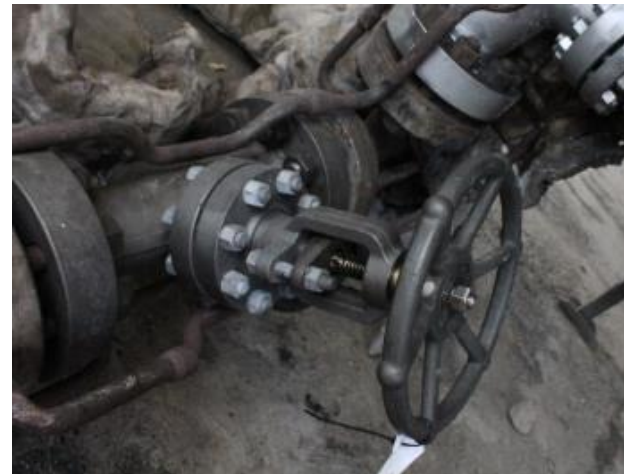
- Gas detectors in the nearby area gave alarm to the control room and the operators identified it as a gas leak in the recycle area of the plant
- Plant alarm was initiated and the fire brigade alerted
- Emergency shut down was activated from the control room
  - The emergency shut down system includes a remotely operated flare valve, which was blocked upstream by a manual closed valve

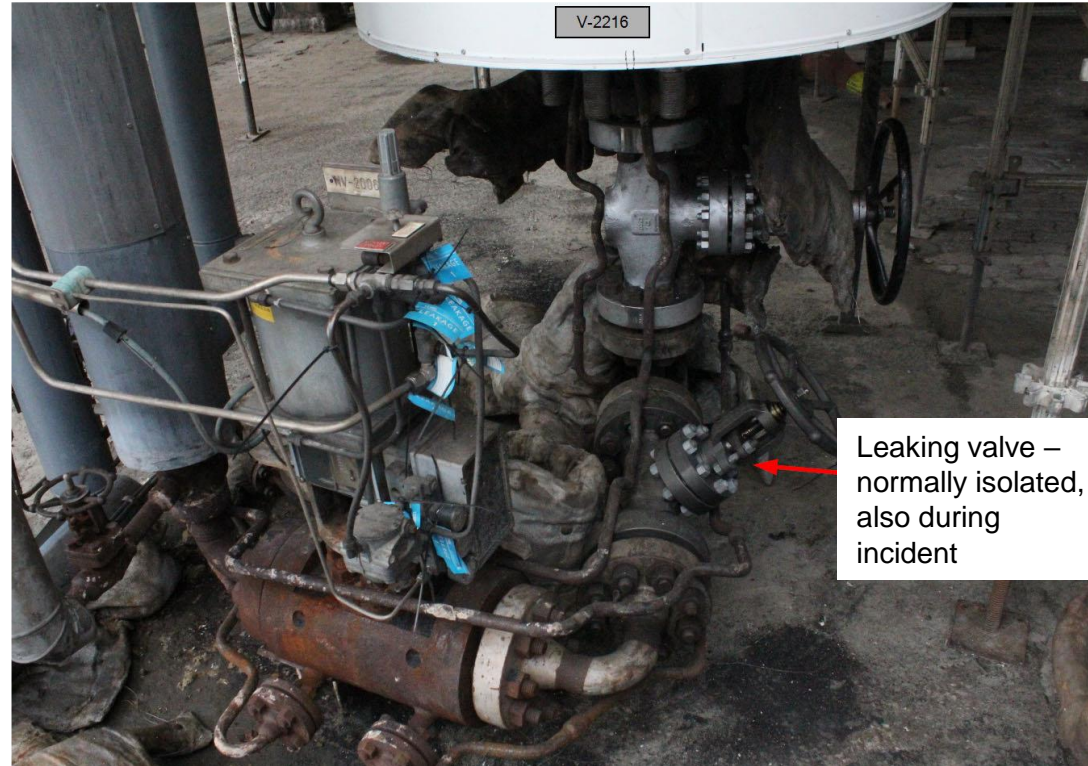
- The leak lasted about 70 minutes in total with approx. 800 kg of ethylene gas released
- The system had a gas pressure of 280 barg and a temperature of 80 degrees Celsius
- The leaking valve was installed new autumn 2019. No maintenance since

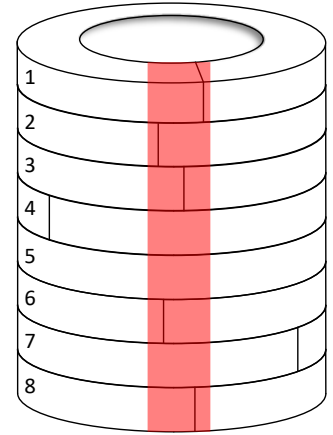
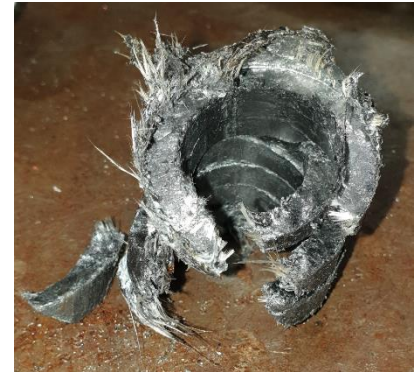
- The leak is likely due to wrong installation of the packing material installed in the valve stuffing box (by vendor)
- This has probably weakened the packing ability to withstand pressure

1. Ensuring packing material is installed correctly from vendor might require new procedures.
2. Closing manual valve upstream flare valve to protect it from wear is not recommendable. Suitable valve installation for the process conditions must be followed so that important functions are intact and operational.

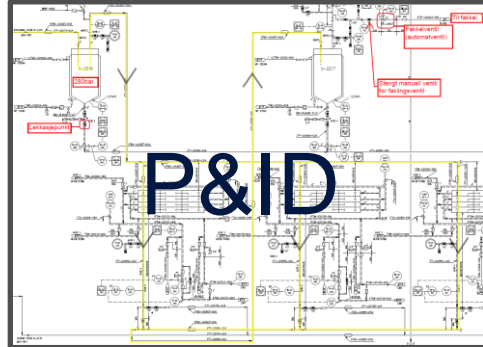
280 bar  
in  
vessel

V1: Point of gas  
leakage

V3: Remotely  
controlled flare  
valve (part of  
emergency shut  
down system)

V2: Closed manual  
valve (original  
design)

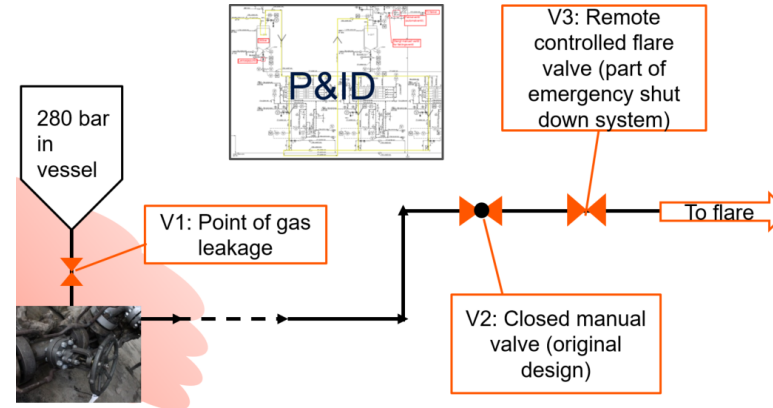
- The released amount would have been much lower if the manual valve (V2) upstream the remotely controlled flare valve (V3) had not been closed
- The valve (V2) was closed due to leaking of gas through the flare valve (V3) to the flare during normal operation
- If the flare valve (V3) had been available (not blocked), the system could be depressurized earlier

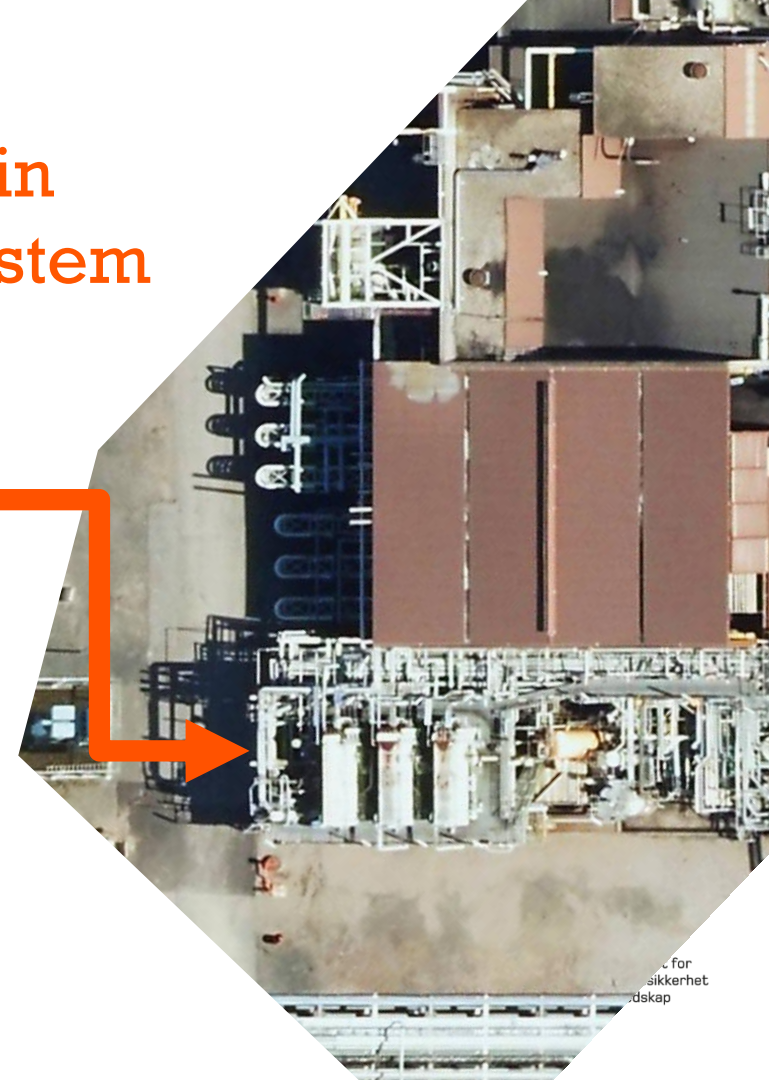
- The manually closed valve (V2) to the pressure release system (to flare) was located just above the point of leakage
- There it was not safe to enter the area in order to open the valve, until the pressure was decreased to a certain level (after about 60 min pressure was 60 bar)
- This resulted in a high release rate of gas for a long period of time

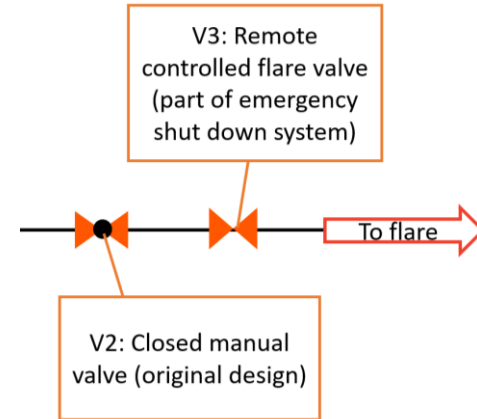
- Original design of the plant was with a manual valve to the flare system
- The system was modified by installation of a remotely controlled valve. The remotely operated valve became then a part of the emergency shut down system
- Due to process conditions this new valve had malfunctions through several years
- The emergency shut down function was then intendedly put out of function
- During the accident this showed to be an important missing safety function and escalated the amount of gas released
- Other design solutions should have been evaluated earlier

New type flare valve was already planned for test during the planned stop of the plant in autumn 2021 and is now installed.
