WEBINAR ON RISK MANAGEMENT AND ENFORCEMENT ON AGEING HAZARDOUS SITES AND ON MAINTENANCE OF PRIMARY CONTAINMENT SYSTEMS

ISPRA, 8th february 2022

**Inspection experiences on ageing infrastructure and
equipment control: case studies**

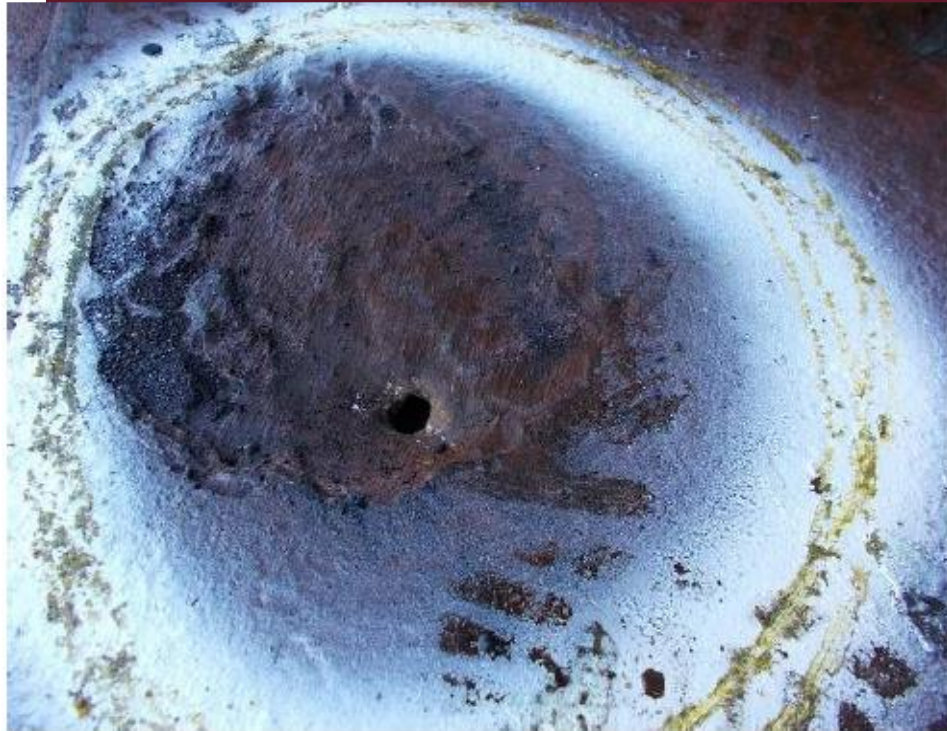
- accident caused by the corrosion of the bottom tank D
- oil leakage under the bottom due to possible cracks in the (flexible) bituminous membrane, in contact with the annular (rigid) concrete foundation
- oil vertical migration from the unsaturated zone (soil under the tank) towards the saturated zone (underground aquifer) for 6 meters
- internal inspection of tank D showed the presence of crater-like corrosion on the bottom, more pronounced in the perimeter area
- **localized corrosion** with the formation of 3 through- holes in the central plates, and 7 through- holes in the annular ring, 4-7 mm depth

Three through-holes in
the central plates -
localized corrosion

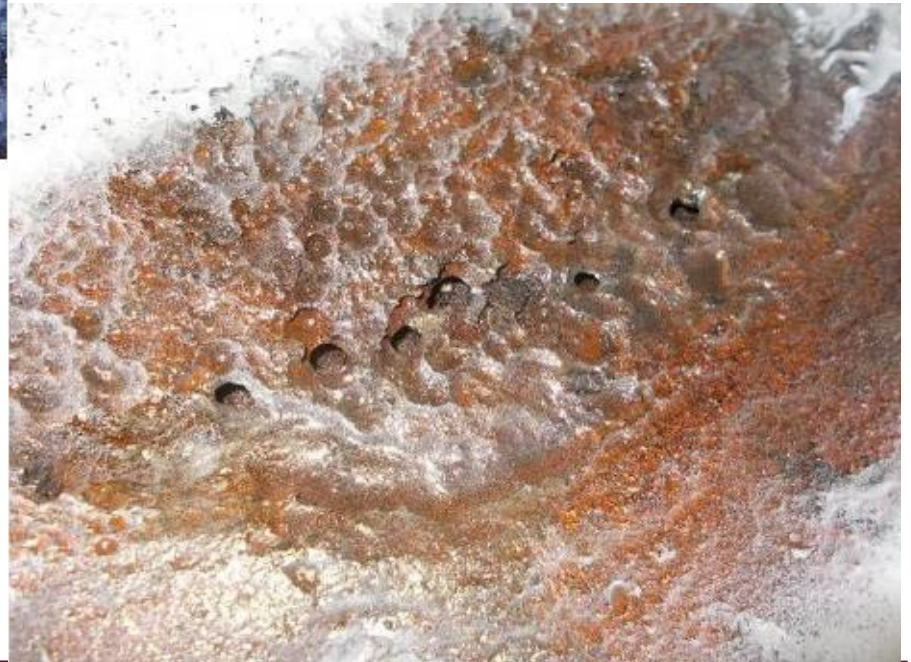
Seven through-holes in
the annular ring -
localized corrosion

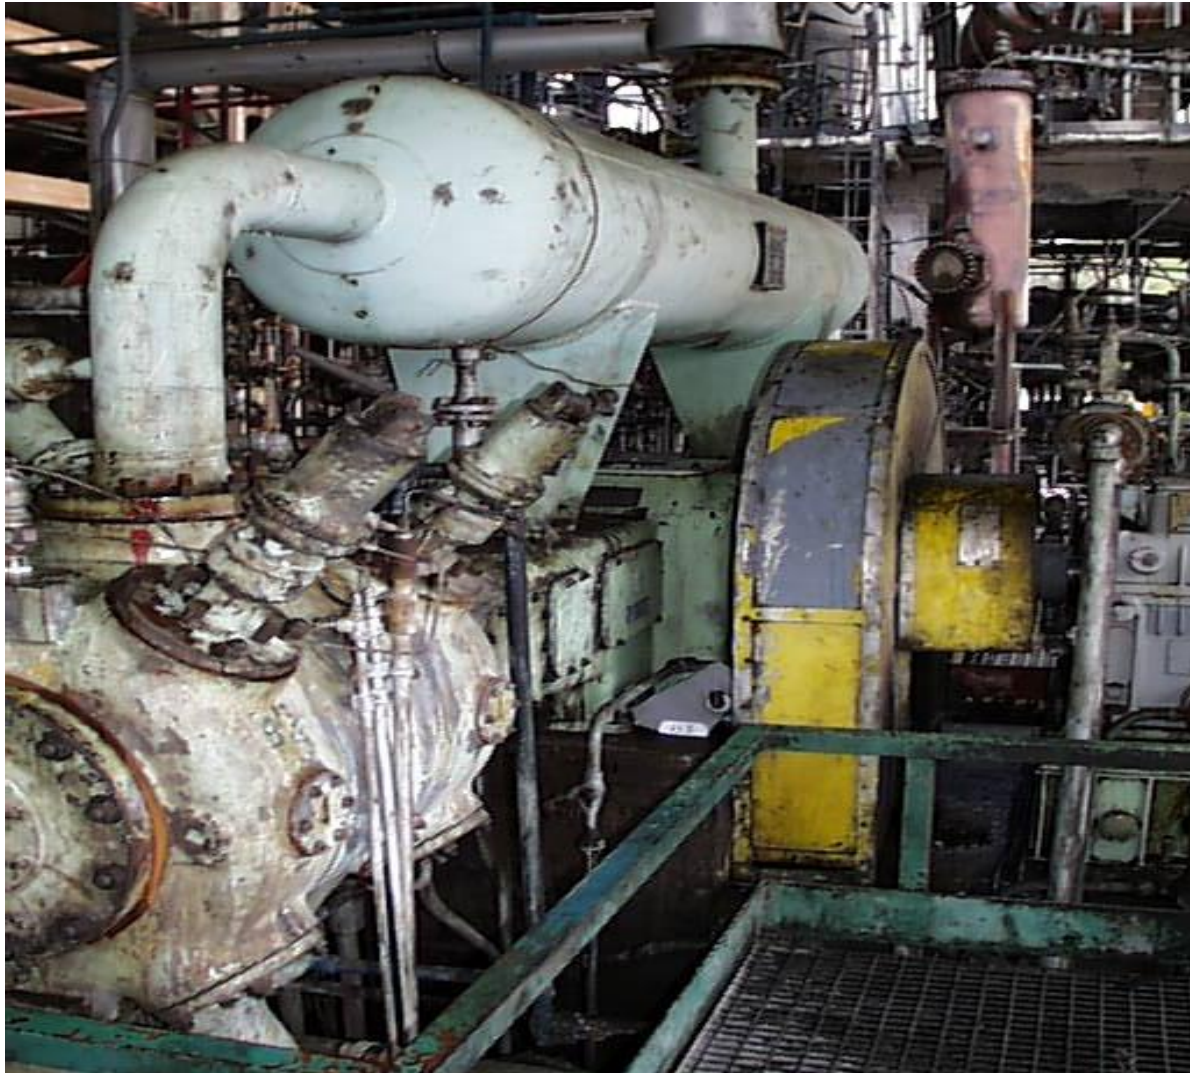
CASE 2: ACCIDENT LINKED TO THE AGEING OF RECIPROCATING COMPRESSOR – COMPRESSOR B

- rupture of the crankshaft-rod mechanism in the compressor, consequent hitting action of the piston on the bottom of the cylinder no.2
- the combined effects of hitting-action with the internal pressure (20 bar) led to the failure of the screws, which hold the bottom
- regular controls/maintenance activities on the compressor B since the last 3 years (according to the technical manual and the supplier's indications: pumping part revision (east and west side), valves substitution (east and west side), speedy joint substitution, compressor general revision, substitution of nuts of crank-rod, revision of sealing packages
- leader supplier on the market

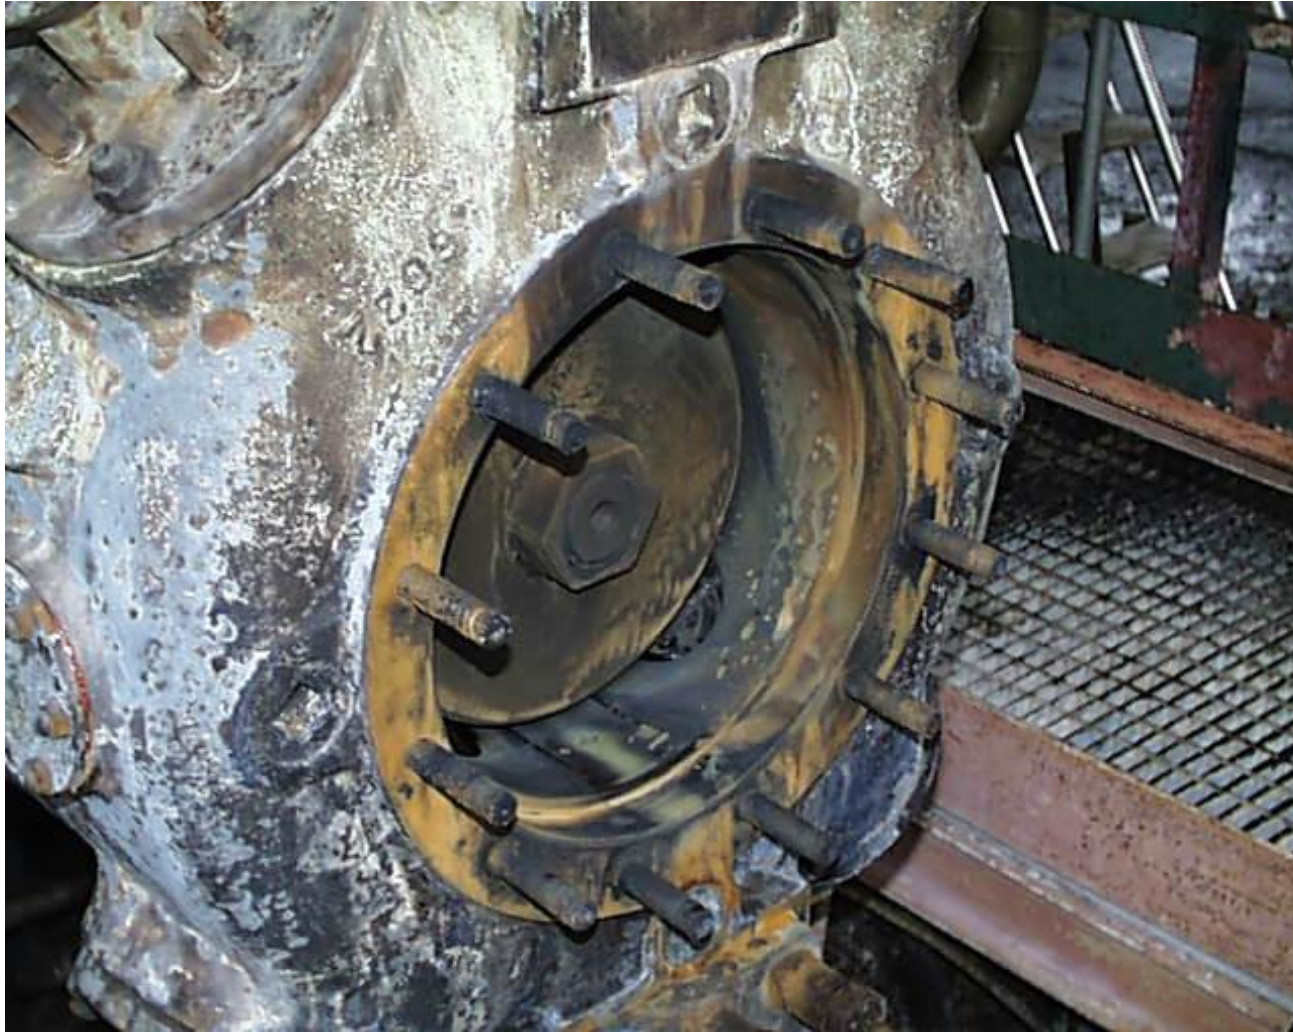
CASE 2: ACCIDENT LINKED TO THE AGEING OF RECIPROCATING COMPRESSOR SCREWS DETERIORATION

- **Defects/damages:** mechanical failure of the bottom of compressor; rupture of the crankshaft-rod mechanism: tests and analysis of the materials of the mechanical parts broken showed defects at the origin (production defects, already present at the moment of the supply)
- **Deterioration:** overly stressful conditions of exercise for the kind of compressor; other compressor deficiencies were found: orientation, vibrations detector system, hand stop-valve in suction. A substitution of the two reciprocating compressor by a centrifugal compressor was planned and realized, together with use of interception electro commanded valves in suction lines in order to limit possible gas release
