Runaway reactions. Part 2 Causes of Accidents in selected CSB case histories

Dr. Zsuzsanna Gyenes^a and Phil Carson^b

Summary

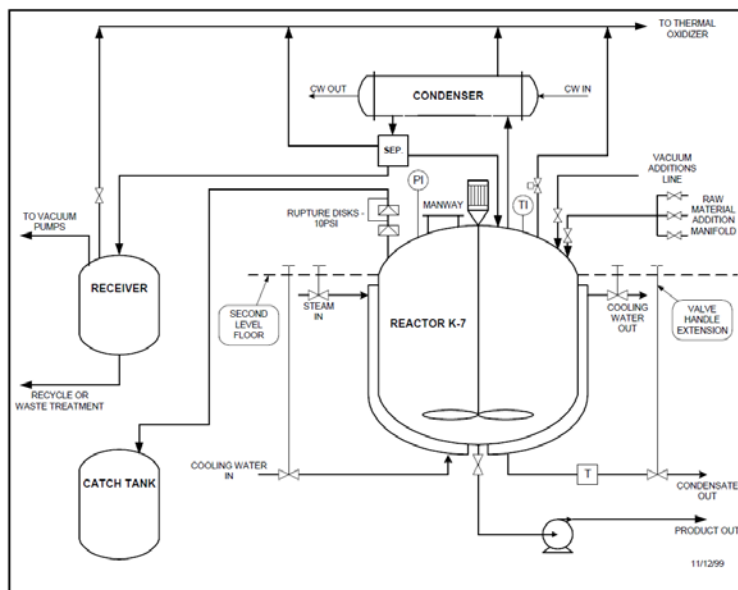
Figure 1: Simplified process diagram (Source: CSB)

The initial runaway reaction was most likely caused by a combination of factors, such as

- the reaction was started at a temperature higher than normal
- the steam used to initiate the reaction was left on for too long, and
- the use of cooling water to control the reaction rate was not introduced soon enough.

Though reasons for these excursions were not given it is noted that the reactor temperature was controlled by operators manually adjusting the flow of steam and cooling-water piped to the kettle and the positioning of the valves was left to their experience. This could result in different operators adopting different settings which was particularly risky since the operating temperature of 150°C was close to the runaway decomposition temperature of 195°C. Kettle instrumentation measured pressure of reactor and cooling-water and temperature. The latter used a single thermocouple linked to a digital display and recorder chart; the chart could not record temperatures > 150°C. The reactor was not equipped with temperature or pressure alarms, automatic shut-down facility or dump/quenching systems.

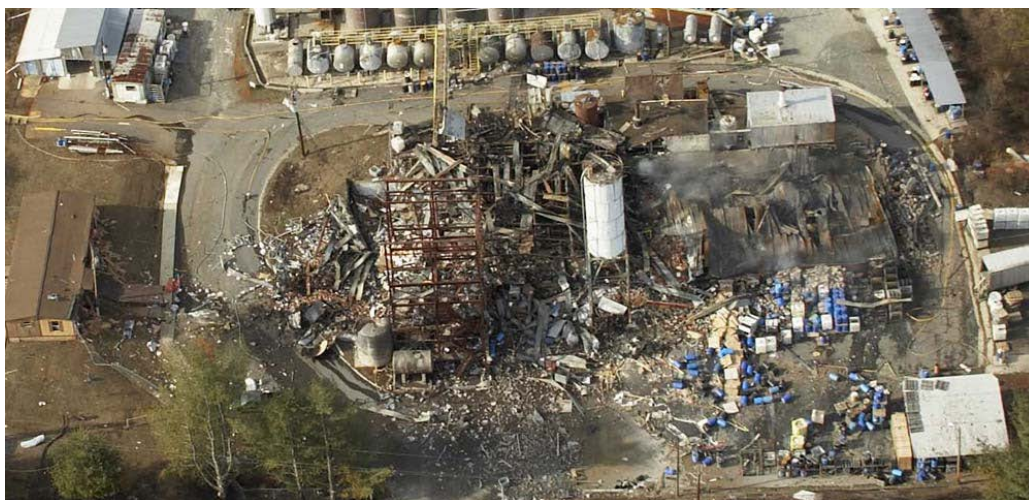
Figure 2: Synthron facility after the explosion (CSB report⁶)

The main causes relate to Company failings

- lack of knowledge/hazard recognition including that used in scale-up from laboratory to production and between production batches)
- poor documentation
- poor practices (e.g. manway bolting procedures entailed securing the manway using only 4 of the 18 clamps, thereby allowing solvent vapour to escape well below reactor's maximum allowable working pressure)
- lack of staff training
- lack of preventative maintenance
- inadequate plant design/safety features including automatic safeguards
- flawed emergency plan
- inadequate corporate oversight.

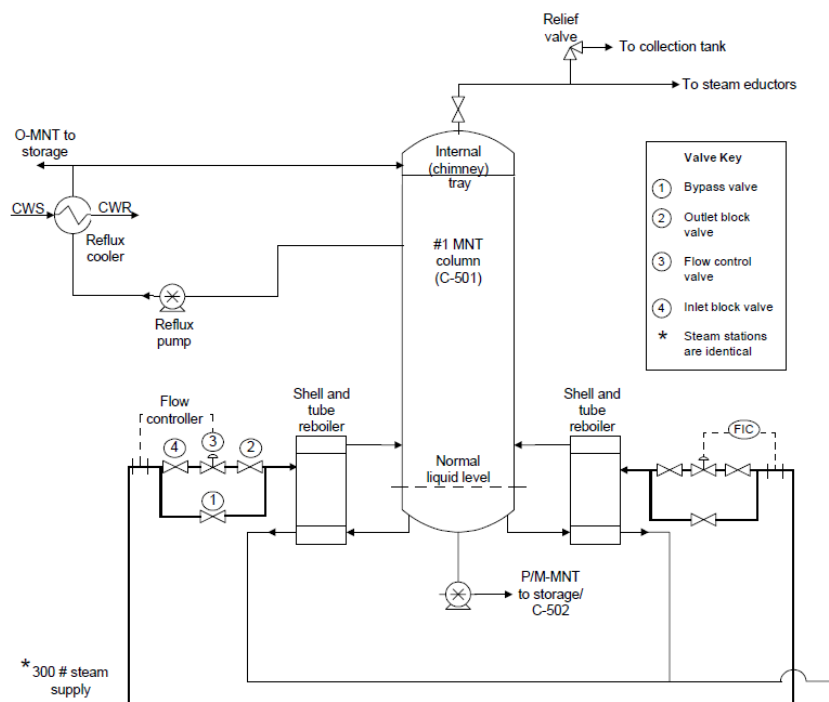
Figure 3: MNT distillation column (C-501) and related equipment

During the several days of shut down the column bottoms had been inadvertently exposed to steam from leaking valves. Nitrotoluenes are known to decompose instantly when exposed to high temperatures and if exposed to elevated temperatures for extended periods, generating gases which could cause pressure build-up if contained. In fact, in 1996 the company performed thermal testing in a separate batch process within the same facility. The test indicated that MNT should be kept below 370°F (187 °C) to avoid decomposition. As a result, temperature limits were incorporated into operating procedures and an interlock system was installed to prevent the distillation equipment from overheating. These procedures clearly warned operations personnel not to exceed 395°F (201°C) in the still pot for more than an hour due to “production breakdown”. Since the test was done in a batch process the company did not integrate these findings nor suggested any modifications to the operating procedures in the continuous process, although the same chemical was used. The column was equipped with temperature indicators these were not fitted with alarms. The silencing of the high-level alarm by operators with no follow-up action accidentally worsen the situation and contributed to the accident. The consequences of this incident were also exacerbated by inadequate evaluation of the location and structure of the control room, and poor community notification.

- Inadequate understanding of the potential hazard of thermal decomposition in continuous processing equipment.

- Insufficient instrumentation to allow monitoring and control of the process to prevent a catastrophic release (alarms, interlocks, overpressure protection).
- Lack of a system to ensure isolation of heat sources.
- Inadequate preventive maintenance, which allowed leaks in isolation valves.

Proactive identification of the hazards based on literature and review of internal company batch operations. Good working practices and training would have prevented steam leakage on to column, monitoring column temperature during shutdown, investigating relevance of high-level alarm. Facilities handling dangerous substances, especially those that are prone to explode should be designed with multiple safety layers of protection. Given the fact, that the MNT left in the column when the unit was shut-down and not verifying positive isolation of the heat source made the conditions in the vessel similar to those in batch operation. In those cases, high temperature interlock should be in place.
