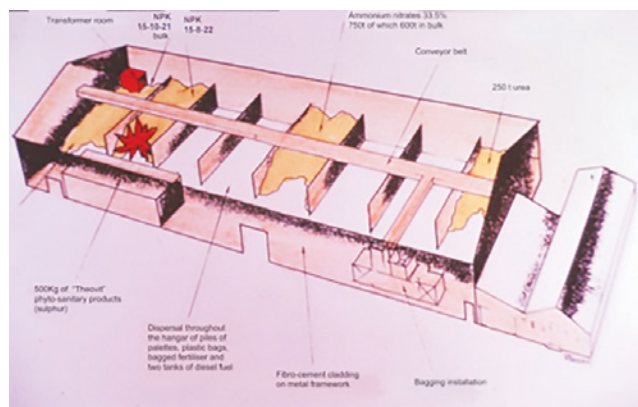
Figure 2: The installation concerned<sup>14</sup>

A fire occurred in a warehouse storing fertilizers and chemical products. The storage installation was subdivided into eight compartments, of which two contained NPK (15% N, 8% P, 22% K) fertilizers in quantities of 600 tonnes and 850 tonnes respectively. One compartment also contained 650 tonnes of ammonium nitrate fertilizer and the other was also storing 200 tonnes of 46% urea solution. On 29 October 1987, smoke was detected by an operator in Box No. 2 of the warehouse, i.e. the compartment that contained 850 tonnes of NPK fertilizer<sup>14</sup>. The first reaction of the personnel was to attack the source of the fire with portable fire extinguishers, in the absence of activated fire hose reels. The intervention of the firefighters appeared to focus solely on the presence of ammonium nitrate fertilizer, ignoring the nature of the other chemical products. The accident resulted in the slight injury of three employees and 38,000 people were evacuated for eight hours.

Due to the conditions of transport (in the holds of a ship that had previously stored wheat) and the storage conditions (on a bed of sawdust to dry the floor of the box), the fertilizer became mixed with organic material. Also, it was found that defective, poorly insulated power cables were near the fertilizer pile. Furthermore, wooden pallets were in contact with the fertilizer compounds. These compounds then caught fire during decomposition and released heat, accelerating the decomposition.

The NPK fertilizer had been unloaded the day before the accident and completely filled the capacity of the storage compartment. At the time no abnormalities in the product (e.g., caking) were observed, although the temperature at the time (40°C) should have been identified as a cause for concern. Furthermore, the electrical installation of the site was old and other potentially unsafe conditions were present, such as lack of insulation, incomplete grounding, oversized circuit breakers as identified by a private verification in a 1986 report. (No repairs were conducted as follow-up to the report.) The zone in which the fire started was located below the electrical cables that hung beneath the transport motor. Finally, there was no effective means of firefighting in place, such as a water riser or a self-propelled fire hose.

- Appropriate extinction equipment for the products stored must be available to personnel trained in the prevention of risks, the detection of abnormalities and in emergency response. In this case, the personnel of the establishment were not aware of the risks associated with fertilizer and only had powder extinguishers which are ill-adapted to this type of fire. No water extinguishing equipment or fire hose reels were available on the site.

- A sound characterisation of the risks involved, particularly involving an understanding of dangerous materials implicated is indispensable for implementing efficient fire prevention and fire-fighting plans. Doubtlessly the loss of information concerning the nature of the products involved in the fire played a major role in the development of the incident. In the absence of characterisation of the products present and thus of the risks involved, disagreements between experts occurred which delayed an effective response. Furthermore, the establishment was not classified by the fire department and was not subject to an emergency plan. It is essential that each emergency centre should hold an inventory of potential risks for its sector of intervention to enable efficient response from the moment that the alarm is given.

- Effective response requires also that there should be adequate and permanently available sources of water including, for example, when the tide is going out.

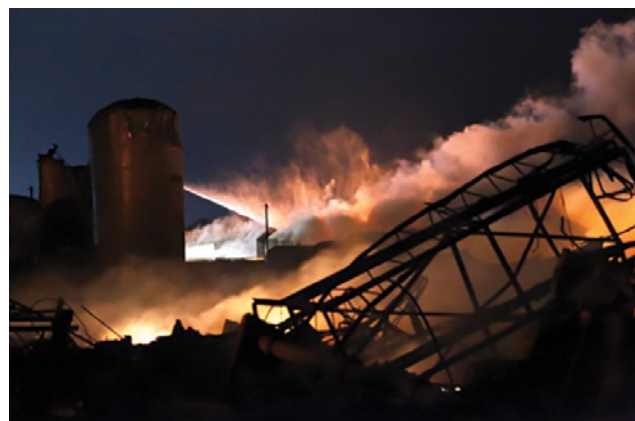
West, Texas explosion 2013
