Major accidents involving contractors

Dr Zsuzsanna Gyenes, *European Commission, DG Joint Research Centre, Italy*

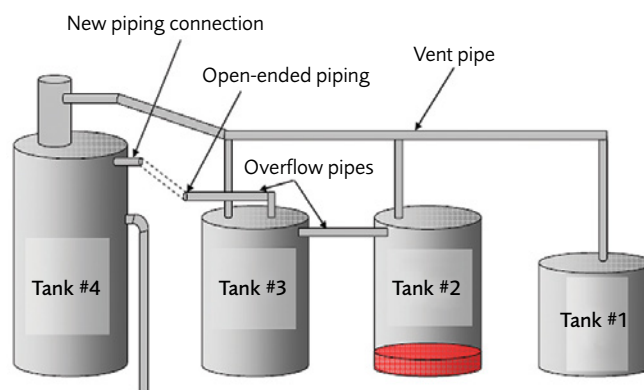
Figure 1 – Tanks involved in the incident (CSB)

The accident occurred when contract workers were installing a new pipe connection from two storage tanks (tanks 3 and 4) to a third one (see figure 1). To prepare for the welding operation, they removed the hatch at the base of tank 4 and entered the tank to remove the crude oil residue. Then they flushed the tank with fresh water and allowed hydrocarbon vapour to evaporate for several days. They did not clean out or purge tanks 2 or 3. On the day of the accident, one worker inserted a lit oxy-acetylene welding torch into the hatch and then into the open nozzle on the opposite side of the tank to verify that all flammable vapour had been removed before welding, which is clearly an unsafe practice. The workers laid a ladder on the tank roof, extending it across the 1.2 m space between the two tanks (tanks 3 and 4). Almost immediately after the welding operation began, sparks ignited the flammable vapour escaping from

an open-ended pipe about 1.2 m away from the contractors' welding activity on a fourth storage tank nearby. The explosion killed three of the contract workers and seriously injured a fourth one.

The accident occurred because neither company (i.e. the client oil company and the contractor company) used available guidelines for hot work safety or had a permit to work system. The client oil company did not require this latter one. In addition, the contractor company had no hot work procedure for welding activities at the worksite. Moreover, it was revealed that most welders hired by the contractor company were expected to have knowledge or experience of how to weld, and given this assumption, the contractor did not provide hot work safety training to its employees.

The client company should develop and implement written procedures and provide contractor training to ensure safe work practices during hot work, tank cleaning and work at elevated locations. These measures would have assisted contract workers in identifying and eliminating hazards prior to beginning the welding operation. Finally, when two or more oil tanks are linked to each other, the connection pipes should be equipped with isolation valves to prevent the escape of flammable vapour.

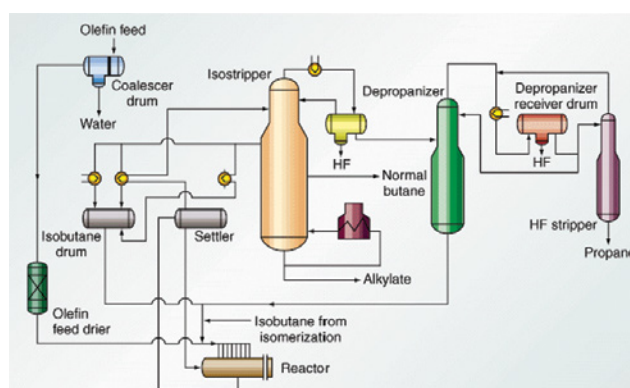
Figure 2 – Illustration of the HF Alkylation Unit (OGJ)

In preparation for an alkylation unit shutdown, the major equipment had been emptied and the installation cleaned with nitrogen (see figure 2). It was then decided to drain the unit to remove all remaining fluids. The drain consisted of two valves and a blind flange. The blind flange was removed and replaced by a T-piece consisting of a manometer and a small valve. The T-piece was mounted in a horizontal way. A permit was written for two contractors to add a copper tube to the small valve on the T-piece. Because it was not easy to work with the T-piece mounted horizontally, they without notice decided to rotate it. While rotating the piece, the handle of the small valve touched a pipeline and the valve opened, releasing hydrofluoric acid. Both contractors were injured, one of them seriously. The T-piece on the drain was a temporary piece only installed for the shutdown. There was no standard in the company to which temporary pieces had to comply. The T-piece used screw thread, which made it possible to turn the T-piece.

The accident highlighted the need for a standard for temporary pieces. The operator should ensure that all contractors understand the hazards associated with a temporary workplace and the process in case of emergency, by requiring them to receive training prior to their work. In the company, it was seen as normal that the manual valves in the line on which the T-piece was fitted had a small internal leak. Therefore, the work permit should have specified protective clothing for working on this line, as they would have anticipated that hydrofluoric acid would build up between the fixed (leaking) valves and the quarter turn valve on the temporary T-piece. A quarter turn valve is easily manipulated accidentally, certainly while doing mechanical work in the immediate vicinity.

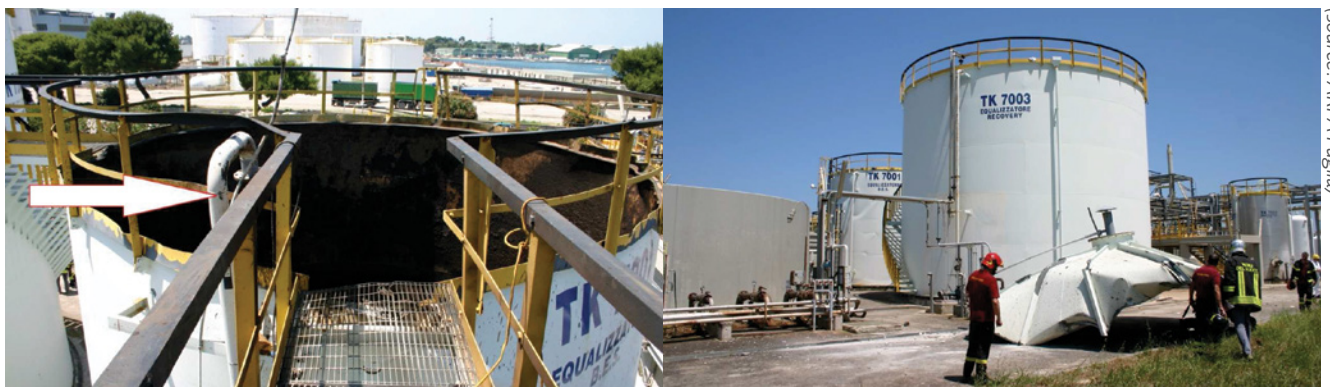
A vapour cloud explosion occurred in a fixed-roof cylindrical atmospheric tank (TKX) containing BES (bottom aqueous layer from stripping in waste water treatment) during hot works on the tank feed line (see figure 3). The existing feed line had been

Figure 3 – Pulled-off sparger line on the TKX viewed from the walkway and the projected roof at the foot of the TKX

cleared up and disconnected from the tank, without closing (blind flange) the tank or the line. The tank was half filled with BES. The aim of the maintenance operation, which had been contracted out to an external company, was to add a second feed line to the TKX tank. There were four contractors and one employee of the establishment involved in the hot work. One of the contractors started to cut the line with an electric disk cutter, generating sparks. These sparks ignited the explosive atmosphere present inside the tank causing an explosion, which resulted in the roof of the tank being thrown 20 metres. The contractor who was standing on the top of the roof, holding the line to be cut, was thrown with the roof and died in the accident. The other four workers, who were on the walkway leading to the tank, were injured by the debris of the tank. It was discovered that the operator had not considered the explosive characteristics of the BES and therefore this scenario was not included in the hazard identification studies or the risk assessment process. Consequently, the unit that involved the TKX tank was not classified as an ATEX area that would have excluded the use of electrical equipment such as electric disk cutter.

The investigation revealed that the work permit procedure was not adequately applied during the maintenance operation and work permits forms were incorrectly filled by both contractor and operator. In particular, the safety measures required for 'hot' maintenance operations were not adopted. Further to these, written safety procedures were not clear and therefore caused confusion regarding the delivery of authorisation to the contractor. These aspects should be avoided by having an adequate permit to work system, with roles indicated and clear written safety procedures in place. Also, the operator should be knowledgeable about the characteristics of the substances appearing in the process, even if they are by-products of fermentation in the waste treatment unit – such a scenario should be included in the hazard identification studies and the risk assessment. These findings also question the efficiency of the plant safety requirements, specifically because internal oxygenation of the tank in order to avoid undesired fermentation must have been conducted regularly.
