Loss Prevention Bulletin

Disaster Anniversaries

Issue 251, October 2016

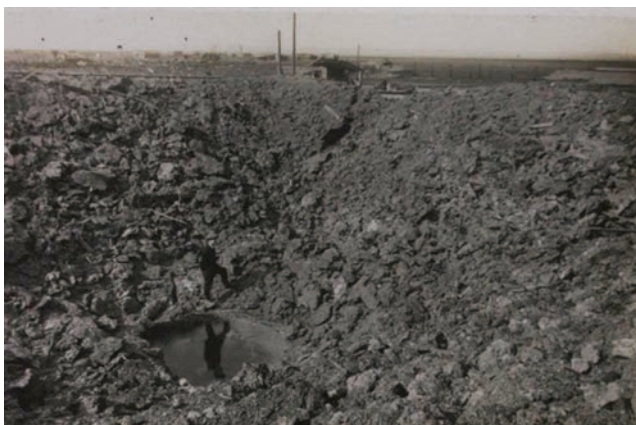
Figure 2 – Crater created by explosion of building 217 (note man in centre)

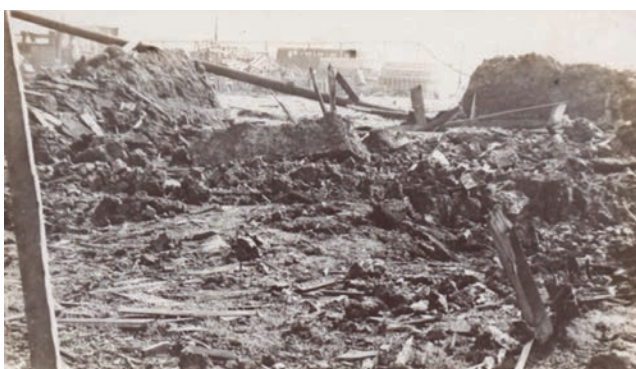
Figure 3 – Remains of building 844

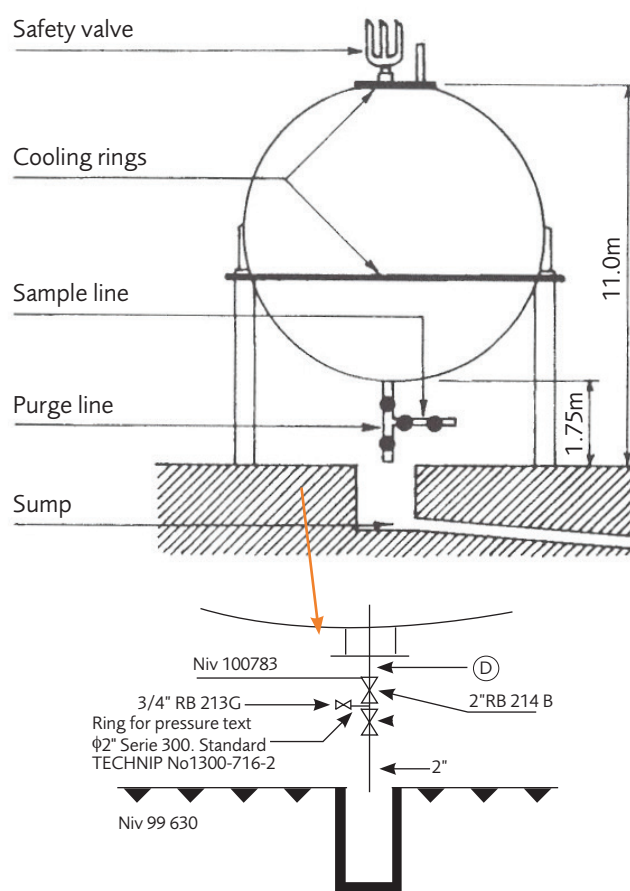
Figure 1 – Schematic representation of the purge valve configuration, Source – N° 1 - 04/01/1966 - FRANCE - 69 - FEYZIN

upper valve and then cracked it open again. There was no flow and he fully opened this valve. The blockage, which was presumably a hydrate or an ice plug, suddenly cleared, and propane gushed out, but the operator was unable to close the upper valve because it had frozen. He did not think at once to close the lower valve and by the time he attempted this, this valve had also frozen open. The leaking propane splashed up from the drain and frost burnt the operator on the face and forearm.

The primary cause of the propane leak was the operational failure by the plant operator; this was made easier by the difficult access to the valves and the lack of permanent valve spanners. It is likely that a solid plug of ice or propane hydrate stopped the draw-off line above the upper valve. This plug released when the upper valve was fully opened. The discharge from the drain line was directed downwards in the immediate vicinity of and under the valves, instead of to the side. This caused frost burns suffered by the operator and formed the cloud, which made the recovery and re-positioning of the valve lever impossible.

- Fit a remotely controlled emergency isolation valve in the drain line.
- Install flammable gas detectors to provide early warning of a leak.
- Provide deluge systems with sufficient water supply to flood the surface of the storage vessels. These systems must be regularly maintained and tested.
- Slope the ground so that any spillage runs off to a collection pit and does not accumulate under storage vessels.
- Insulate vessels with a fire resistant insulation, such as vermiculite or mound the vessels with sand or similar.
- The legs of spheres should be protected against fire and impact with missiles.

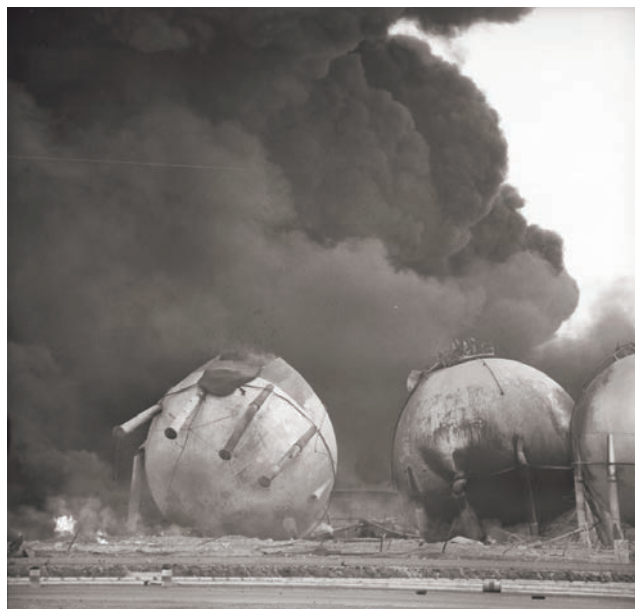
At around 7:15 a.m. the sphere was enveloped in a fierce fire. Its pressure relief valve lifted at 7.45 a.m. and the escaping vapour ignited. Following the ignition at the pressure relief valve the firefighters stopped spraying the sphere, as they considered the opening of the valve as positive and assumed that the tank would burn itself out over a period of the next two to three hours. They then concentrated instead on cooling the other spheres. At around 8.45 a.m. the sphere ruptured, killing the men nearby. A wave of liquid propane was flung over the compound wall and flying fragments cut off the legs of the next propane sphere, which toppled so that its relief valve began to emit liquid and then exploded. Further BLEVEs occurred at around 9.30 a.m.

Burnt out storage spheres, Feyzin. Courtesy of Collection Bibliothèque municipale de Lyon, Fonds Georges Vermard, P0702 B02 07 618 00001

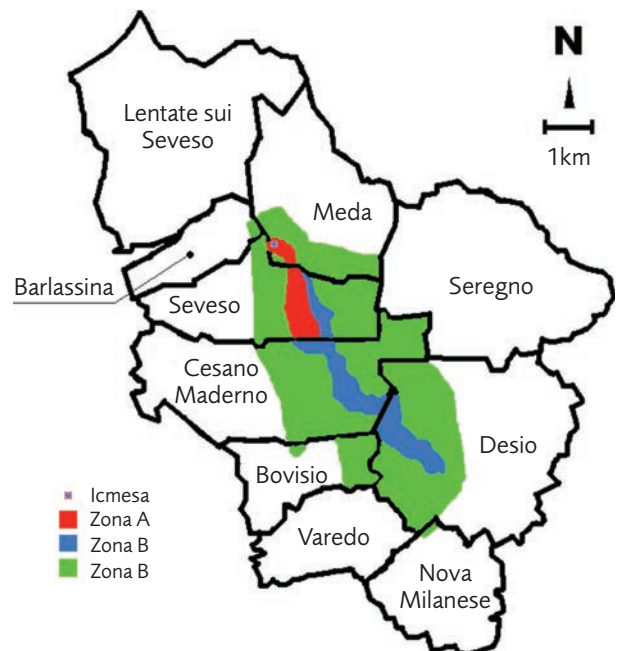
Figure 3 – Contamination zones (it.wikipedia.org, public domain)

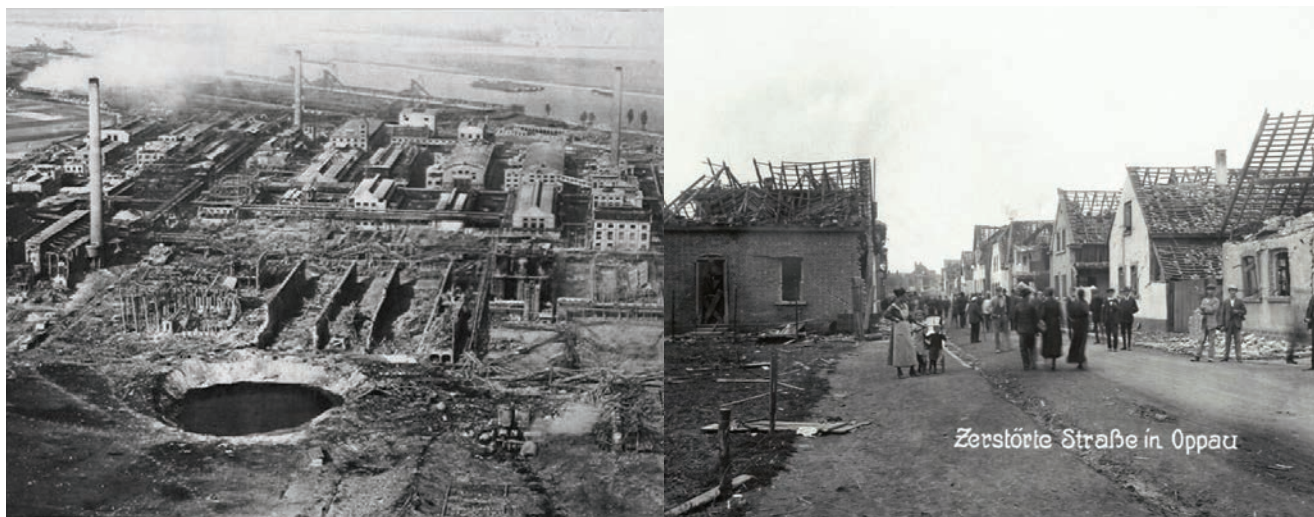
Figure 1: Oppau – The consequences of the explosion¹

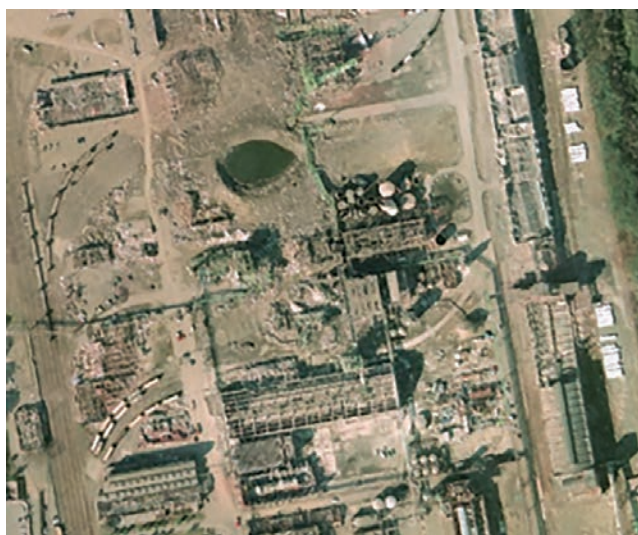
Figure 2: The area affected by the explosion (Source: Archives Grande Paroisse¹⁷)

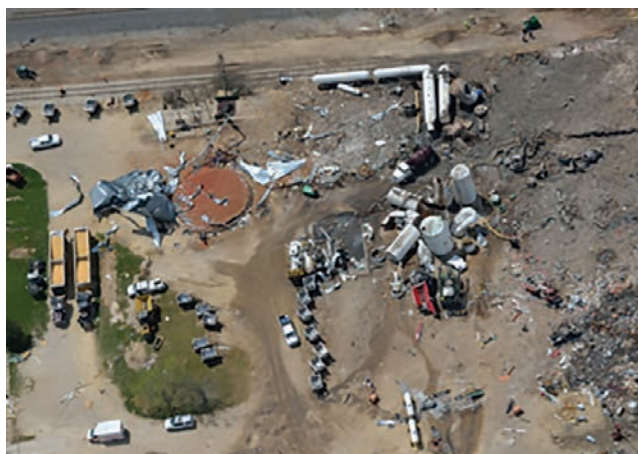
Figure 3: West explosion aerial photo (Source: Shane Torgerson)
