Chemical Accident Prevention & Preparedness

Learning from incidents involving liquefied natural gas (LNG) on fixed sites

This 13th issue of the Lessons Learned Bulletin (LLB) accompanies the publication of the JRC's Good Practice Report on Risk Management and Enforcement on Liquefied Petroleum Gas (LPG) and Liquefied Natural Gas (LNG) Sites. The Good Practice Report provides an extensive description of the properties of LNG and typical risks associated with LNG production, storage and handling. This issue focuses on incidents on fixed sites although some of the lessons may also be applicable to LNG transported on land and sea. The next issue of the LLB will cover lessons learned from incidents involving LPG storage.

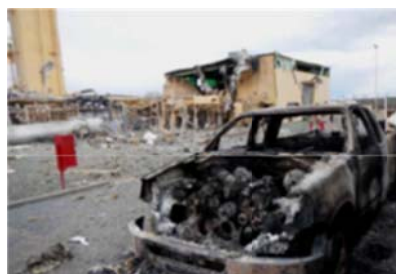
Figure 1. One of the twin adsorbers lying on its side. Compressor building in center-back. Refrigerant tower top-left. (PHMSA, 2016)

Debris from adsorber D20A and the associated piping caused extensive damages to the surrounding plant facilities, including penetration of the outer shell of the LNG-1 storage tank, a significant number of process units, plus the plant communication

The apparent cause of the failure was determined to be the auto-ignition of a gas-air mixture left in the piping after the pack and purge that was conducted on March 18, 2014. This pack and purge occurred 13 days prior to liquefaction startup. The following are considered contributing factors:

- The low toughness of the adsorber metal allowed it to fail in a brittle manner causing fragmentation and creating the potential for serious domino impacts. The exploded equipment generated debris that acted as high velocity projectiles. The debris penetrated the outer shell of the LNG-1 storage tank and nearly penetrated the inner shell. Rupture of the LNG-1 storage tank would have released. The control room was also severely damaged and after the incident, it was relocated.

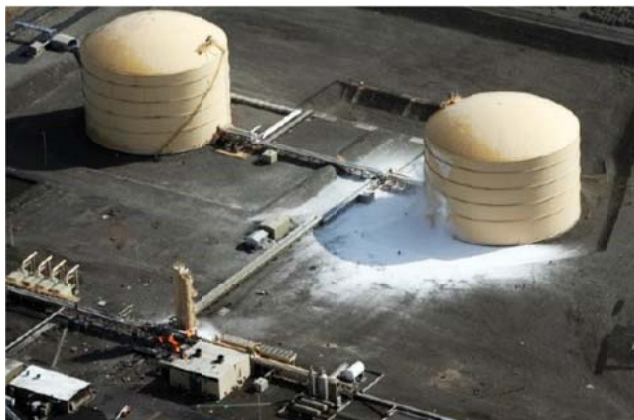
It was unknown at the time of the incident whether the inner tank shell of LNG-1 had been penetrated by debris. Hence, a decision was made to evacuate the town and the surrounding communities within a two-mile radius.. Additionally, an instrumentation pipe located near the bottom of the LNG-1 tank was damaged, allowing LNG to release in a spray and vaporise. There was no pooling of the LNG and there was no resulting vapour (methane) cloud that left the plant. As soon as the plant was made safe, personnel wearing cryogenic suits, entered the facility and closed the valve between the damaged pipe and LNG-1 tank wall, shutting off the LNG release at the tank. The release continued for approximately 25 hours. A total of 234 barrels was released.

Figure 2. Aerial view taken shortly after the failure. Fires still burning. Perlite insulation leakage from the penetrated outer LNG-1 storage tank. Control room lower left. (PHMSA, 2016)
