Lessons Learned Bulletin No. 13

Learning from incidents involving liquefied natural gas (LNG) on fixed sites

Number 13 December 2018

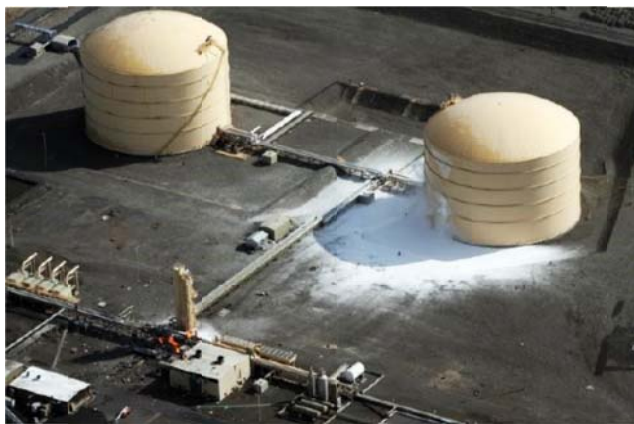
It was unknown at the time of the incident whether the inner tank shell of LNG-1 had been penetrated by debris. Hence, a decision was made to evacuate the town and the surrounding communities within a two-mile radius. Additionally, an instrumentation pipe located near the bottom of the LNG-1 tank was damaged, allowing allowed LNG to release in a spray and vaporize. There was no pooling of the LNG and there was no resulting vapor (methane) cloud that left the plant. As soon as the plant was made safe, personnel wearing cryogenic suits, entered the facility and closed the valve between the damaged pipe and LNG-1 tank wall, shutting off the LNG release at the tank. The release continued for approximately 25 hours. A total of 234 barrels was released.

Figure 2. Aerial view taken shortly after the failure. Fires still burning. Perlite insulation leakage from the penetrated outer LNG-1 storage tank. Control room lower left. (PHMSA, 2016)
