Major accidents related to ageing

The aim of the bulletin is to provide insights on lessons learned from accident reported in the European Major Accident Reporting System (eMARS) and other accident sources for both industry operators and government regulators. In future the CAPP Lessons Learned Bulletin will be produced on a semi-annual basis. Each issue of the Bulletin focuses on a particular theme.

CHEMICAL ACCIDENT PREVENTION & PREPAREDNESS

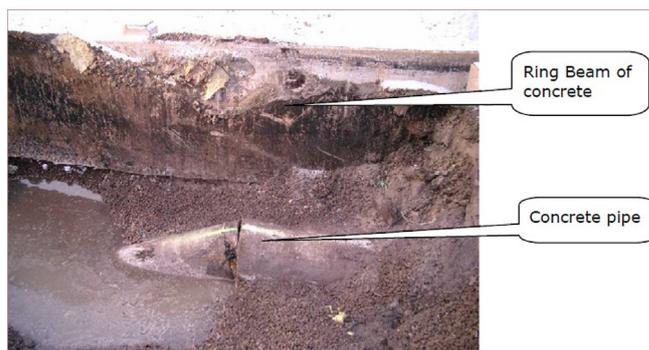
The cause of this incident was a leak in an underground coolant supply pipe of reinforced concrete installed over forty years before that resulted in a weakening of the ground under the tank farm. Apparently, water forced its way out of the pipe, eroding the ground near and around the sulphuric acid tank. This erosion damaged the ground under the tank which ultimately failed due to the lack of support of the tank floor. A study of the appearance of the involved part of the coolant supply pipe suggests that the corrosion was a result of an acidic attack on the concrete.

- The pipe had been in use over many years and the operator had no suspicion that the pipe was suffering severe degradation. The inspection of the failed pipe after the incident detected little or no internal corrosion, but heavy external corrosion to the concrete. In certain places the concrete had corroded so severely that the reinforcing steel was exposed.

Figures 1 and 2: The damaged tank and underground pipeline (Source: Swedish Investigation Board report).

- Similarly, underground piping that entail risks to foundations should be inspected and measured.
- There are a number of strategies that can be applied to piping where there is accelerated potential for degradation or where there are high consequences should significant degradation occur. Pipes may, for example, be tested for stability (remains in place) and hydraulically checked on a regular basis. Alternatively, consideration should be given to positioning the pipe above ground. The pipe could also be placed in casings, especially where a leak may cause damage to the surroundings or where pressure and ground deformation may cause damage to the pipe.
