CHEMICAL ACCIDENT PREVENTION & PREPAREDNESS

Major accidents related to ageing

Number 7
June 2015

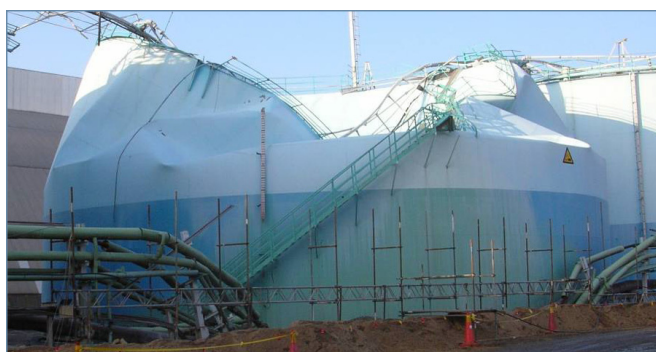
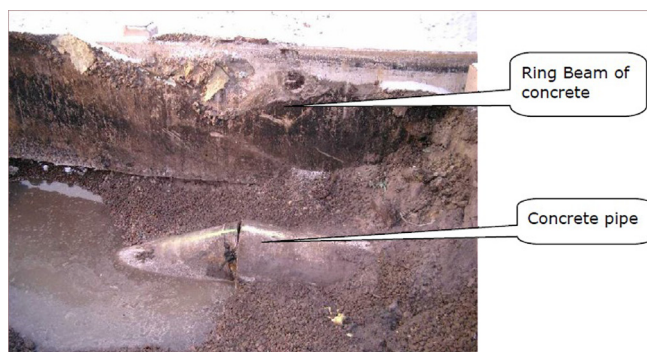
The cause of this incident was a leak in an underground coolant supply pipe of reinforced concrete installed over forty years before that resulted in a weakening of the ground under the tank farm. Apparently, water forced its way out of the pipe, eroding the ground near and around the sulphuric acid tank. This erosion damaged the ground under the tank which ultimately failed due to the lack of support of the tank floor. A study of the appearance of the involved part of the coolant supply pipe suggests that the corrosion was a result of an acidic attack on the concrete.

- The pipe had been in use over many years and the operator had no suspicion that the pipe was suffering severe degradation. The inspection of the failed pipe after the incident detected little or no internal corrosion, but heavy external corrosion to the concrete. In certain places the concrete had corroded so severely that the reinforcing steel was exposed.

- According to the German standard, DIN 4030 (equivalent to the European standard, EN 260) a strong attack on concrete occurs if the pH level in surrounding water is < 5.5 and a very strong attack can occur if the pH level is < 4.5 . Fifteen years before the accident a ground pollution study was carried out in the area, during which one of the sample taking points was close to the failed coolant supply pipe. At this point the pH level was measured at 4 in the shallow groundwater. With this knowledge the company drew the conclusion that this pH level entailed risks for strong acidic attacks on the concrete.

Figures 1 and 2: The damaged tank and underground pipeline (Source: Swedish Investigation Board report).

- The uneven corrosion on the outside of the pipe can possibly be explained by the fact that it lay partly in groundwater flow. In this environment, the acid can pass through the barrier more easily, and the reaction products (gypsum) formed can be more easily dissolved. As such, the concrete barrier was not as effective as on the part of the pipe that remained in drier surroundings. Therefore, concrete piping exposed to ground water should be subject to protective measures, monitoring and inspection to take into consideration the increased risk from groundwater exposure.

- Similarly, underground piping that entail risks to foundations should be inspected and measured.
- There are a number of strategies that can be applied to piping where there is accelerated potential for degradation or where there are high consequences should significant degradation occur. Pipes may, for example, be tested for stability (remains in place) and hydraulically checked on a regular basis. Alternatively, consideration should be given to positioning the pipe above ground. The pipe could also be placed in casings, especially where a leak may cause damage to the surroundings or where pressure and ground deformation may cause damage to the pipe.

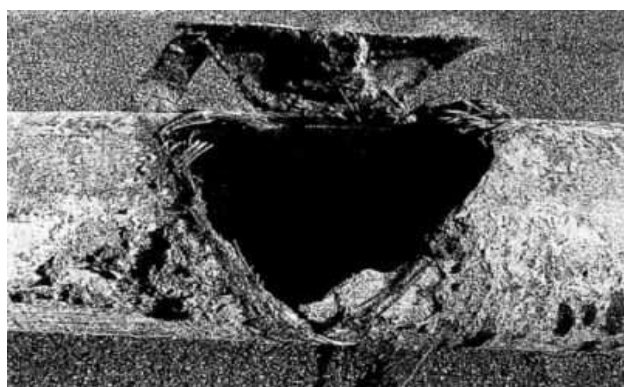
Figure 5: The damaged pipeline (Source: ARIA No. 23562)

Deterioration of the infrastructure was due to a corrosion mechanism occurring in an acid-stressed environment. A number of factors contributed to this accident. One factor is ageing. The corrosion of the pipe material caused an effective loss of strength. In addition, the process design did not adequately address the pressure surge that could occur when the pump is shutdown, in particular, insufficient number of vents made difficult to cope with this situation that is a routine part of the process. Furthermore, there was a failure in installation because of incorrect setting of the surge chamber pressure.

- Leaks were primarily noticed adjacent to pipe elbows and during directional changes. The pressure never exceeded 5 bar vs. a 10-bar design pressure, in a diluted sulphuric acid medium with a temperature below 35°C. The maximum temperature allowed for GRP tubes was 50°C. Therefore, the fact that failures occurred near or at high points and near a change in direction, confirms the role played by hydraulic transitions.

- It was demonstrated that the damage to the pipe was due to a mechanism of stress corrosion in an acid environment. Stress corrosion is a fissuring mechanism that requires a combination of three factors, such as stress or permanent distortion, the material sensitive to the phenomenon and a corrosive environment.

- Although the pipes and their assembly complied with the provisions in the regulations as required by the project service order, the installation of the pipe and pressure control systems were not in accordance with good custom and practice. In particular, they were not compliant with the original installation specification, sizing of the buffer chamber and calculation of the number of vents required.

- Even without the mistakes in design and installation, corrosion of critical components of the equipment would ultimately have led to failure, and therefore, should be subject to a systematic inspection program similar to all safety critical elements.
