## CHEMICAL ACCIDENT PREVENTION & PREPAREDNESS

### Major accidents involving explosives

## MAHBULLETIN

Number 8  
December 2015

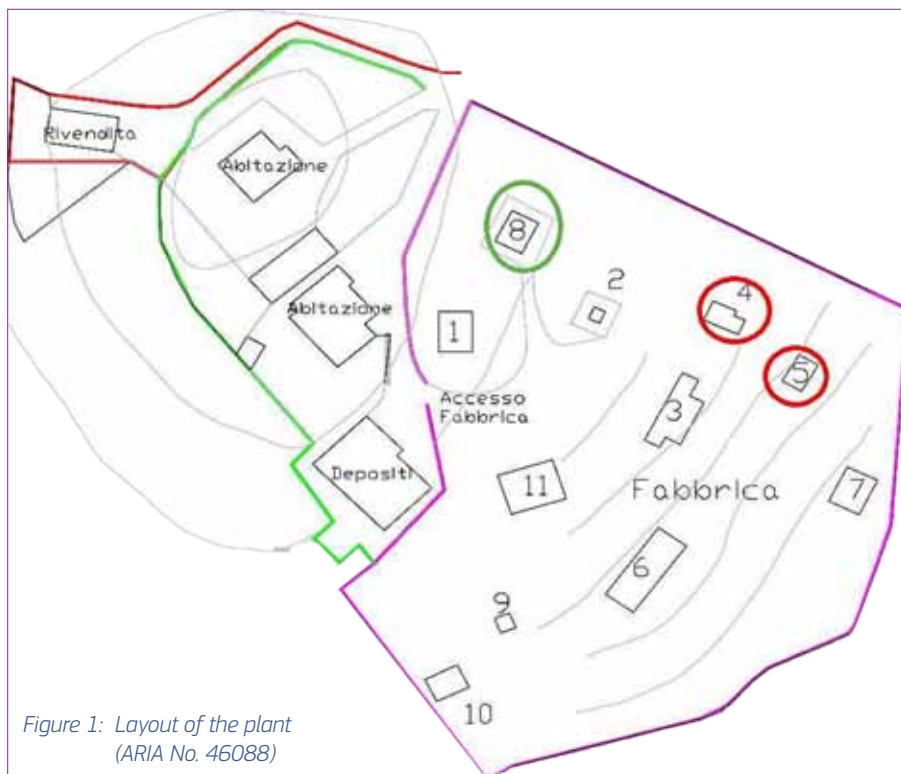
Figure 1: Layout of the plant (ARIA No. 45088)

A series of explosions occurred in the finished products storage area of a fireworks factory. The initial three explosions in short succession presumably occurred in the vicinity of sheds No 4 and 5 (Figure 1), which were used to store finished products (fireworks). Forty minutes after the first three detonations a fourth explosion occurred in explosives storage building No 8. At the time of the first series of explosions three workers, the operator and two technicians were transferring fireworks from the shed No

4 to shed No 5, using a small truck that was available for internal transfer. All of them died immediately in the first set of explosions. The fourth victim, the operator's son was killed in the fourth explosion while he was looking for his missing father.

A fire fighter was also hit by a projection triggered by the explosion of building No 8 and died in the hospital three months later. The successive explosions destroyed the factory and the blast waves caused serious damages in the buildings within a 500 m radius. The damage caused as a result was estimated to be more than 1.5 million Euros.

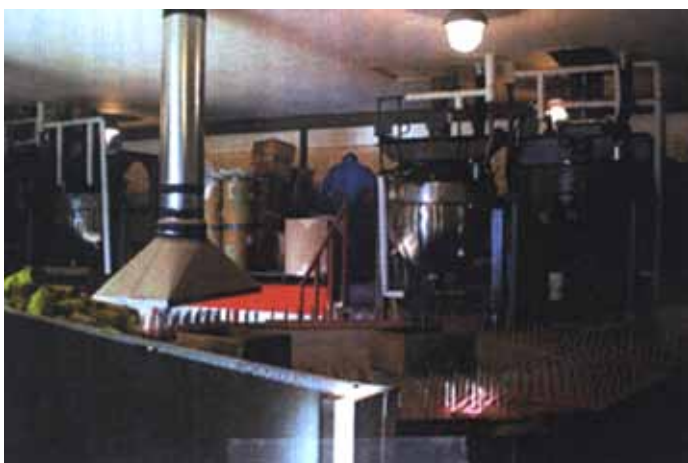
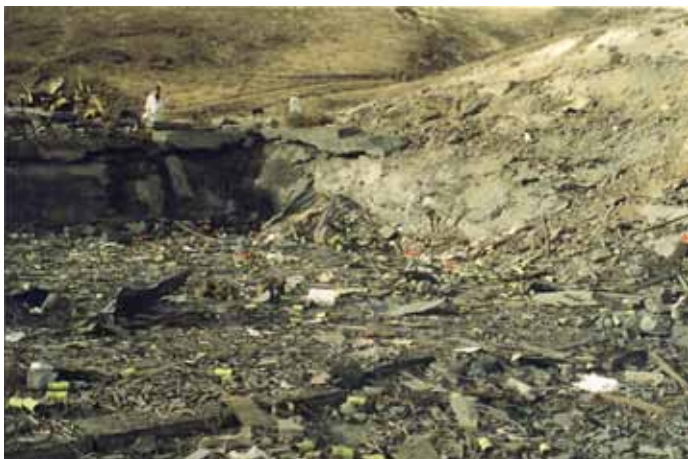
Two massive explosions just seconds apart destroyed the Sierra Chemical Company's Kean Canyon explosives manufacturing plant in Nevada, killing four workers and injuring six others. Because everyone was killed, the exact cause of the accident could not be determined. However, it is thought that on the day before the incident, leftover base material was left in the mixing pot by an operator but this information was apparently not communicated to the next shift. The next morning the worker returned, and may have assumed that the pot had been emptied. Without checking its contents, the worker turned on the motor to the agitator blades, setting off the initial explosion. This explosion occurred in a room where workers made "boosters" - small explosive devices used in the mining industry to detonate larger explosives. A second, more powerful blast destroyed a building used for drying explosives, leaving a 40-by-60-foot (12 m x 18 m) crater that was up to six feet (1.8 m) deep. The explosions had the force of a magnitude 2.0 earthquake and were felt some 20 miles (32 km) away from the plant. Sierra Chemical estimated that in all, 47,000 pounds (21 t) of explosives were consumed during the accident. The facility was never rebuilt.

Figures 2 and 3: Booster Room 2 before and after the explosion (CSB)

It is speculated that explosive material remained in a pot over night and due to the low outside temperature it solidified. The bottom of the mixer blade, which was embedded in the solidified explosives in the pot, detonated the explosives by impact, shearing, or friction of the explosive material with the pot wall. Another possibility is that chunks of explosive material were pinched between the mixer blade and the pot wall, causing the detonation.

- Process Hazard Analysis (PHA) was conducted for Booster Room 1 applying the same process as Booster Room 2. However, no PHA was conducted for Booster Room 2. Furthermore, supervisors and workers were not involved in the hazard identification activities.

- The storage facilities and the two workshops were closer to each other than it is determined in the related guidelines, allowing propagation of explosion to occur. Also, it was found that building constructions were not compatible with the recommendations by the Department of Defense guidelines.

- A process hazard analysis was only conducted on one activity. Process hazard analysis should be conducted for all dangerous activities on site. Moreover, workers were not involved in the hazard identification. Had they been, they may have pointed out additional dangerous activities that should be subject to the PHA.

- It is particularly important that high risk sites also employ appropriate technical measures to counter safety management system weaknesses. Appropriate separation distances between buildings are a standard technical measure to mitigate explosive risk. Having a protective building structure in place that complies with regulations could also prevent further injuries in case of an accident.
