Chemical explosion in Tarragona, Spain 2020 - key aspects of the DNV investigation

DSB – Norwegian Seveso Conference 2021

21 September 2021

The IQOXE plant in Tarragona, suffered a large explosion on 14th of January 2020 causing multiple fatalities, injuries and major damage:

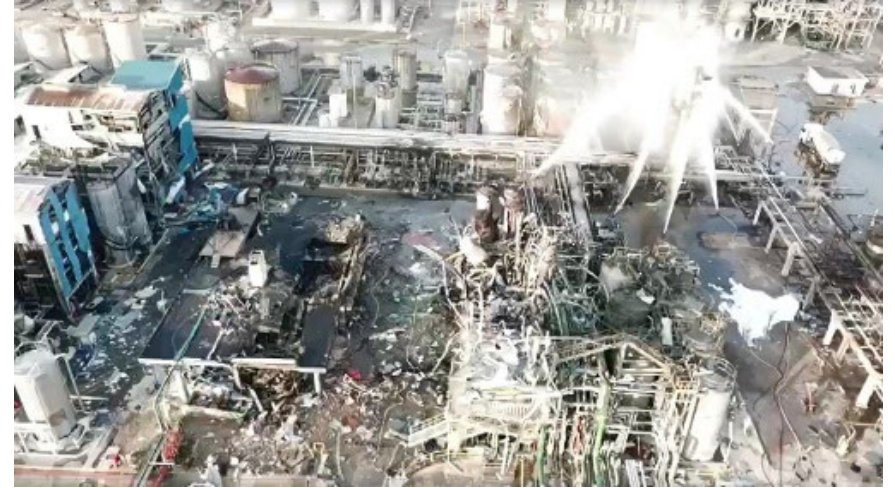
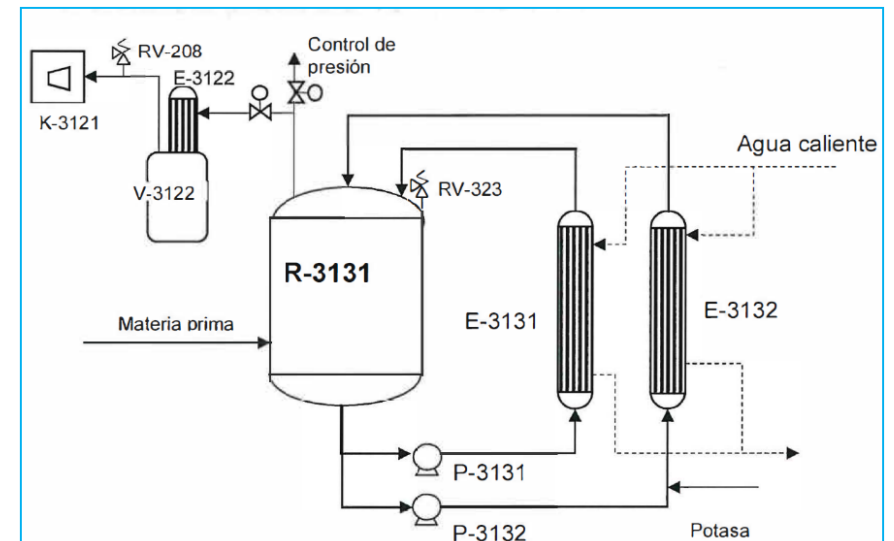
- Three fatalities: one person killed by missile fragment from explosion in his flat in a nearby village (Torreforta). One operator employee got killed working in the control room and another operator employee died as a result of his injuries
- Missile fragments also damaged neighbouring plants in the industrial area of Tarragona

The explosion happened at the end of the production of a batch of MPEG 500, an ethoxylation derivative used e.g. as an additive for cement. The reactor vessel R3131 of the derivatives plant U3100 exploded.

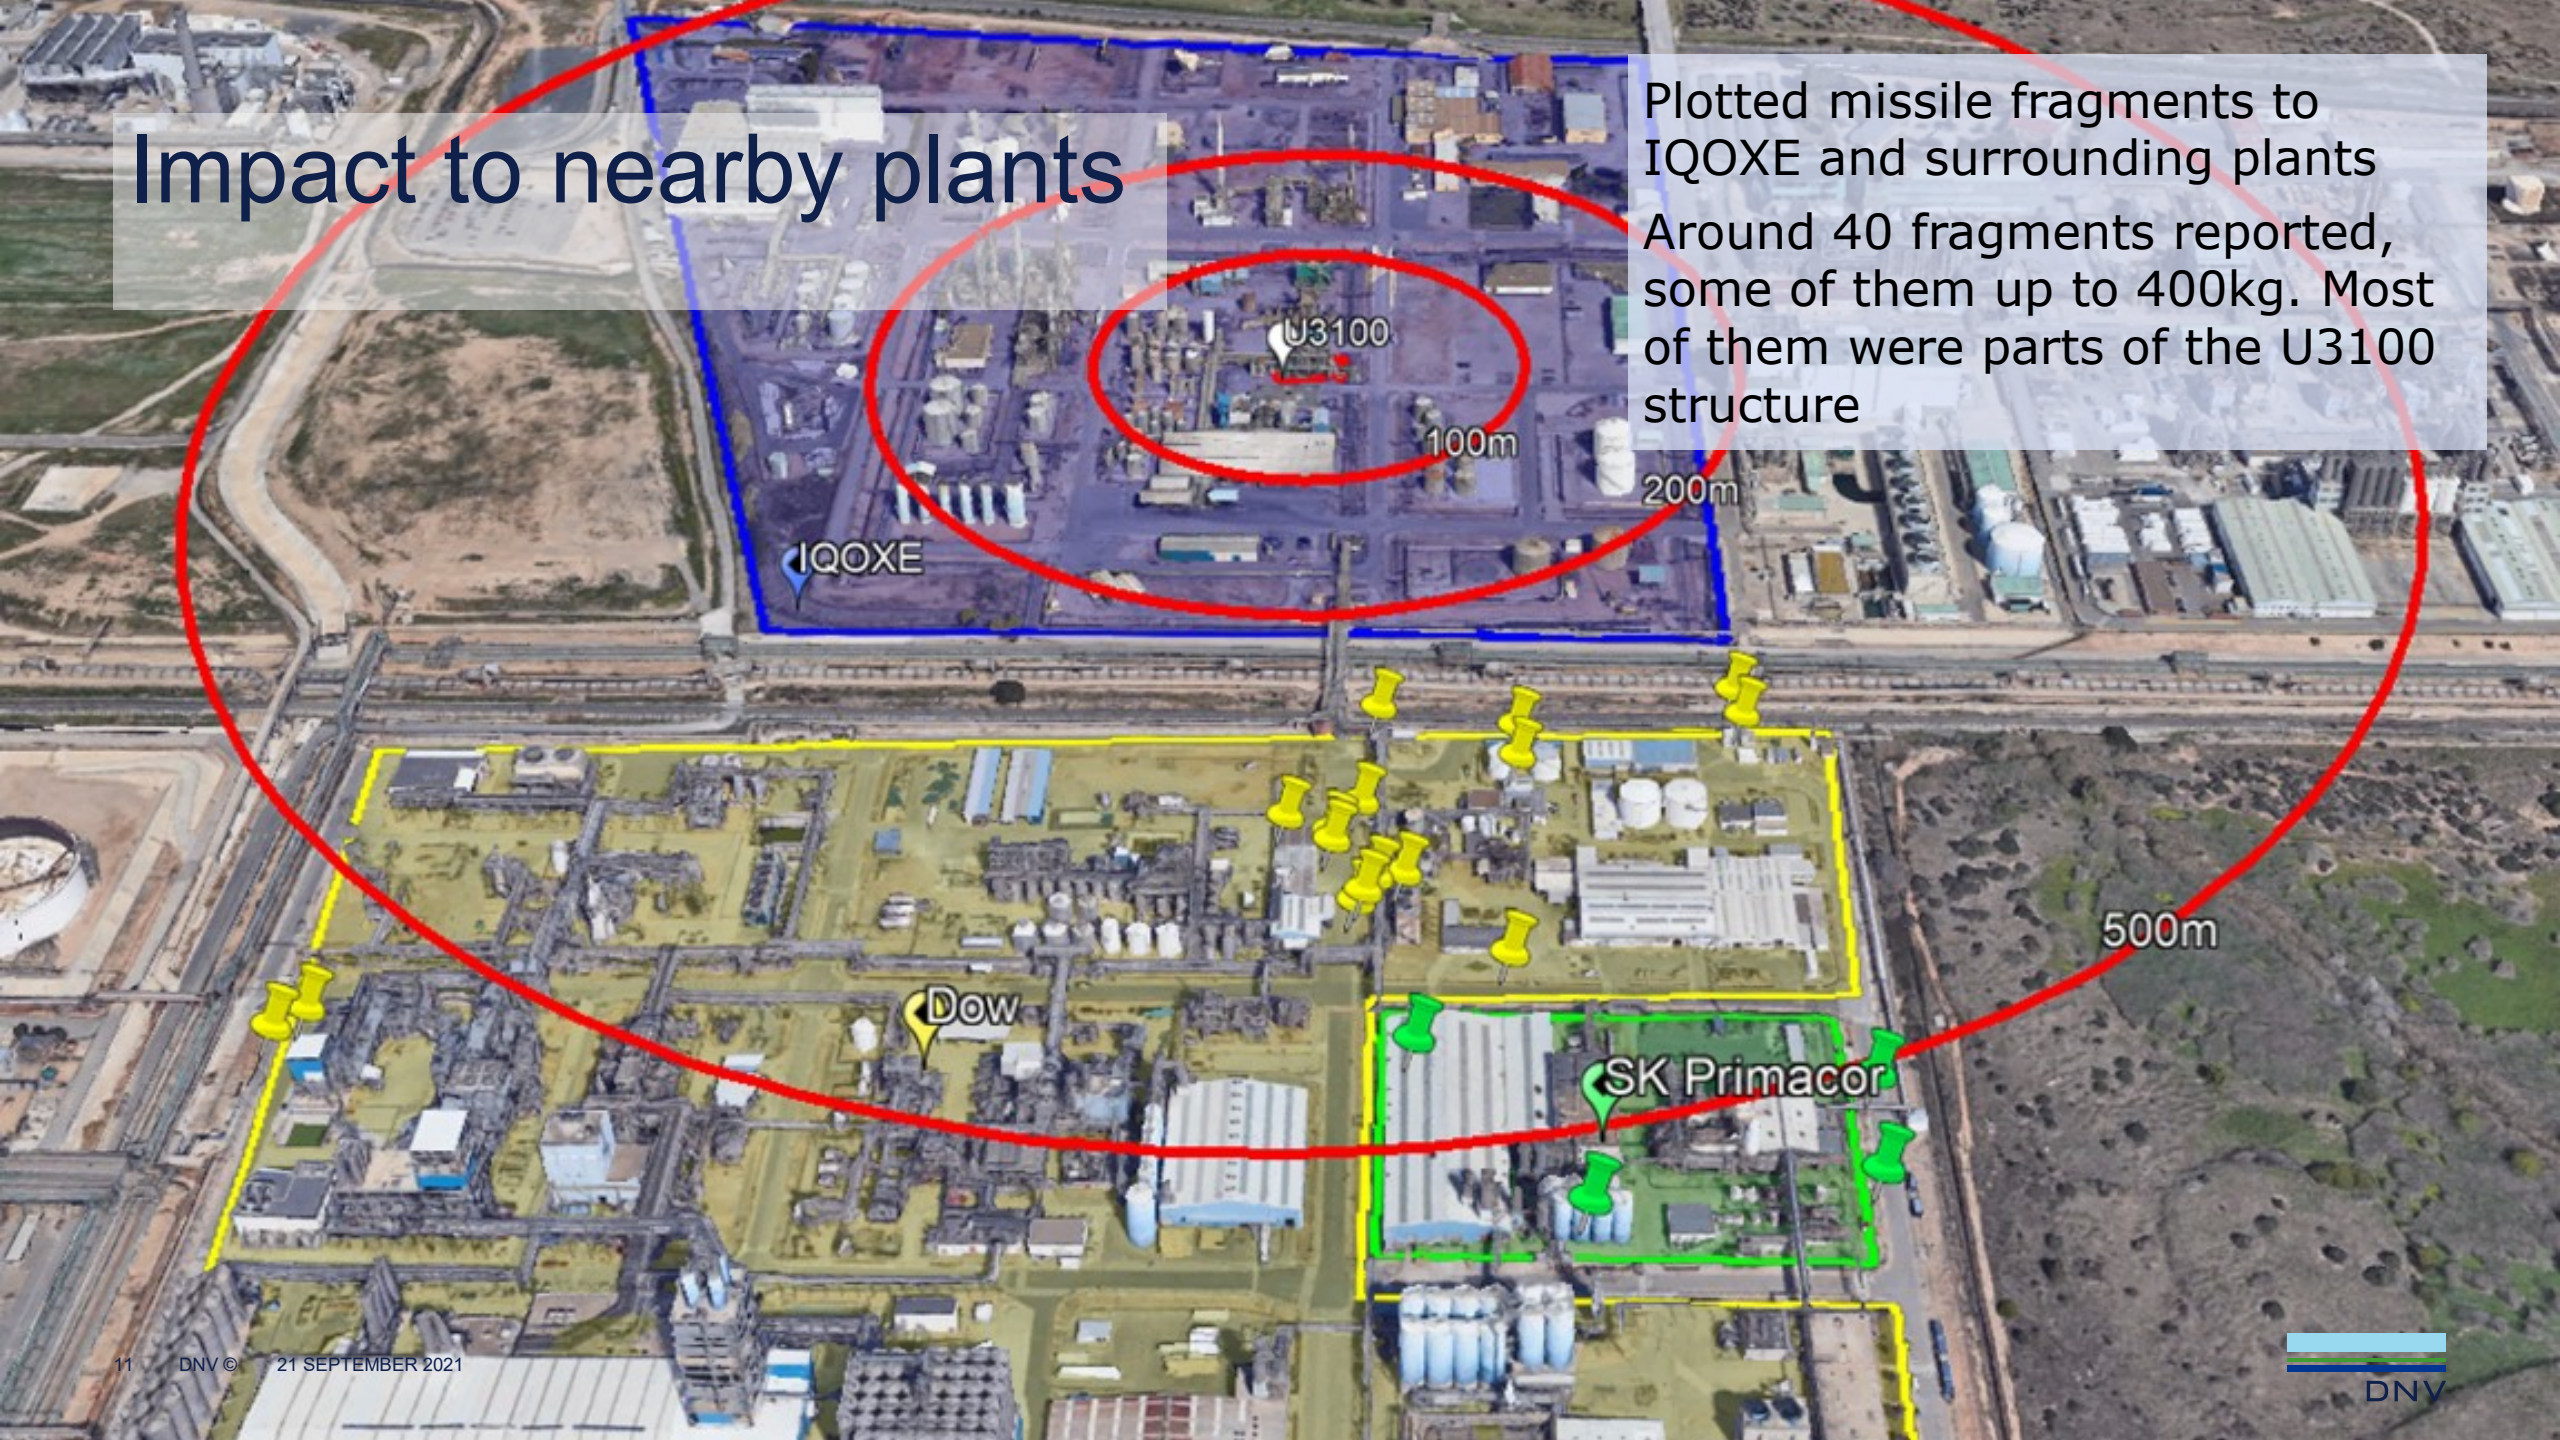
Plotted missile fragments to IQOXE and surrounding plants
Around 40 fragments reported, some of them up to 400kg. Most of them were parts of the U3100 structure

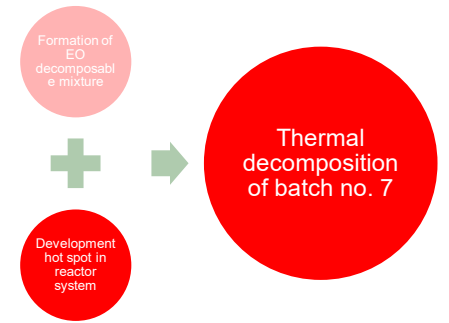
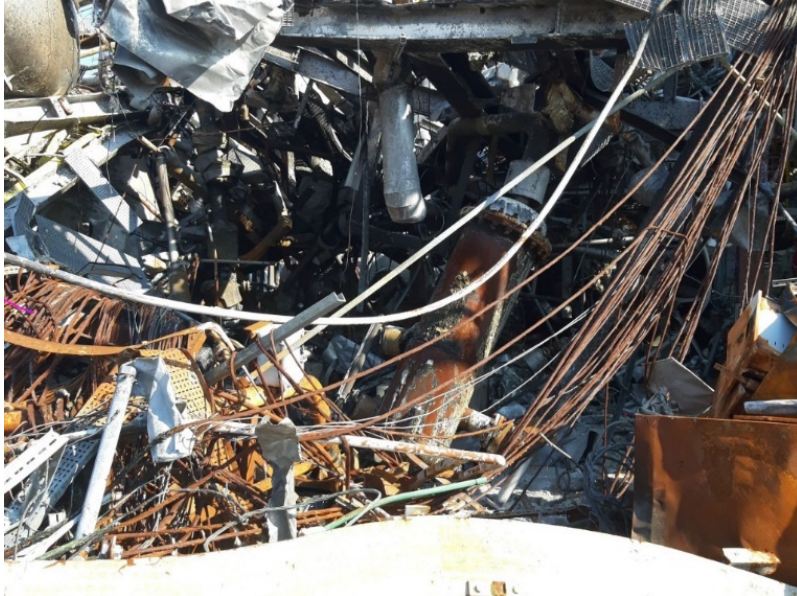
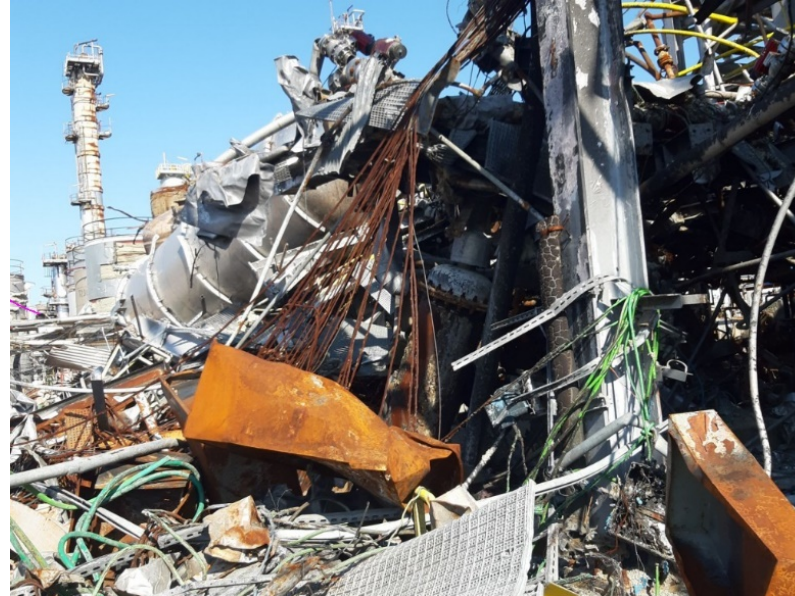
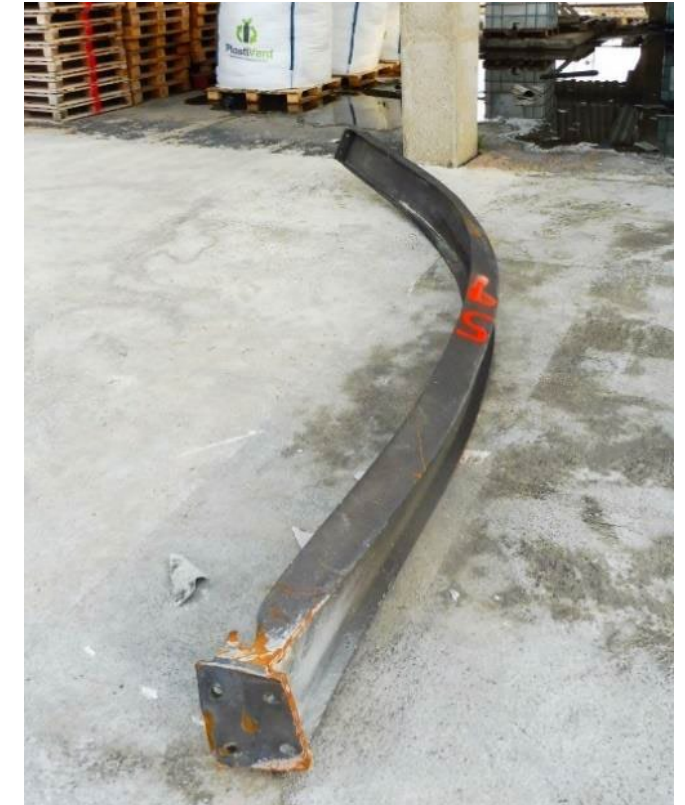
Fire

- Examination of photographs of missile fragments as well as photographs from the incident scene suggests that fire damage had been caused prior to the explosion
- Recommendation for forensic testing

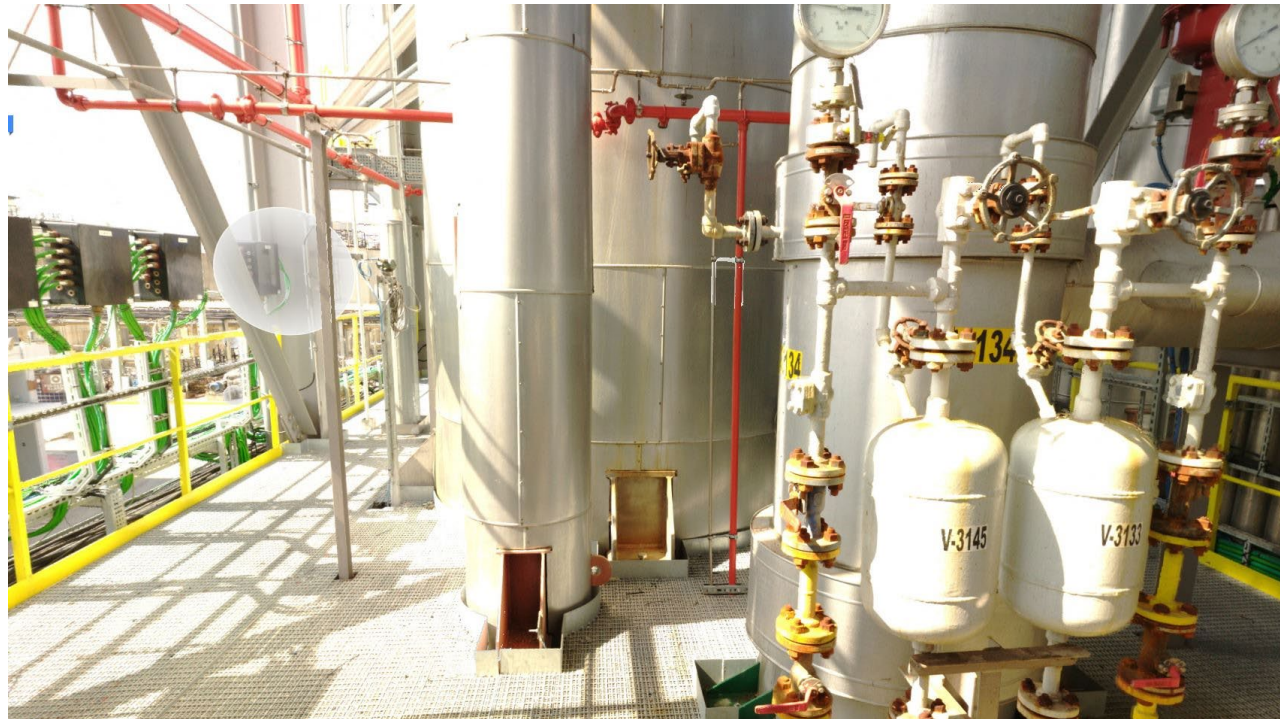
Direct cause(s)	<ul style="list-style-type: none">• Insufficient fire detection system• Inadequate firefighting systems
Basic cause(s)	<ul style="list-style-type: none">• The installed sprinkler system only protected the reactor vessel, but not the entire EO connected system in U3100• No evidence was seen of safety studies to identify possible fire sources in U3100, that might affect the EO-connected system, nor was evidence seen of identification of required active or passive fire protection other than a design document based on industrial building regulatory requirements• The EO User Guide suggests applying NFPA 58 and API 2510 and 2510A to the design of fire protection systems for EO storage and processing areas. Moreover, it suggests using process hazards analysis methods that examine the severity of the consequences of a fire scenario for identification areas appropriate for deluge protection• Furthermore, the basic design documents specify that gas and fire detection in the neighbourhood of sources of possible leakage shall be installed. Dilution of leakage and control of fire will result if automatic operation of a water spray system

Fire sprinklers (red piping system) around reactor before accident

- Apply NFPA 58 and API 2510 and 2510A to the design
- Using process hazards analysis for identification of areas appropriate for deluge protection
- Gas and fire detection in the neighbourhood of sources of possible leakage should be installed.
