Accident initiated by Power Failure

TWG 2- meeting 2018
The Hague

Yara Porsgrunn

Ammonia Factory Layout

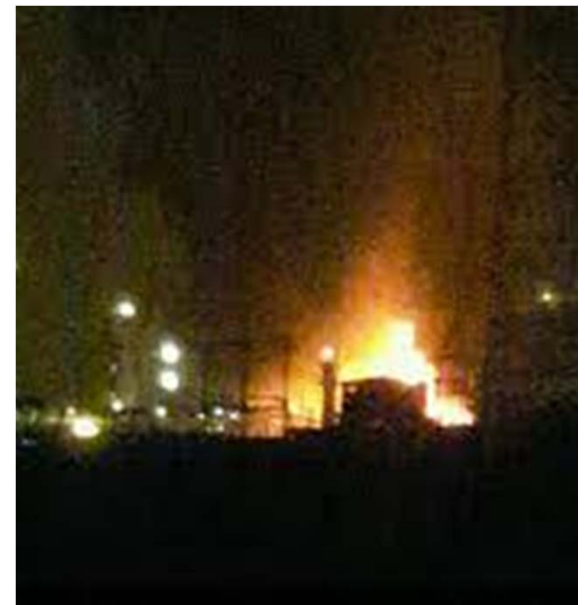
Restart followed by explosion and fire

- Preparations are made for restart of the factory
- Operators follow restart procedures, all seems to be normal
- 03:15 an explosion occurs, followed by an intense oil fire in the compressor hall.
- Two operators that are present, evacuate without physical injuries
- Internal and external fireservices are on site shortly after, and 45 minutes later the fire is extinguished.
- Soon after they can see that the main syngas oiltank (lubricant oil) has «torn» and the fire is localized to this tank.

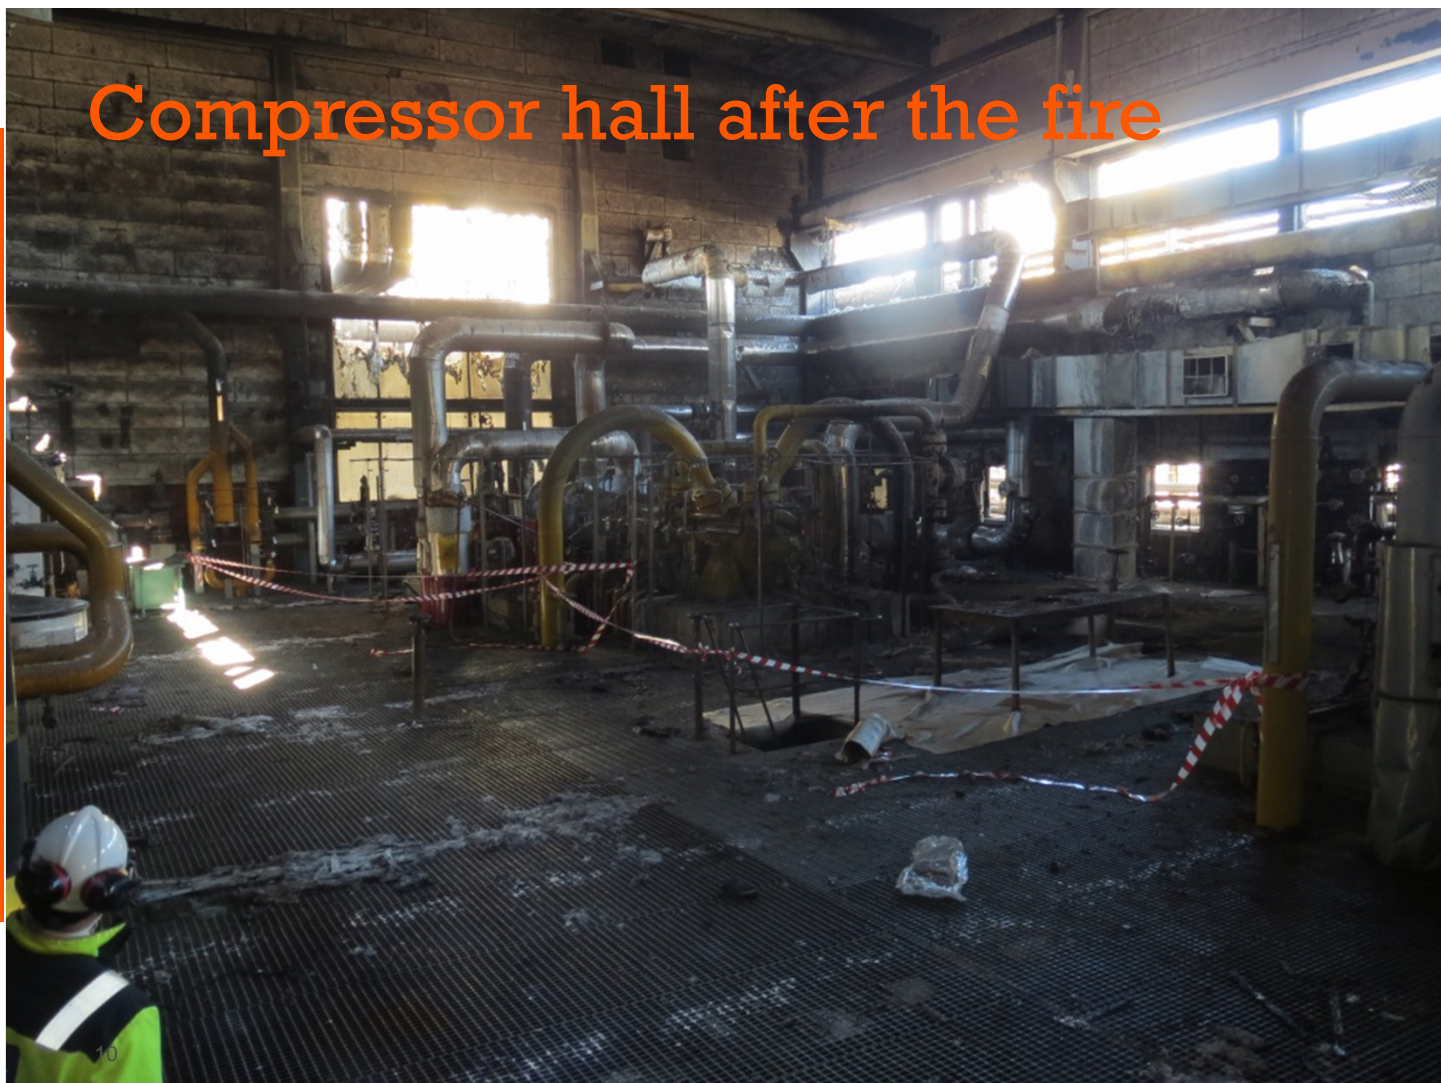
Compressor hall after the fire

- No physical injuries
 - Immediate consequence on people are limited to psychological impact (one employee in a long sick leave).
- In terms of environment there has been a limited oil release to the fjord that has been rapidly and effectively cleaned.
- Large fire damages on building, no damages caused by overpressure
 - Damages under roof, windows, and on traverse crane
- Extensive damages in the electrical/instrumentation systems.
- Vast amount of cleaning
- Cost: 165MNOK
- Restarted and ordinary operation from October 4.

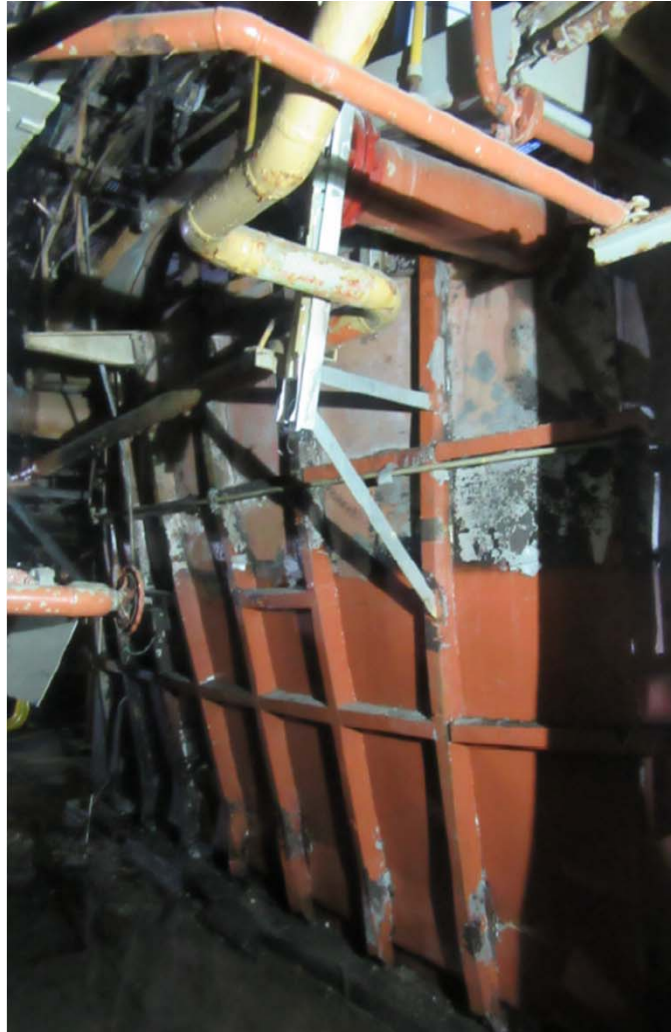
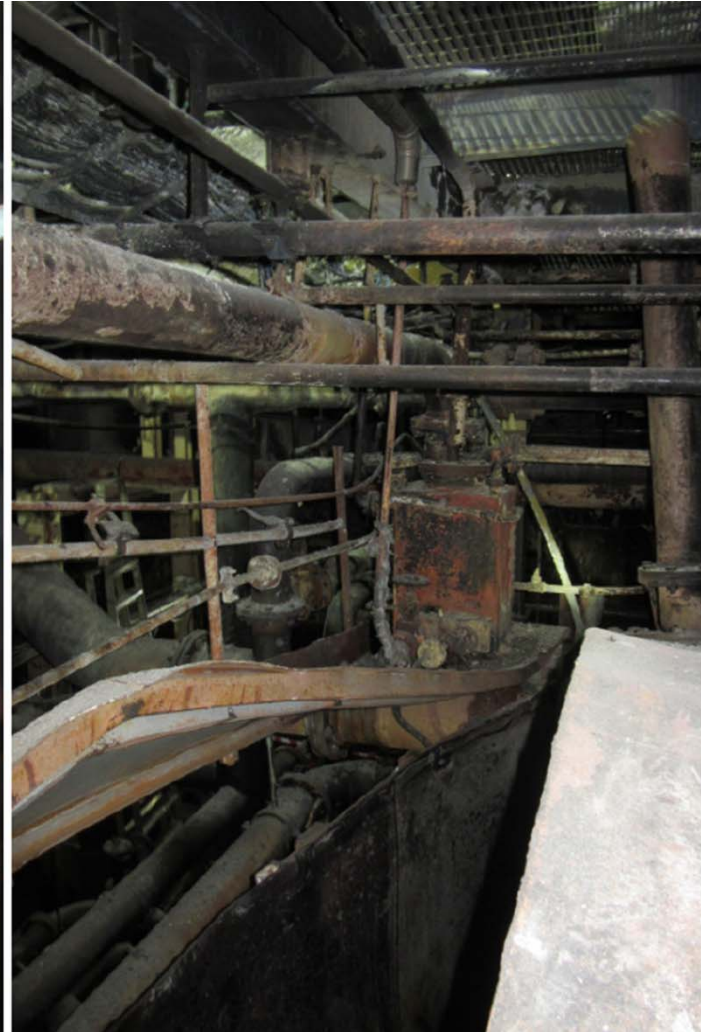
Oil
tank
after
the
fire

- The initial power fluctuation did not cause the accident, but initiated the shut down.
- The direct cause is the generation of an explosive and highly sensitive atmosphere in the vapour phase of the oil tank.
- Oxygen enriched air came into the nitrogen purging system from the Air Separation Unit.

- The main root cause is an uncontrolled Management Of Change on the air separation unit trip system that allows enriched air to be sent in the nitrogen grid used as a safety barrier in the syngas compressor oil tank explosion scenario.
 - a low suction pressure trip mentioned in both P&ID and standard operating procedure was removed from the field some years back (2011).
- Contributing factors:
 - Lack of Process Hazard Analysis that generated inadequate standard operating procedure and inadequate training.
 - Lack of proper alarm management program and poor human machine interface
