Lessons learned from LPG/LNG Accidents

Maureen Heraty Wood
Major Accident Hazards Bureau

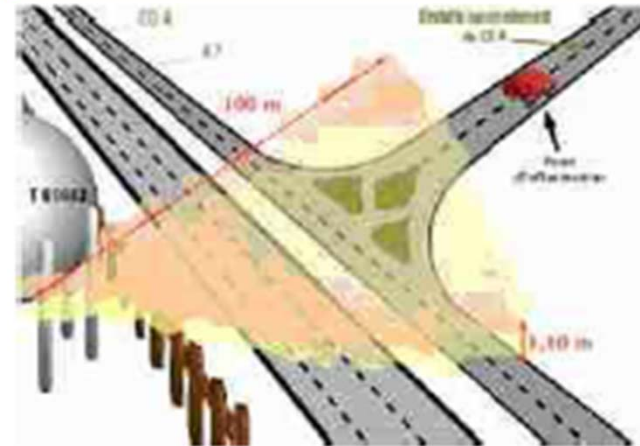
Figure 18 A highly schematised representation of the cloud according to witnesses

A technician's assistant was extracting a sample from and **performed the steps in the wrong order.**

The valves froze and locked.

Eventually, a car engine in start-up ignited the cloud (the driver died). An intense blowpipe flame appeared beneath the sphere 1 min later.

The sphere suddenly exploded around 8:45 am (1st BLEVE explosion), causing **13 fatalities**. **An adjacent propane sphere then exploded** at 9:40 am (2nd BLEVE).

The primary cause of the propane leak was the operational fault of the plant operator. This fault was exaggerated because of **poor access to the valves** and the **lack of permanent valve spanners**.

It is probable that a **solid plug of ice or propane hydrate stopped the drawoff line above the upper valve**. This plug released when the upper valve was fully opened.

The **discharge from the drain line was directed downwards** in the vicinity of and under the valves, instead of to the side.

This formed the cloud which made the recovery and repositioning of the valve lever impossible.

Where possible, **the direct draining of aqueous liquid from LPG vessels should be avoided** on systems which have to be regularly operated and, in particular, **where large volumes of LPG at high pressure could accidentally be released.**

If it is not practicable to install a closed draining system then consider the use of a dewatering pot isolated from the main vessel during the draining operation.

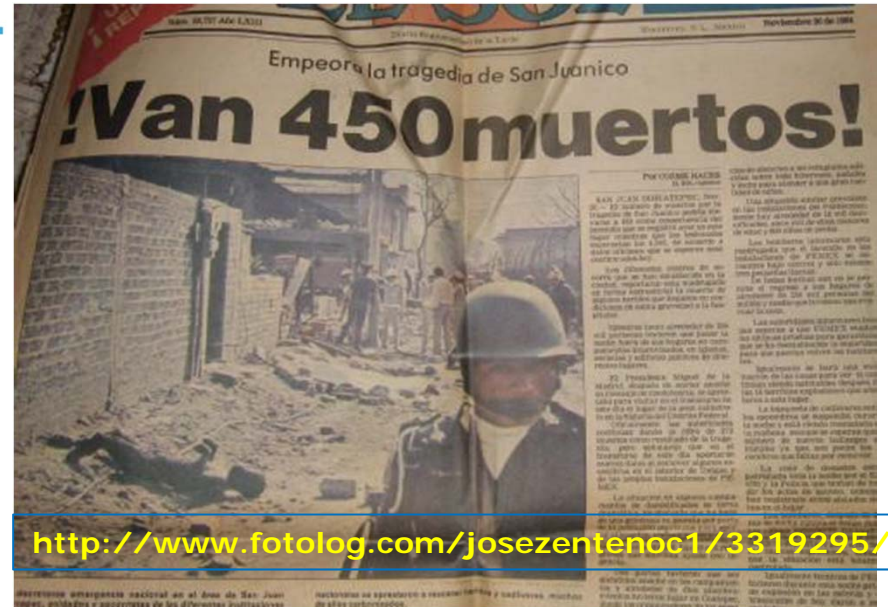
The disaster was initiated by a **gas leak** on the site, likely **caused by a pipe rupture during transfer operations**, probably due to tank overflow and overpressure in the line. A plume of LPG concentrated at ground level for 10 minutes. The plume eventually grew large enough to drift towards the facility's waste-gas flare pit.

At 5:40 a.m., the cloud reached the flare and ignited, resulting in a vapor cloud explosion, and a massive conflagration. Just four minutes later, at 5:44 a.m., **the first tank underwent a BLEVE**.

Over the next hour, **12 separate BLEVE explosions** were recorded. It is believed that the escalation was caused by **an ineffective gas detection system**.

Leak / Gas Detection: **Installation of a more effective gas detection and emergency isolation system could have averted the incident.** The plant had no gas detection system. When the emergency isolation was initiated it was too late.

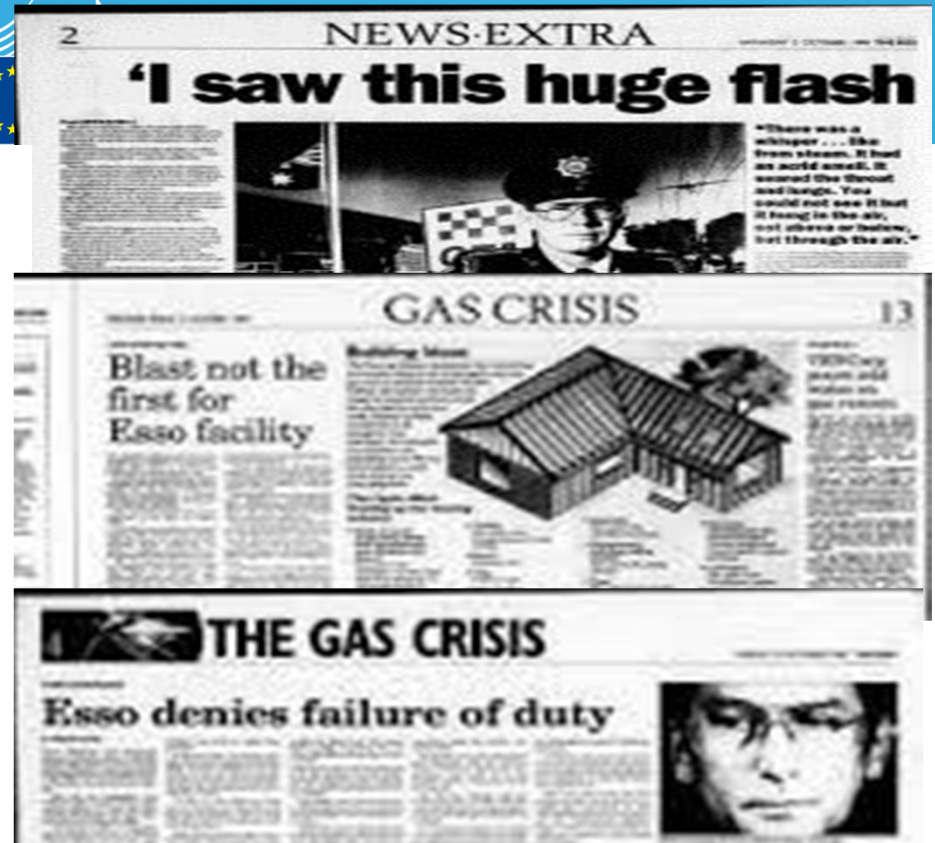
At 8:20 am, a hot oil pump failed and would not restart, resulting in a loss of lean oil circulation in Gas Plant No. 1.

A failure to restart the pumps, which then stayed off-line for several hours, resulting in no flow of hot lean oil to key vessels.

An absence of hot lean oil meant the cold liquid from absorbers chilled the vessels to extremely low temperatures.

Re-introduction of hot lean oil into the heat exchanger caused it to rupture and release about 25 metric tons of hydrocarbon vapor, which then ignited, setting off an explosion and fire.

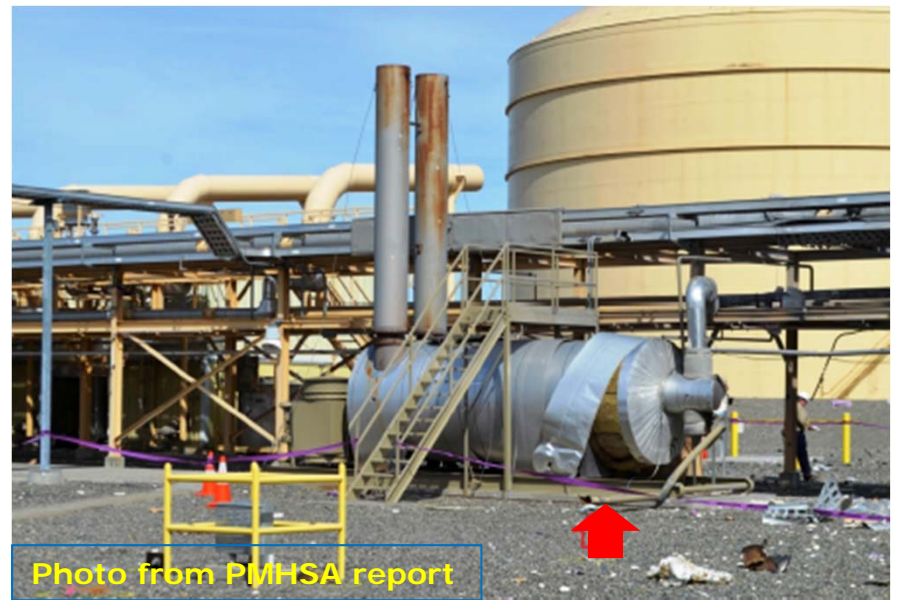
Photo from PMHSA report

LNG Plant experienced a **catastrophic failure and a resulting explosion** in the LNG-1 purification and regeneration system during start-up

The **primary cause was a substandard purge** performed after leaving the LNG-1 purification loop open to the atmosphere for 5 subsequent days.

A **flammable gas-air mixture remained in the system** which then entered the salt bath heater and **auto-ignited during start-up**

Low toughness of the adsorber metal allowed it to fail in a brittle manner causing fragmentation.

LNG-1 Salt Bath Heater where auto-ignition initiated.

Make sure that gas supply lines contain nothing but gas before the equipment they feed is started

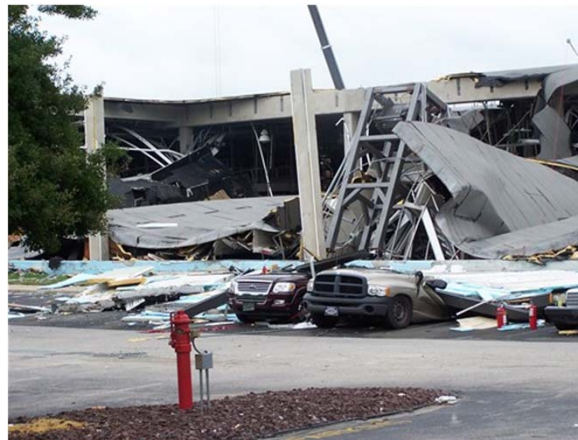
The **Kleen Energy Natural Gas Explosion** investigated by the CSB caused **6 deaths and 50 injuries (2010)**
