NATECH ACCIDENT INVESTIGATION DURING THE 2011 GREAT EAST JAPAN EARTHQUAKE AND RECOMMENDATIONS FOR DISASTER PREPAREDNESS BASED ON A RESIDENT SURVEY

3. CASE STUDY I: JX Refinery, Miyagi Prefecture, Japan

4. CASE STUDY II: Cosmo Oil Refinery, Chiba Prefecture, Japan

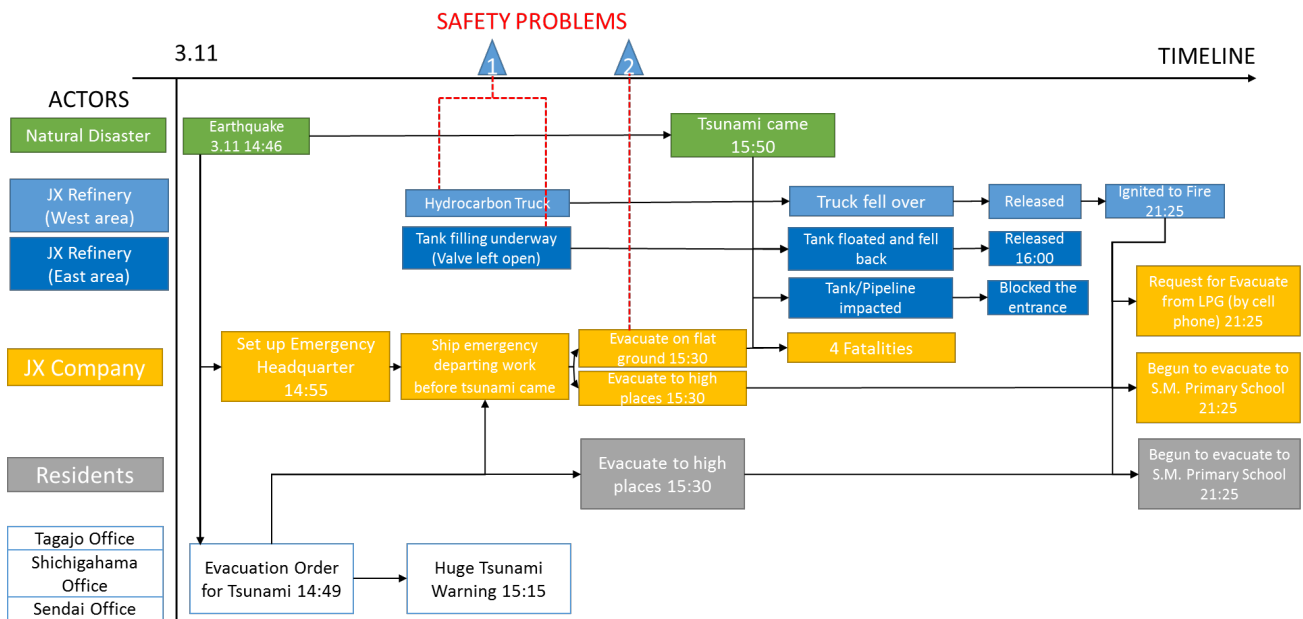
The JX refinery Sendai fire is illustrated by a STEP diagram in Fig.3 and Fig.4. Because of page

limitation, we divided the diagram into 2 parts. The first half shows what happened till the ignition, and the second half shows the events flow after the fire occurred. In Fig.3, the Tagajo Office, Shichigahama Office and Sendai Office are considered as one actor named “government”, because they had similar actions before ignition. In Fig.4, each of these office actors is separated since their actions are different. Also because of the limitation, actors of firefighting department only showed in Fig.4. In both figures, the timeline is on X-axis and actors are labeled on Y-axis. The events are actions by actors. In Fig.3 for example, the first yellow rectangle means that JX Company set up Emergency Headquarter on

Fig. 3 1st half of STEP

2011.3.11, 14:55. Arrows are used to link related events. Safety problems are identified during the analysis, which marked as triangles on the top. The STEP model is easy to show tractable accident clearly. However, the model only focuses on events. The STEP does not have a way to point out the interrelation or cooperation between each actor, which makes it hard to indicate the cooperation problem, such as lack of communication in Sendai case. As a result, if the investigator does not have sufficient knowledge of the specific accident, the reason for safety problems could not be recognized.

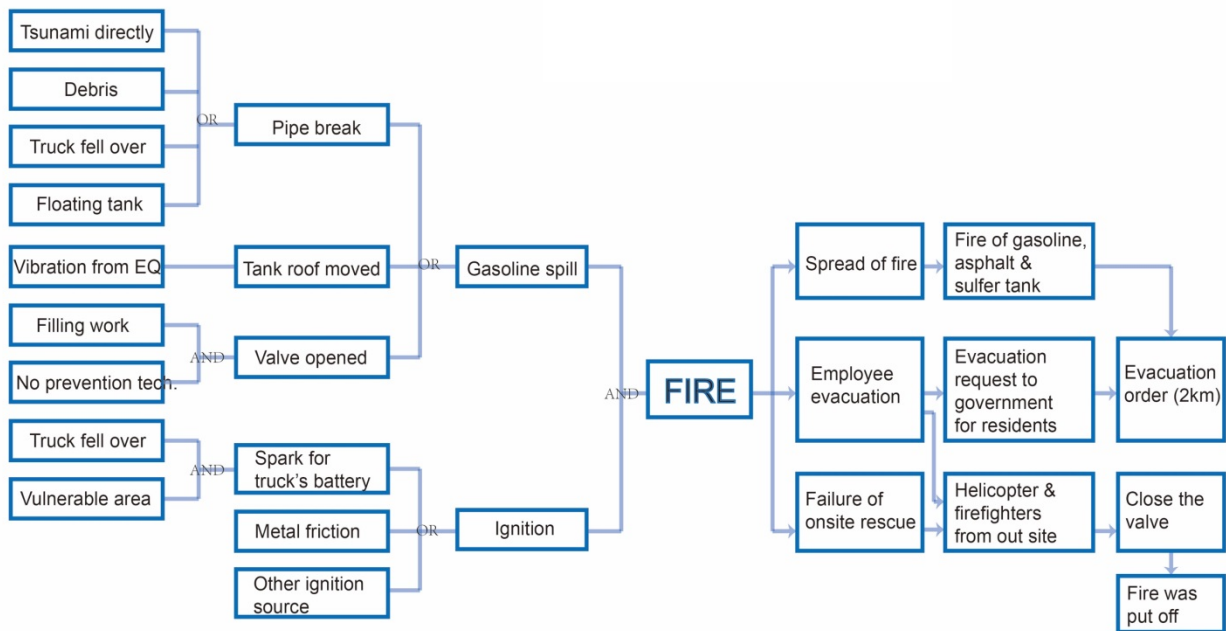
The FTA analysis involves three steps. (1) Define the undesired event to study: There were a lot of undesired event during the JX refinery incident such as gasoline released, heavy oil released, 4 people died and fire. After putting everything in order, we finally decided to choose fire as the undesired event to study. (2) Obtain an understanding of the system: After sorting out the reference materials, we can know that there were 3 fires—2 in eastern area and the main one in the western area. Gasoline spill, as well as ignition, led to the fire. There were several reasons caused the spilling such as pipelines were broken for reasons and one of the tank roof was moved due to the earthquake and a valve remained open while tsunami came, which caused even serious spilling. Also, ignition sources can be the spark of truck’s battery or metal to metal friction caused by the tsunami. (3) Construct the fault tree: After se-

lecting fire as the undesired event and having analyzed the system so that we almost get all the causing effects to construct the fault tree. A fault tree is based on AND and OR gates which define the major characteristics of the fault tree. (Left side of Fig. 5)

An event tree analysis of JX refinery accident is performed as follows: (1) Define the system: Since we want to unify the fault tree and the event tree, so our event tree begins from the fire and end at the extinguished of fire. (2) Identify events: Here, the fire is considered as the initiating event. After the fire occurred, it spread and onsite rescue failed. The employee were evacuated and called the government for residents’ evacuation request. Then, the helicopter came and firefighters from out site came to fight the fire. Finally, the opened valve was closed and the fire was put off. (3) Build the event tree diagram. The diagram is showed as the right side of Fig. 5.

Fig. 5 Fault Tree and Event Tree Analysis

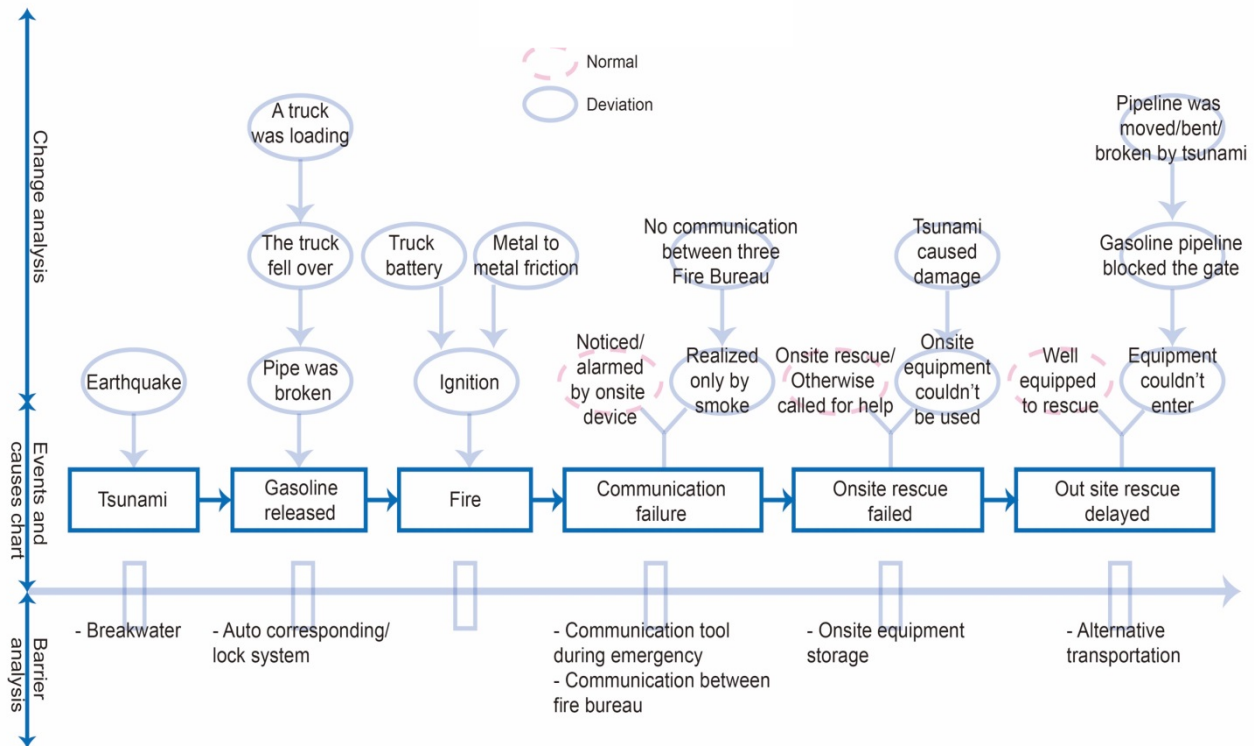
To do an MTO analysis, the first step is to develop the event sequence longitudinally and illustrate the event sequence in a block diagram. Here, we defined the events started from the tsunami and temporarily ended at “out site rescue delayed”, with an order of tsunami, gasoline/heavy oil released, fire, communication failure, onsite rescue failed, out site rescue delayed (Fig. 6). Then, analyze which technical, human or organizational barriers that have failed or was missing during the accident progress. In JX refinery accident, firstly, when the tsunami came, if there’re breakwater in front of truck loading/unloading area, it may make any sense that the

Fig. 6 MTO Analysis

truck may be just floating but not fell over, or metal friction may not happen that there would be no ignition for the fire. Secondly, during the fuel releasing happened, an automatic lock system may help towards the release problem. Also, there's a huge problem about the communication tool during emergency on site and the communication between fire bureaus as well as three local governments almost failed. What's worse, there's barriers failed of onsite equipment storage as well as fire trucks since the storage location should consider the worst condition. Finally, transportation method needs more consideration that if the rescue couldn't be conducted via land, there should have alternative transportation method. Further, we need to assess which deviations or changes in which differ the accident progress from the normal situation.

These changes are also illustrated in the diagram (shown in nominally titled circle). During the communication failure period, in common practice, the fire would be noticed or alarmed by the onsite device but actually, it was noticed only by smoke and the communication between three fire bureaus as well as three local governments were terribly delayed. Moreover, when the fire occurred, normally we will do onsite rescue firstly and call for help. However, onsite equipment was damaged by the tsunami and couldn't be used, neither do the communication tools. Additionally, after onsite rescue failed, usually the helper from other places will come but at that time the out site rescue found out that they couldn't enter the site because the gate was blocked by the

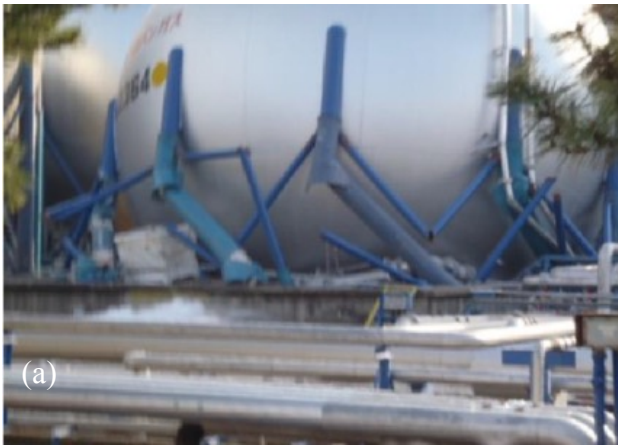
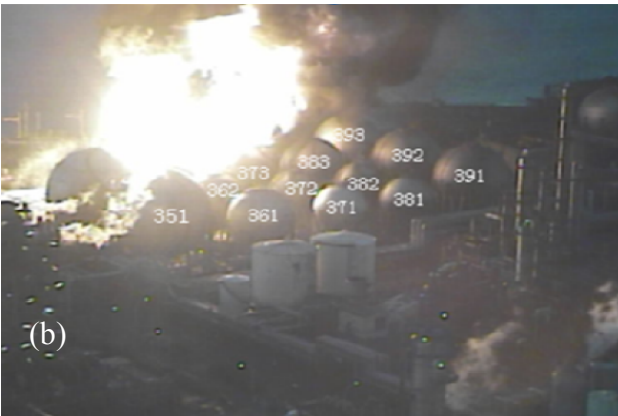
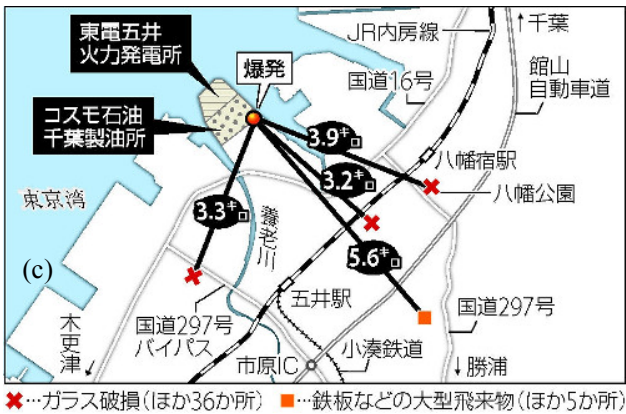
Fig. 7 (a) Collapsed Tank resulting from the damaged bracing
 (b) A photo just before the explosion (c) Range of flying debris projectiles

There were 17 tanks in the LPG storage farm area of the industrial complex. During maintenance inspection, the tanks are filled with water to check for possible leakage. In usual practice this is done for 2-3 days. On March 11, tank no. 364 was holding water for 12 days. Also, before the earthquake, there was a

confirmed leakage of air from the pipe to which air was supplied to activate the emergency shut-off valve. As a temporary measure this valve was fixed open until the pipe was fixed. This manually switching of the emergency valve to “open” position was a violation of the “High Pressure Gas Law” by the Cosmo Oil authorities. Unfortunately, this emergency shut-off valve stayed open at the time of the earthquake too. After the first earthquake, the bracing of the LPG tank no. 364 suffered some damage. The tanks are designed for holding LPG and not for the temporary confinement of water. A mass which is 1.8 times heavier than LPG is much more viable to damage in a seismic event. The damage was not identified during the visual inspection after the main shock at 14:46 hrs. It is difficult to visually inspect a tank of 20 m diameter and 2000 kl capacity in a short period of time. At 15:15 there was the aftershock. The emergency valve was still not closed as it was wrongly assumed that the strength of the tank was not compromised. At 15:20 the legs failed and the entire tank collapsed. The collapse damaged the neighboring pipelines and triggered a release of LPG.
