Major Accidents with explosives in Bulgaria Lessons Learned

MJV, Norway, 9-11 November 2016

Major accident in Midzhur Ammo Plant, Gorni Lom:

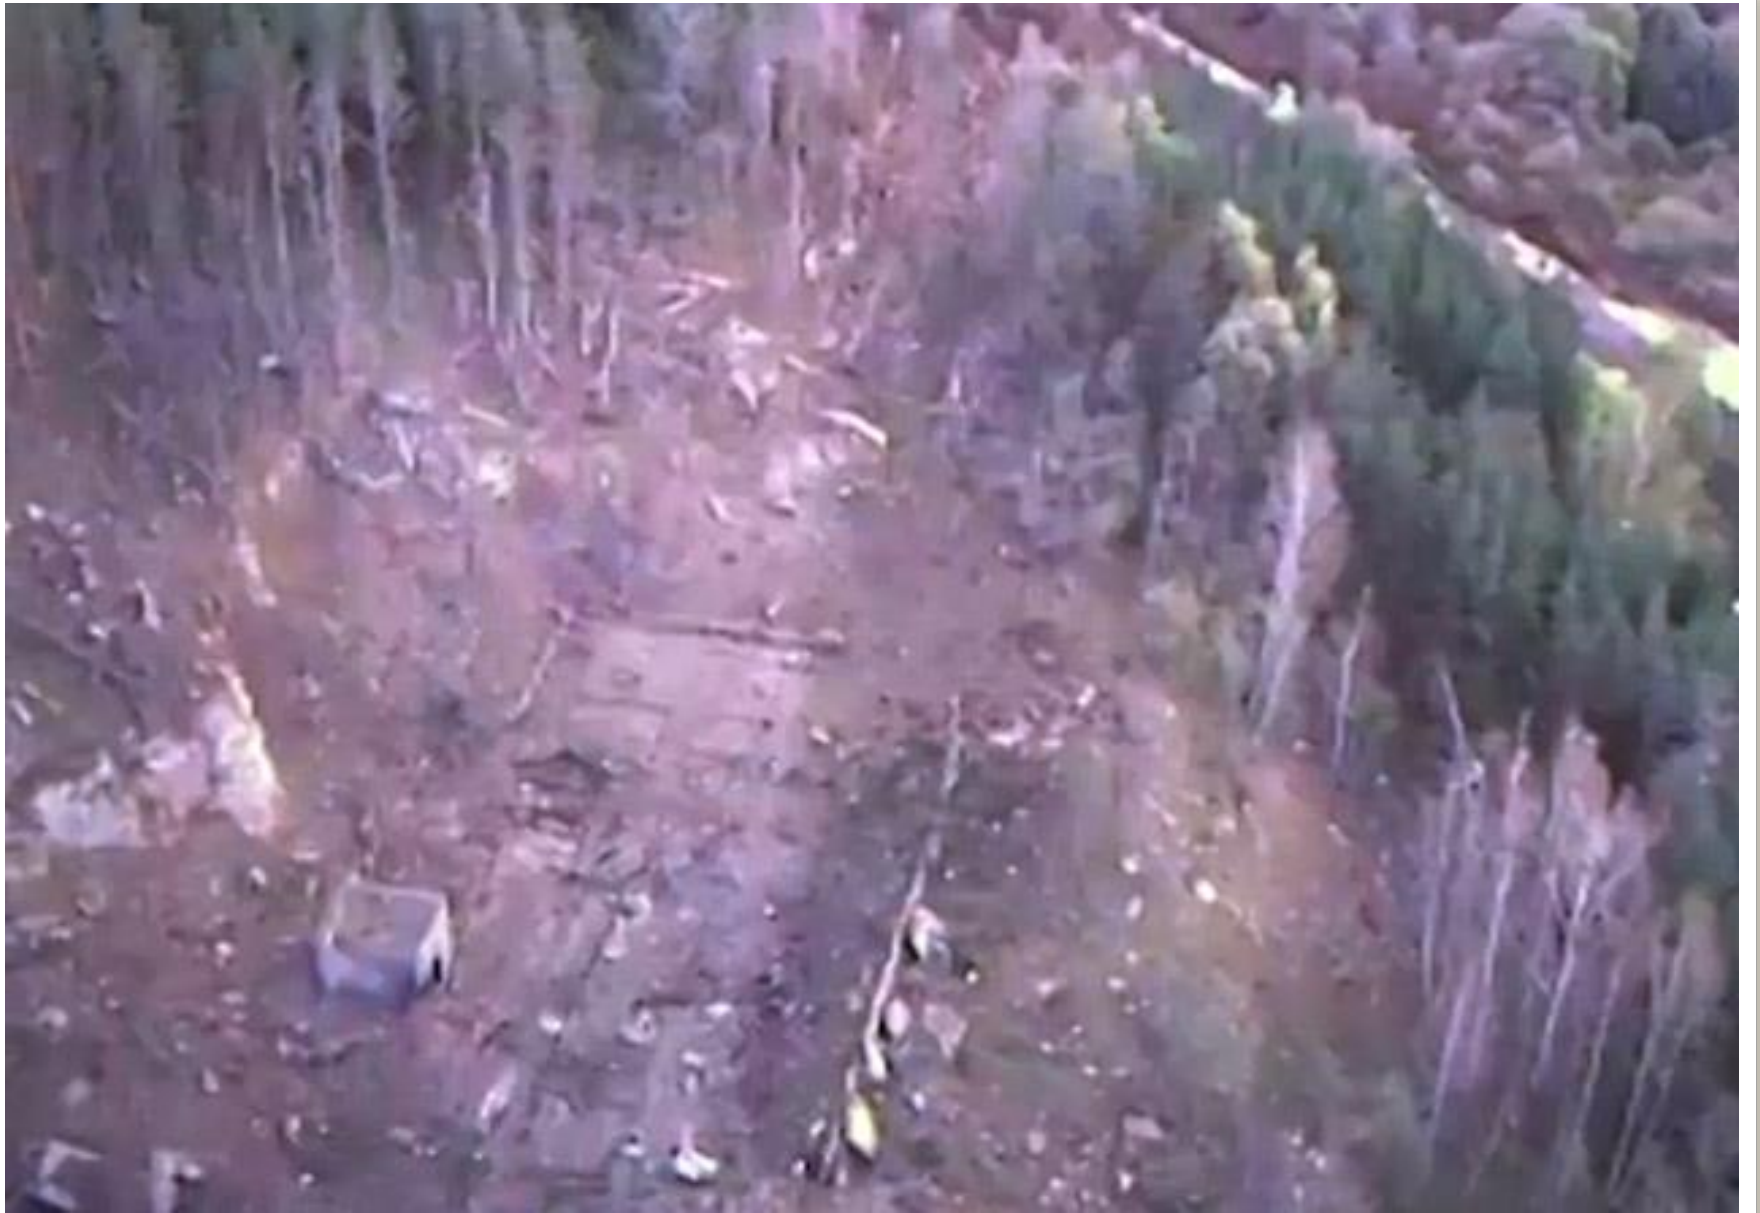
Workshop „C” –
Section “Utilisation of
ammunitions”

Conditional
blast center

Workshop „C” –
Section “Cast
Booster”

Ring concrete
tunnel
connecting the
two rooms

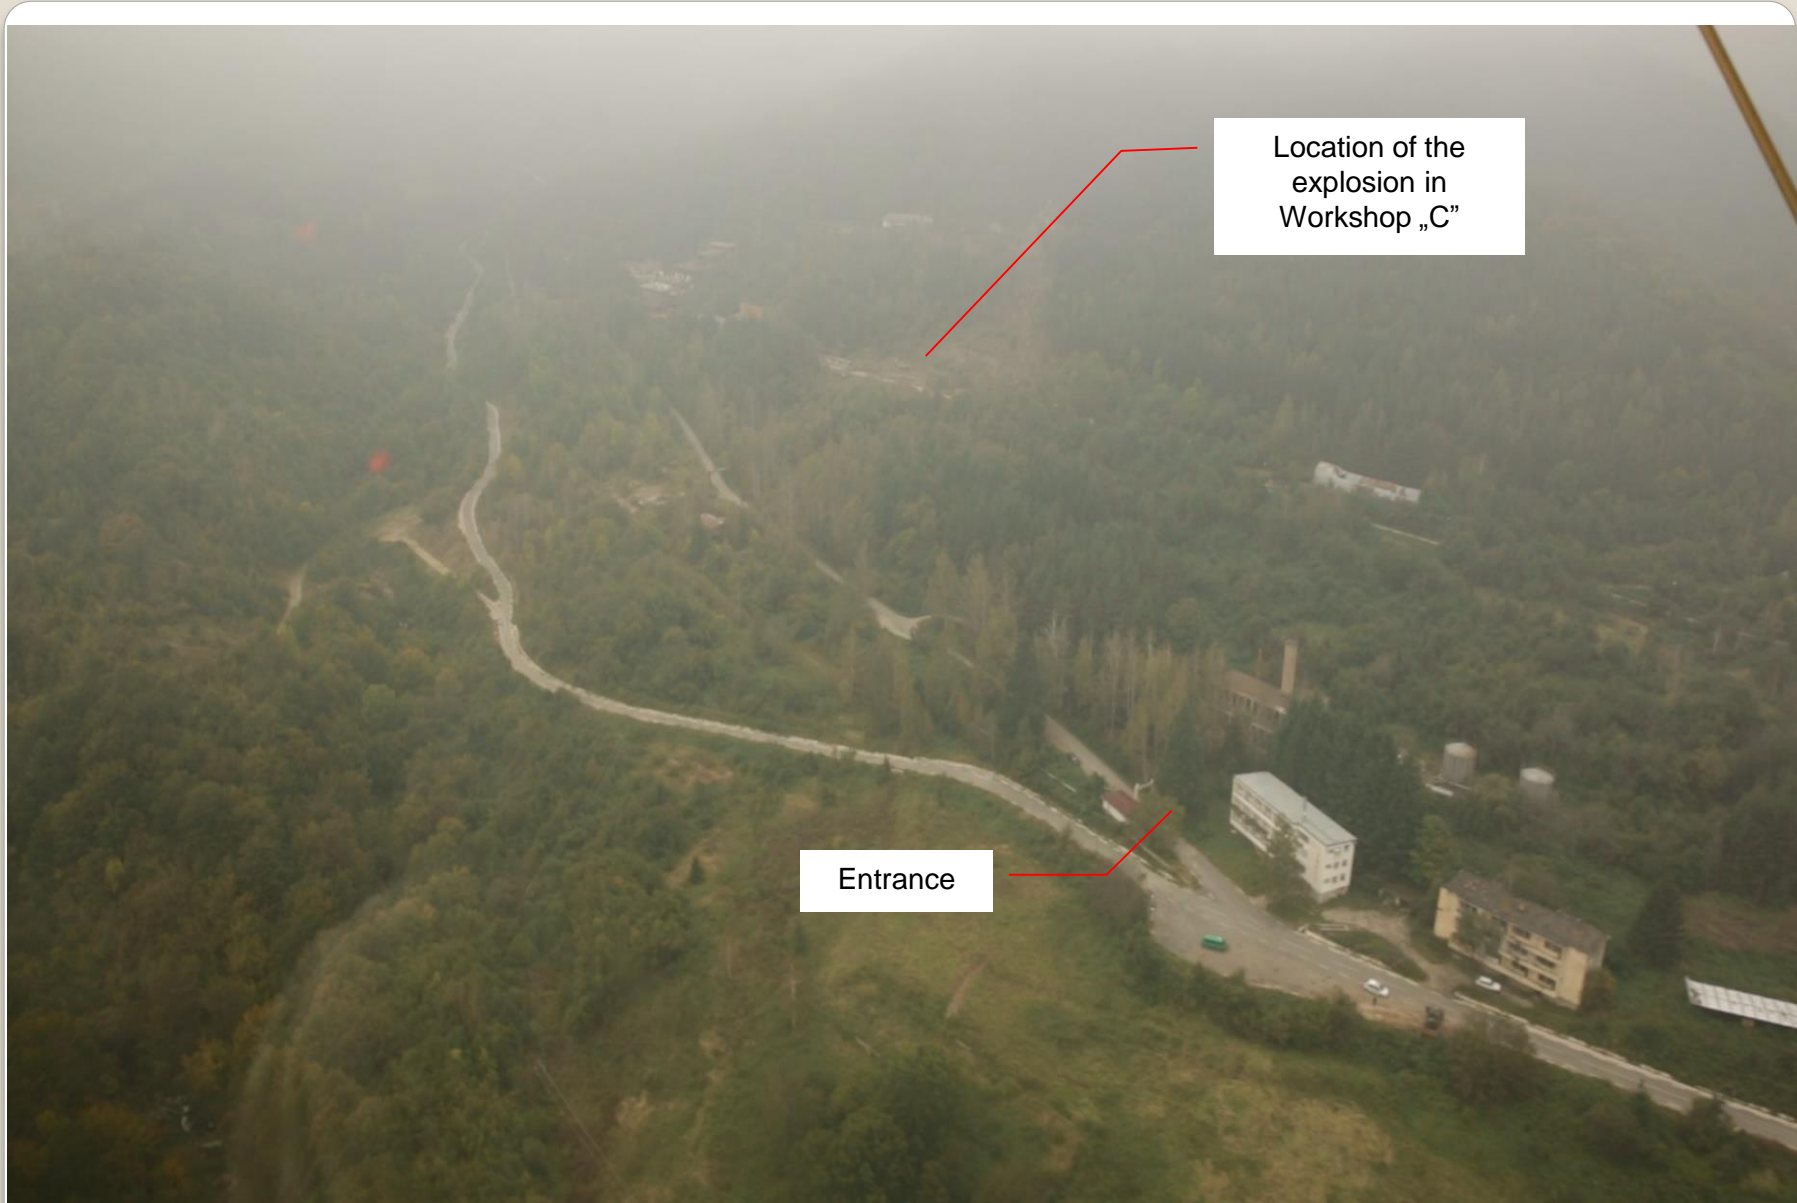
Location of the explosion in Workshop „C”

Entrance

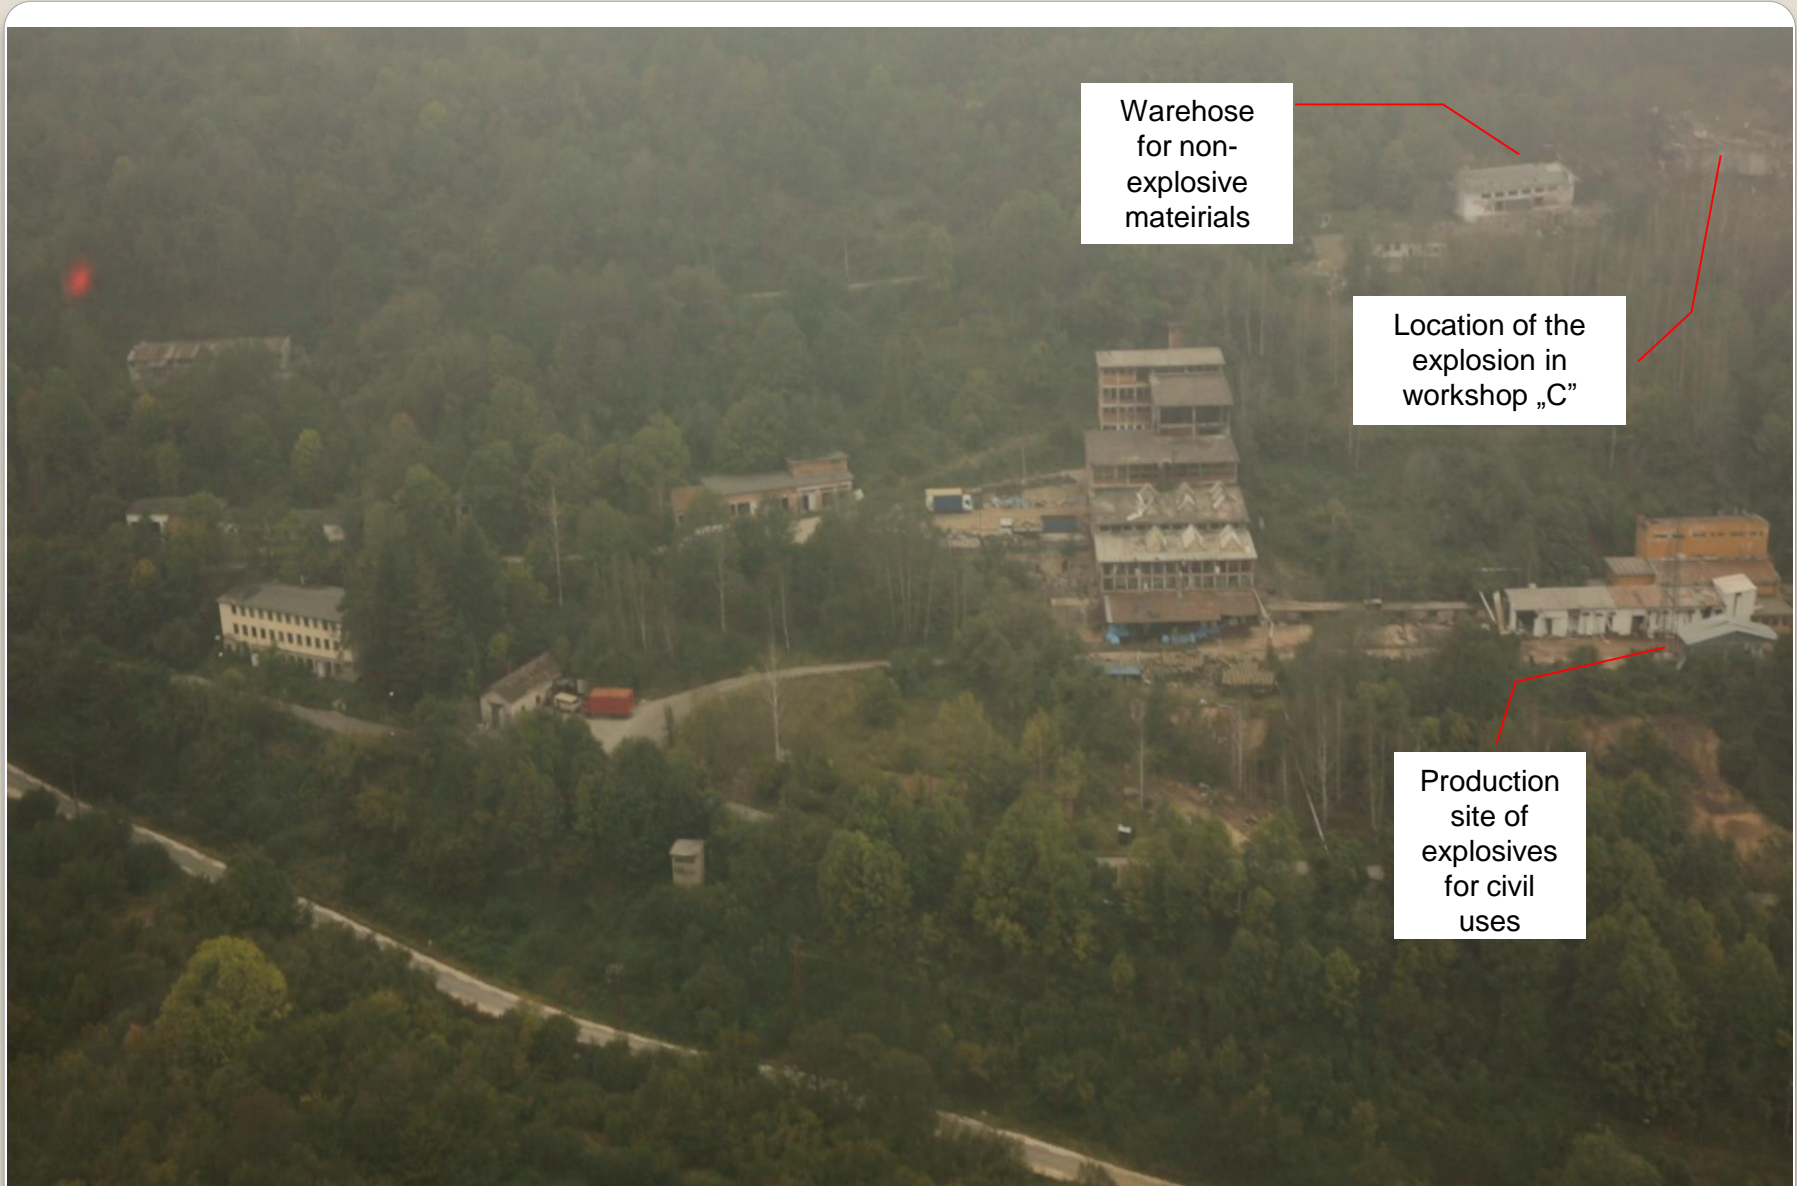
Warehouse
for non-
explosive
materials

Location of the
explosion in
workshop „C”

Production
site of
explosives
for civil
uses

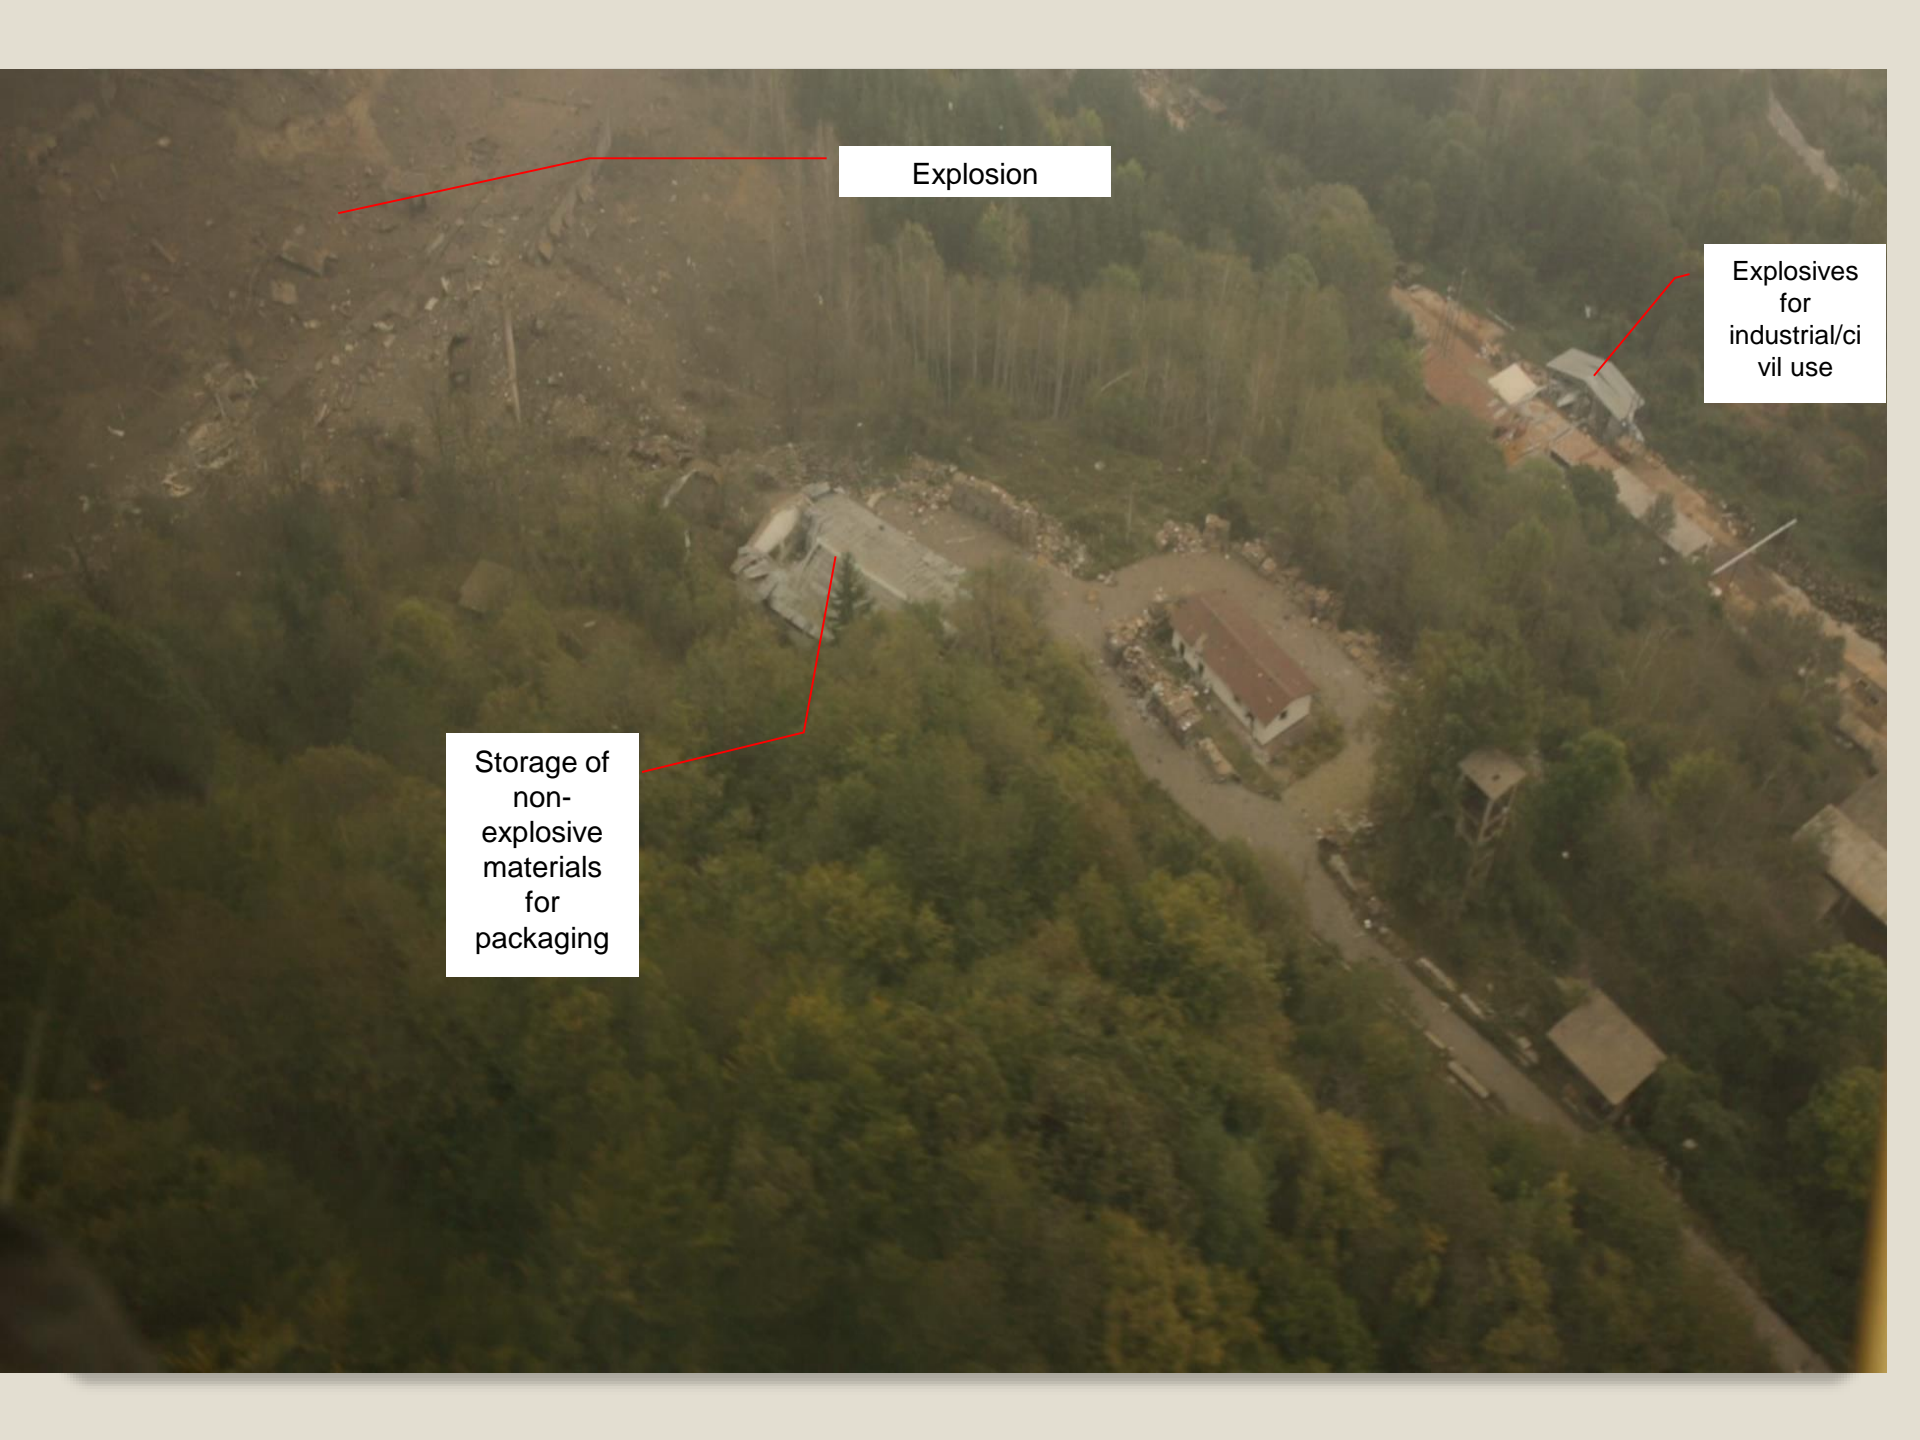
Explosion

Explosives
for
industrial/ci
vil use

Storage of
non-
explosive
materials
for
packaging
