MJV Ravenna  
Emergency planning and management  
Rouen accident 2019

# FR feedback

16-18 Oct. 2024

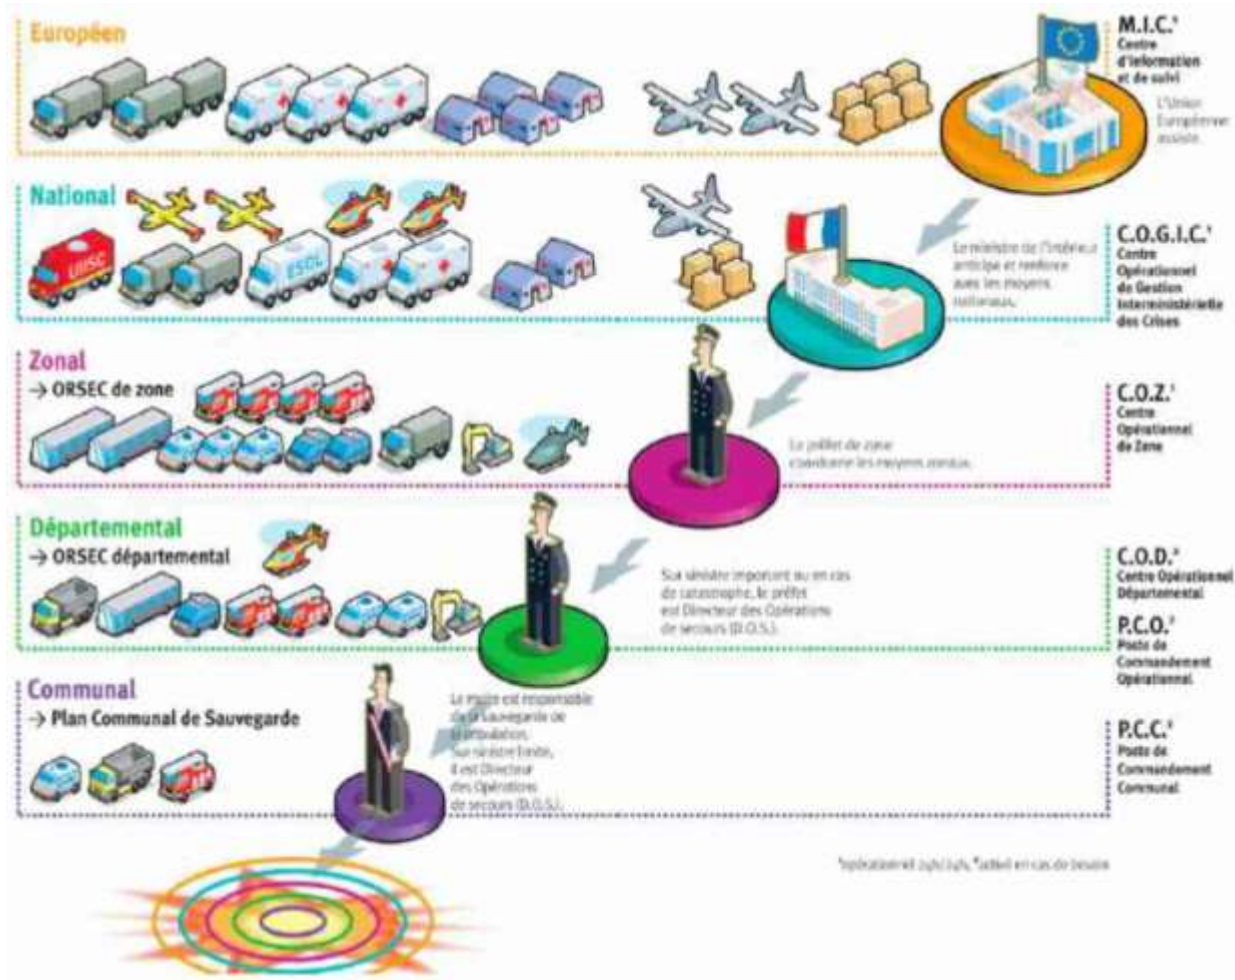
# Crisis management - chain of command

EU level

National (Minister of interior)

Defence zone (Prefect of the zone)

Province (Prefect)

Municipality (Mayor)

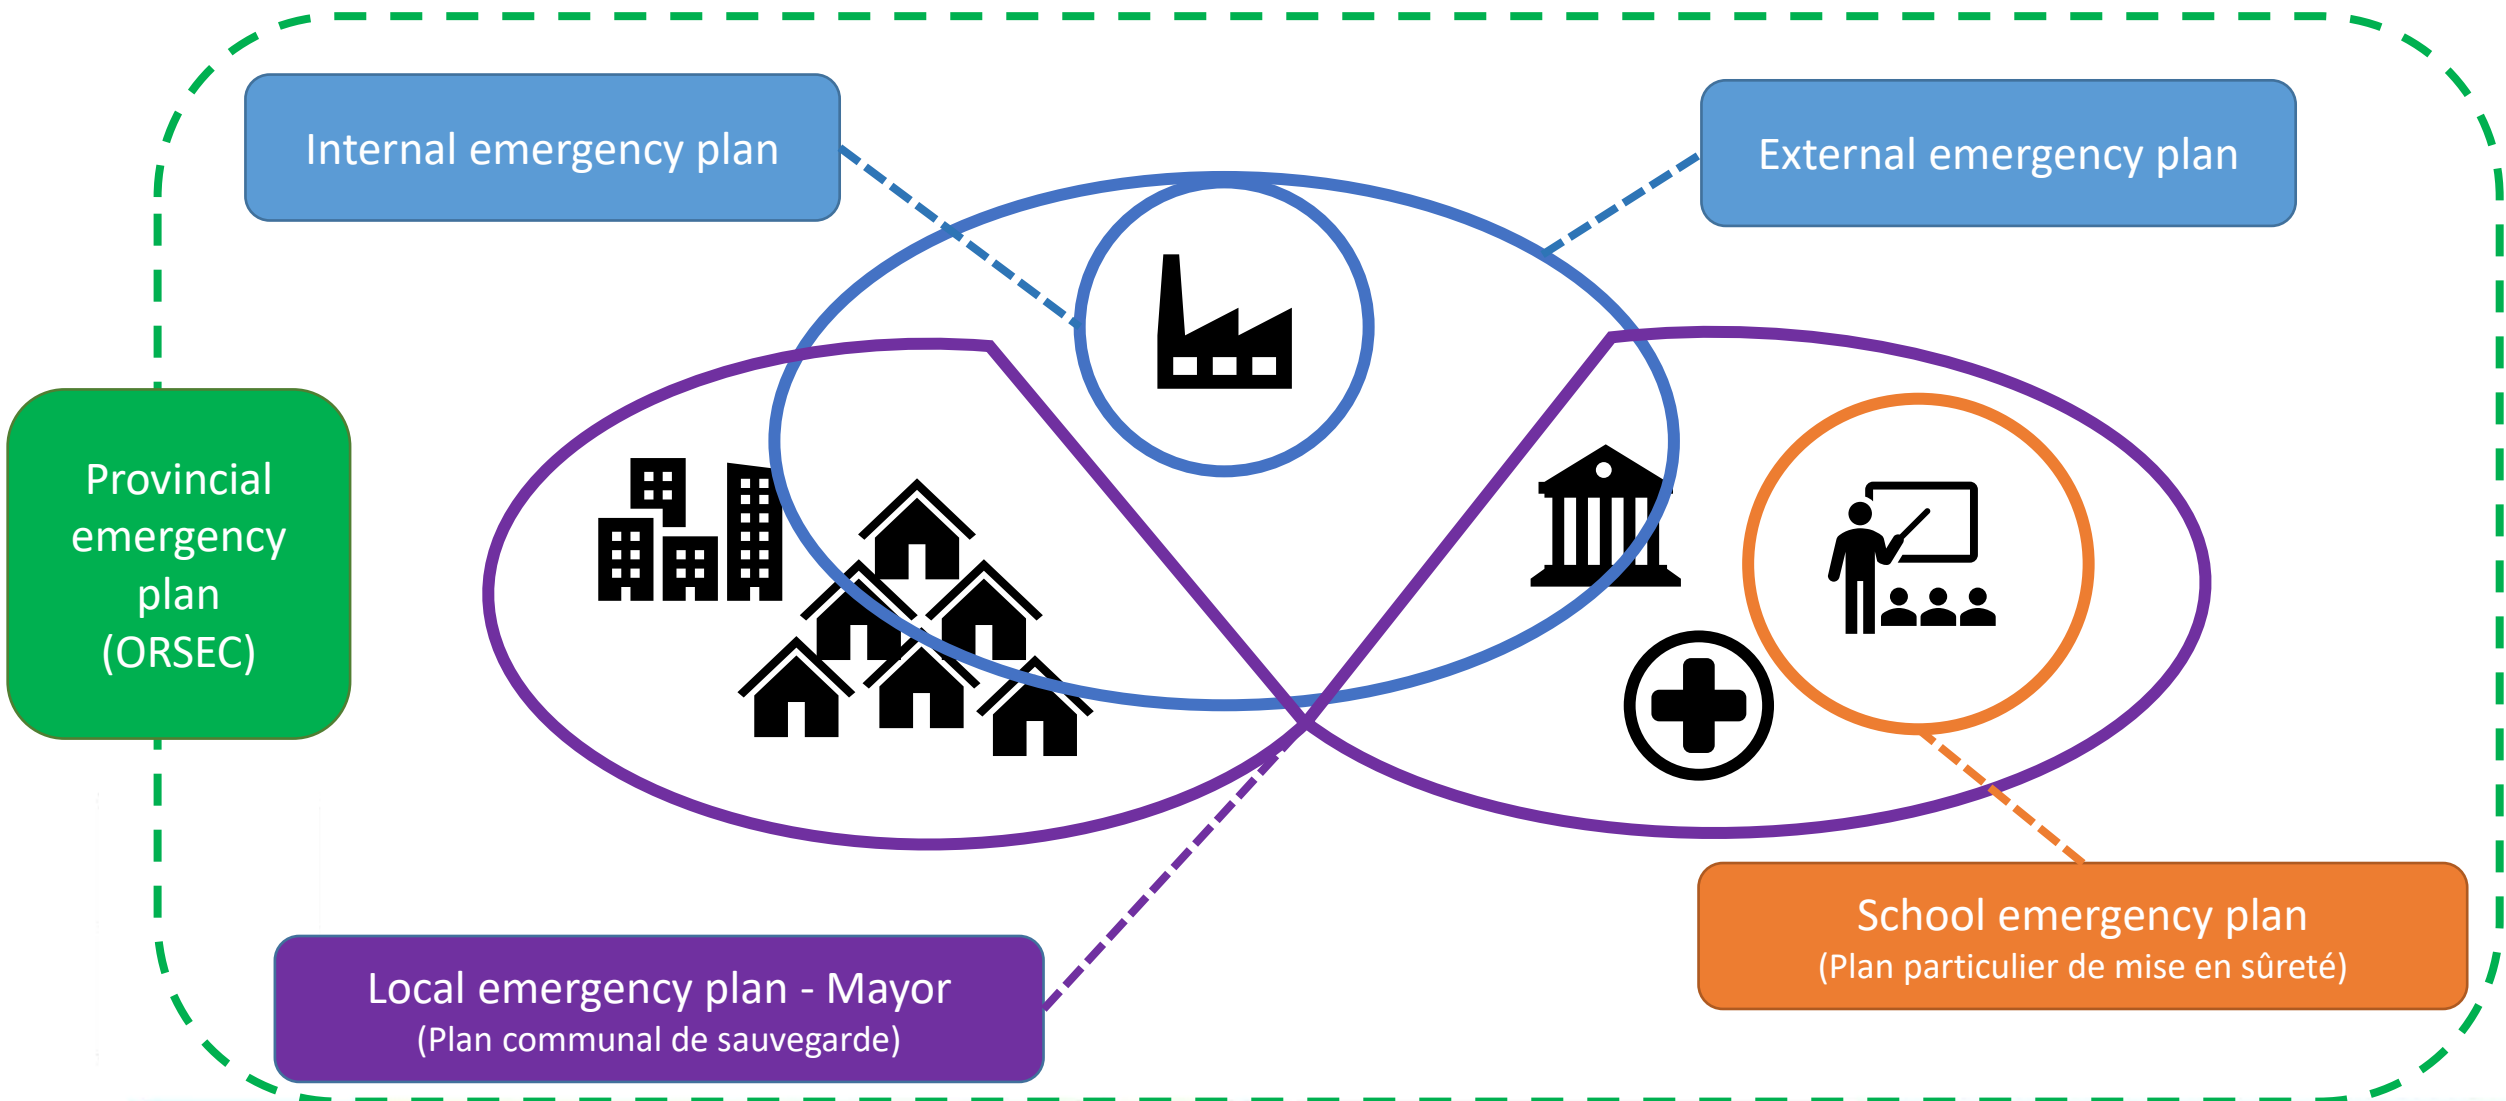
# Interactions between the different emergency plans

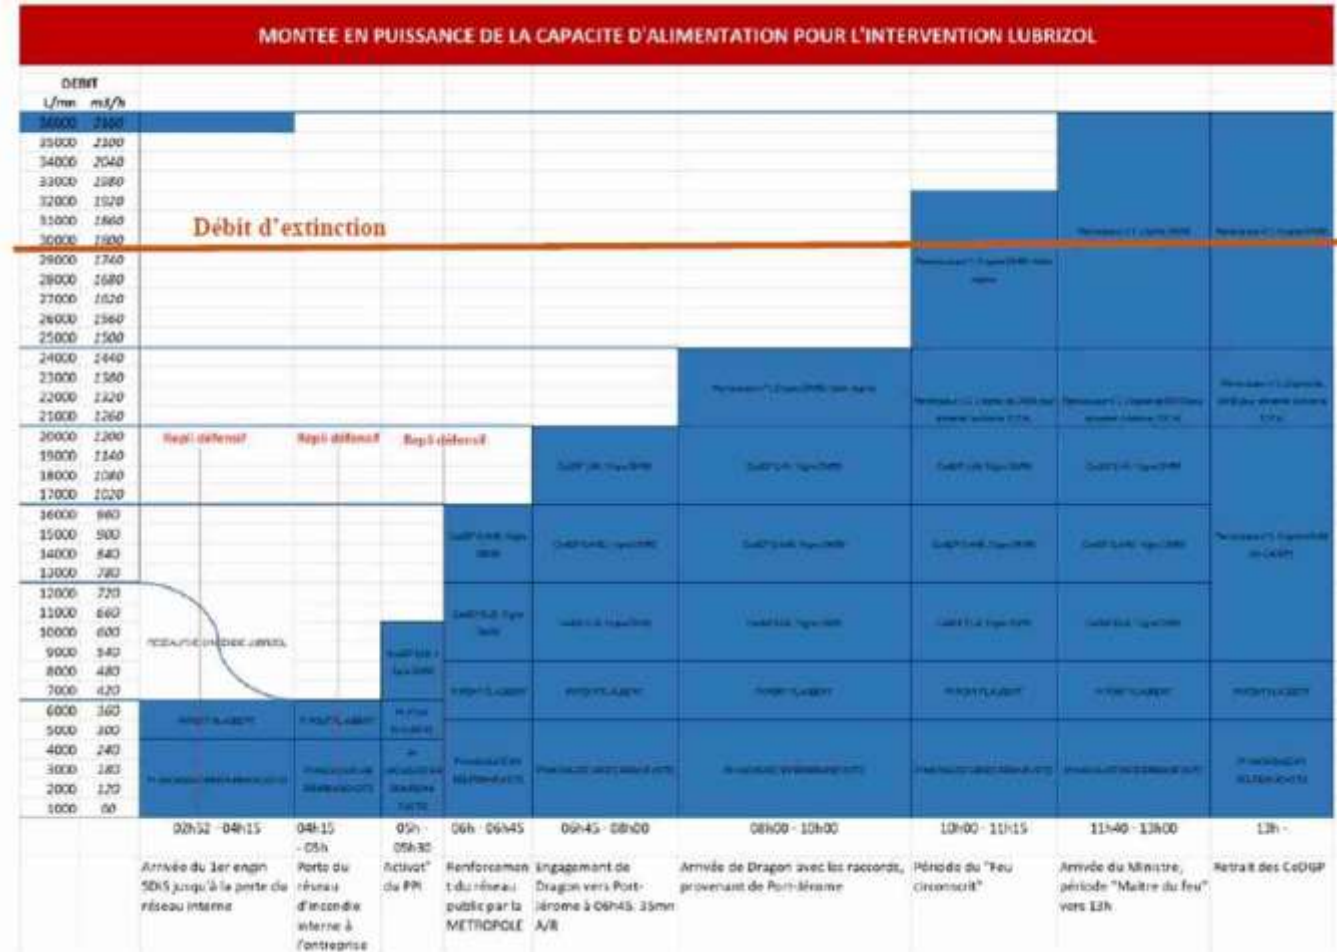
# Water resources ramp-up

Schéma du dispositif hydraulique (Cne KOPYLA)
