# Inspection following a major accident: lessons learned for the chemical specialties industry

The Role of Authorities in Promoting Lessons Learned

Technical Working for Seveso Inspections (TWG 2) and the EC Joint Research Centre (MAHB)

Romualdo Marrazzo

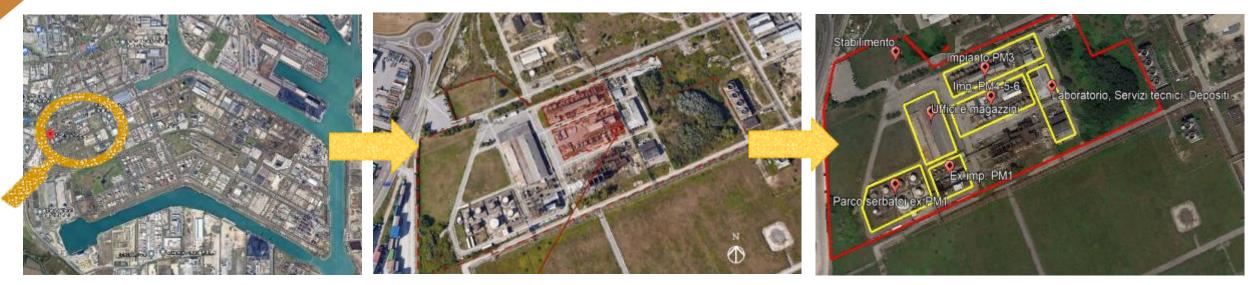
### The site of the industrial establishment

The area within a two-kilometers include industries and populated buildings, airport, port, lagoon

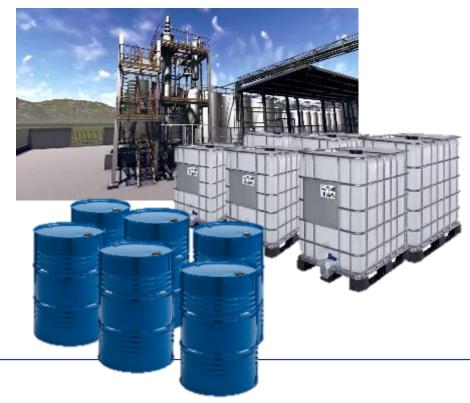
Tank TK 2.2 was likely to have been holding

WASTEWATER CONTAINING METHYL ALCOHOL, ETHYL ACRYLATE, WHITE SPIRIT, XYLENE (*H226 - Flammable liquid and vapor; H411* - Toxic to aquatic life with long-lasting effects)

The amount directly involved in the event was 130 tonnes

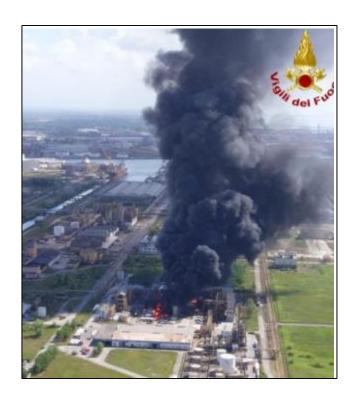
The accident occurred in the morning during modification works, by an external firm, which was connecting tank TK 2.2 to the wastewater network

One hour before the event, these workers had cut the pipe that was being worked on

The event occurred when the cut pipe was being sealed, while an electric arc welder was in use

The trigger gave rise to the explosion and catastrophic rupture of the atmospheric tank

An internal domino effect was generated, in a succession of fires and explosions

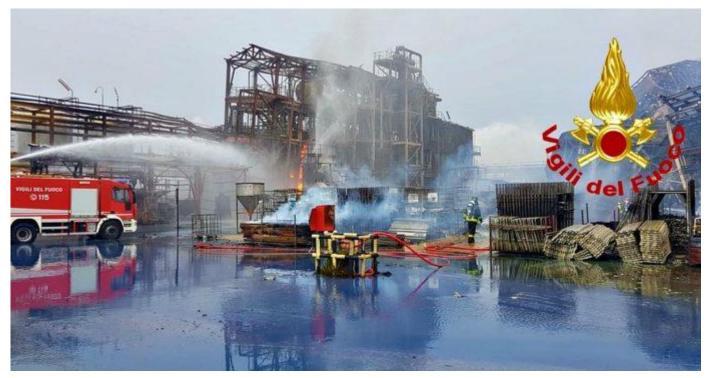
The External Emergency Plan (EEP) was activated by the Prefect's Office, following first notification from the fire brigade

People living in the industrial district within 1 km radius of the establishment were asked to stay at home with the windows closed until the emergency was over

Following intervention by the offsite external emergency services, the fire was brought under control at 14:00, and the emergency was declared over at 17:00

Approximately 30 fire brigade vehicles attended with 90 firefighters, including from neighbouring stations

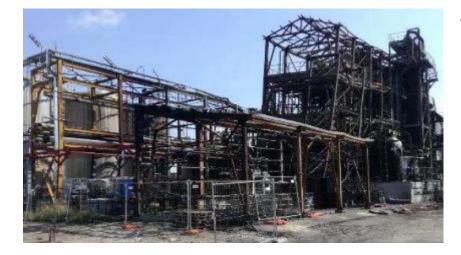
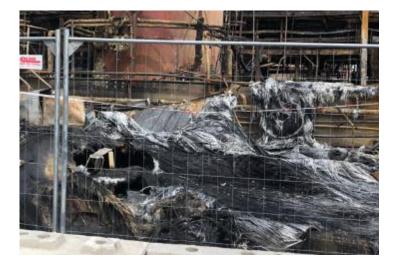
#### Consequences on equipment and structure Tanker Truck
