Safety practice

Natech risk management in Japan after Fukushima – What have we learned?

Elisabeth Krausmann*, Ana Maria Cruz#

Summary

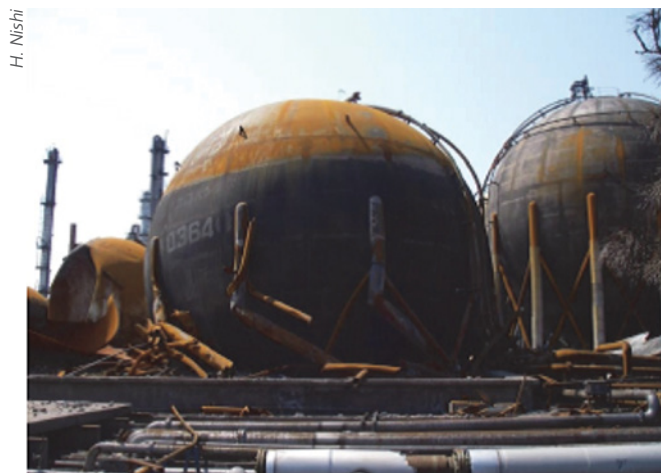
An example of a major Natech accident caused by the earthquake were the fires and explosions at the LPG tank farm of a refinery in Chiba. Damage to the support braces of a tank during the main earthquake shock and buckling of the legs when the aftershock hit, led to tank collapse and LPG release from the severed connected pipes (Figure 2). The LPG spread and ignited, causing several consecutive BLEVEs and eventually destroying all 17 tanks

Figure 2 – Buckling of tank legs due to earthquake

The fires and explosions at the Chiba refinery also highlighted the need for more active government oversight to monitor compliance with safety regulations and to carry out inspections. A combination of bad practice and violation of regulations was the root cause of the accident. The collapsed tank was under maintenance and had been filled with water already for 12 days when the earthquake struck. This almost doubled the weight considered in its design basis, rendering it vulnerable to earthquake impact. In addition, the manual override of a safety valve on an LPG pipe continuously provided fuel to the fires and allowed them to burn out of control⁷.

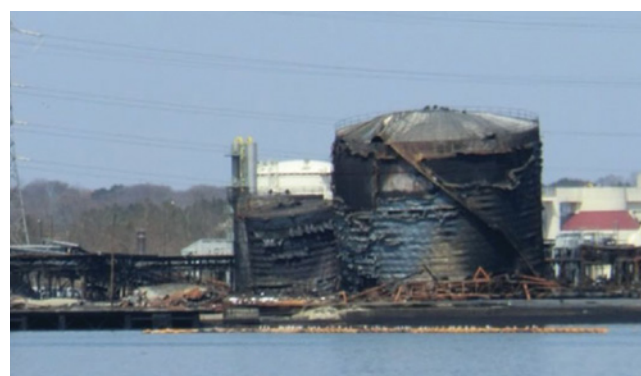
events at the same time⁷. In the refinery's loading facility, the tsunami hit a tanker truck, breaking a pipe in the process and releasing gasoline which ignited. It has been speculated that sparking from collision of a truck with refinery units could have been the ignition source¹³. The fire destroyed the entire loading station and also engulfed adjacent sulphur, asphalt and gasoline tanks (Figure 3). A large part of the western section of the refinery was destroyed in the blaze. The fires were eventually extinguished five days after the tsunami. In other refinery locations, LoCs occurred when pipelines broke after direct tsunami impact (Figure 4), or when the tsunami waters caused a tank to float which broke an attached pipe⁷. In both cases, heavy fuel oil was released but did not ignite. In the second case the LoC was aggravated by an open valve on the tank which underwent filling when the tsunami hit. The earthquake caused minor spills on atmospheric tank roofs due to roof vibration.

Figure 3 – Burned and melted tanks at a refinery in Sendai port due to tsunami

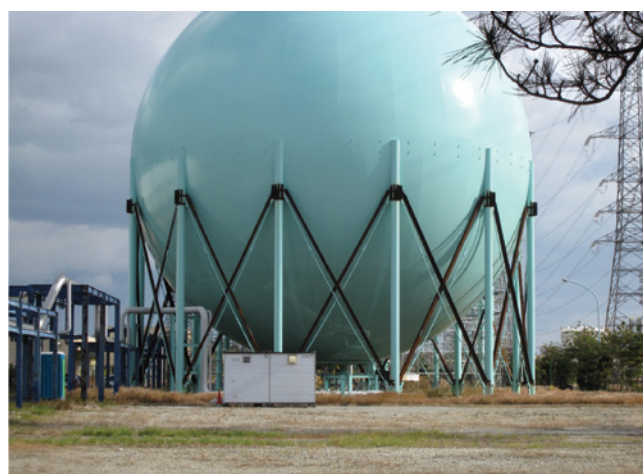
Figure 5 – Strengthening of tank supports in the Sendai coastal area

For instance, Japan has modified the seismic code for high-pressure gas storage tanks to minimise the damage to gas storage facilities that can be impacted by long-period seismic events causing liquid sloshing. The amended code also increases the seismic resistance of the supporting frames of pipe braces by reinforcing the intersection of the braces¹⁷ (Figure 5). With a trend towards larger storage tanks, which translates into higher risks, adequate seismic design of the tank structure and foundation has become even more important¹⁸.
