Accidents with LPG in Norway

The Lillestrøm LPG Accident April 5 2000

2012 - LPG accident at a food-factory –non Seveso

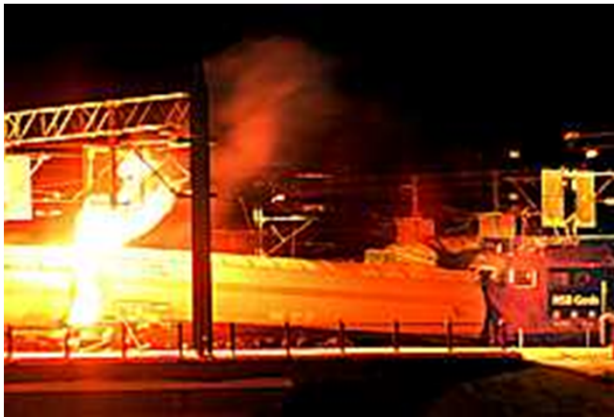
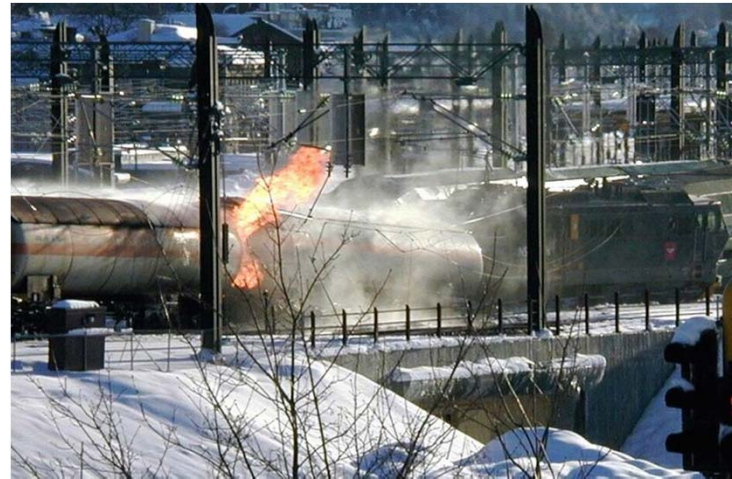
Photos: NRBR

- A train with two fully loaded LPG tanks (92 tons) lost brake power and collided with a waiting train at Lillestrøm train station, the LPG-tanks derailed.
- LPG started to leak from both tanks and caught fire, and the potential for a disaster was there:
 - 200 meters from the centre of Lillestrøm
 - The accidents happens 00:57, cooling of the tanks starts 03:05, the tanks were quickly getting overheated.
 - Over the next hours more and more water cannons were brought in and the tank temperature was lowered

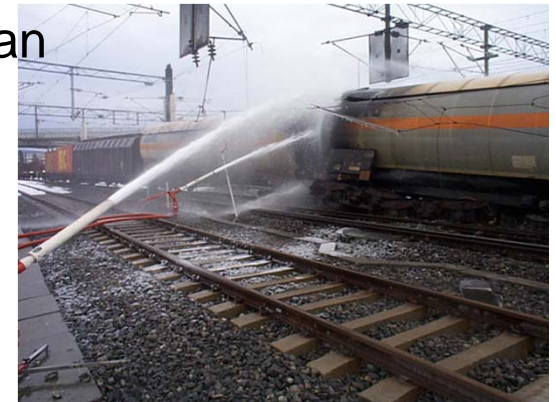
Photo: NRBR

- Thursday April 6 an increasing wind caused the water cooling to become less efficient. Efficient cooling was essential to avoid a BLEVE
- A team of swedish gas experts were brought in, in an attempt to empty the tanks by controlled burning off of LPG.
- The fire needed to be put out before this could happen, but all actions were unsuccessful.
- The fire spread to the top of one tank, probably because of a cracked weld.

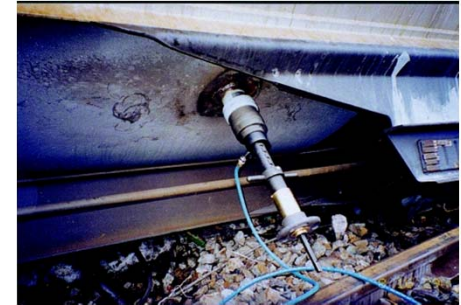
Photo: NRBR

- Late Thursday night all personnell close to the tanks were removed from the site and the tanks were left without cooling for a couple of hours, and the risk of a BLEVE was greater than ever before.
- Statoil made a plan for how to burn off the contents of the tank in a more controlled manner
 - For the second tank at the back, this could be done by connecting of flexible piping to the tank valve
 - For the front tank new valves were installed by hot-tapping – an operation that required specialist personnell
- Late April 8 the contents of the tanks was burned off.

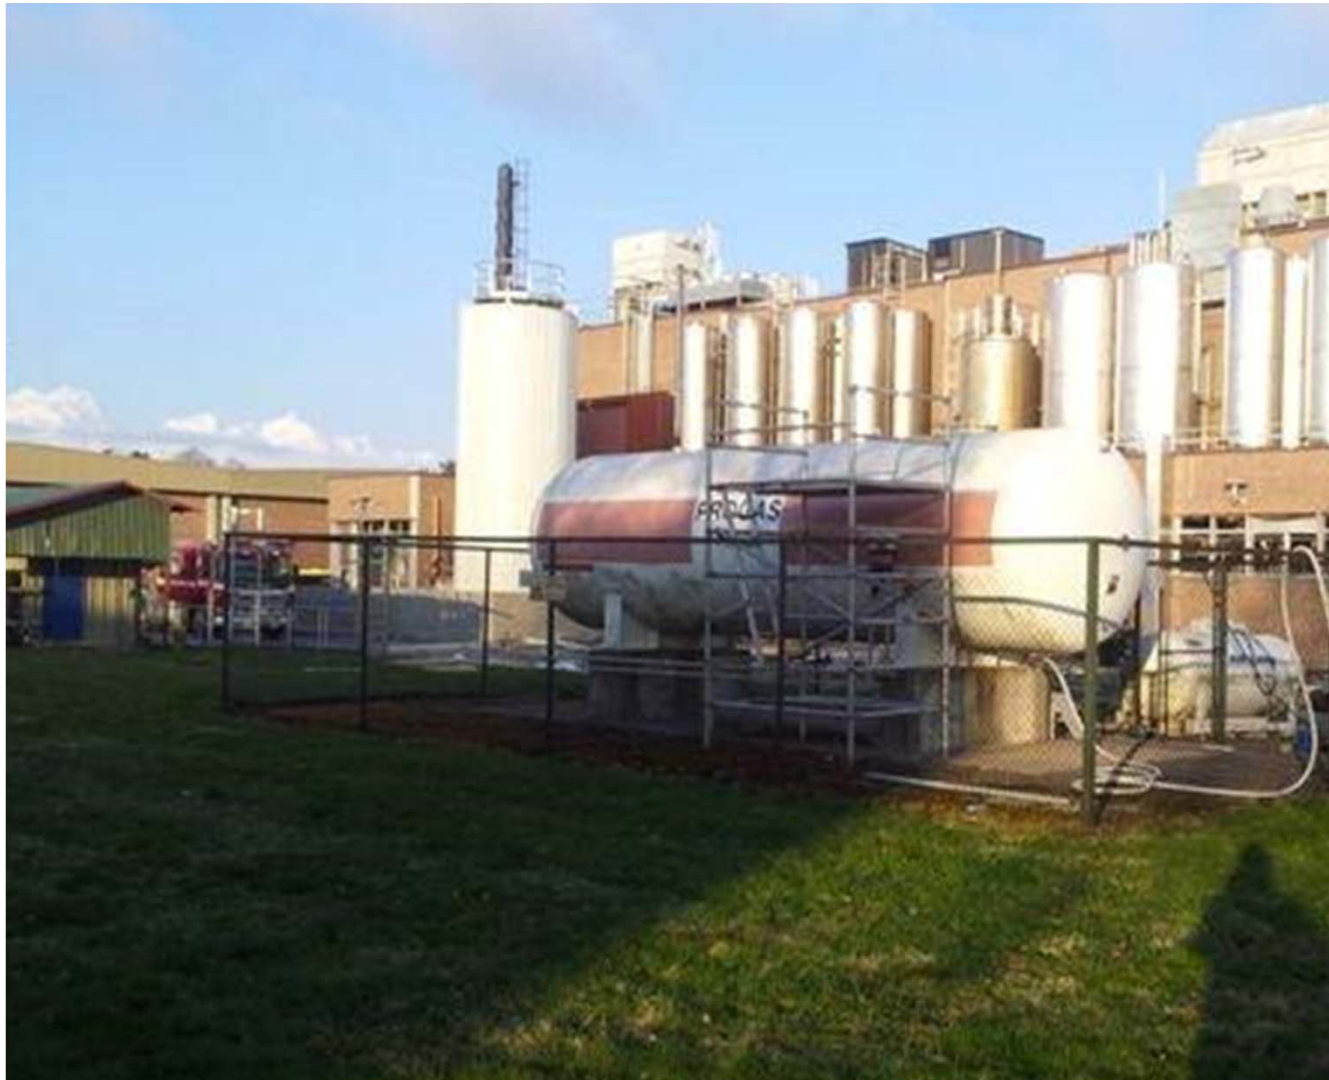
- Father and son was performing this work.
- The son leaves the site in order to buy lunch.
- When he leaves the flare is burning, the manometer on the tank shows 0,5 bar overpressure.
- As he returns from shopping an explosion occurs in the water purification unit, the entire building collapses and several nearby buildings are damaged by the overpressure.
- The father dies.

- The connection of the waterhose to the tank was highly irregular, and a back-flow of gas from the tank to the water purification plant occurred.
- The explosion in the water-purification plant was caused by non-ex equipment.
- When our colleague went to the factory to find out what had caused this to happen, he found that a lot of irregularities had taken place which caused this accident to happen.
- Even «non-Seveso» amounts of LNG can create havoc.
