Mutual Joint Visit Workshop for Seveso Inspections SAFETY CULTURE, LEADERSHIP, AND ENFORCEMENT 16-18 September, 2015, The Hague, The Netherlands

### Inspections following major accident in a chemical establishment: management perspectives and repercussions on company safety culture

#### Background: the accident profile (eMARS database – Major Accident Reporting System)

- Location/Date/Time of Major Occurrence
  - Lombardia Region north of Italy; 10/09/2013; h. 4.00
- Accident title
  - Flash-fire during upload of DMC (Dimethyl carbonate) under vacuum condition
- Accident type
  - Major Accident, reported under Seveso II Directive
  - Seveso II status of the establishment: art. 9 upper tier (SR
    - Safety Report)
- Industrial Activity
  - General chemicals manufacture
- Reason for Reporting (Annex VI of Seveso Directive)
  - Injury to persons: 1 death

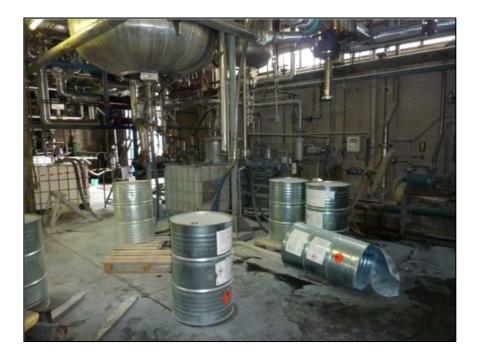
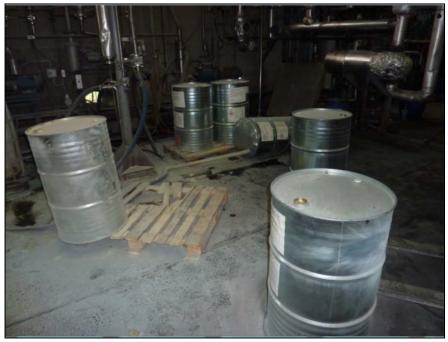
#### Views of the whole area involved

- On 10/09/2013, at 4:00 am, two operators were concluding the loading phase of Dimethyl carbonate in the R20 of the RS1 from 200 liters metal sheet drums, by vacuum suction with flexible pipe connected to the reactor, for a total of 849 kg (open cycle transfer)
  - To empty the 4<sup>th</sup> drum (10-15 lt. remaining), it was inclined to facilitate the suction
  - Probably in the next step of extraction of the loading nozzle, it was produced the ignition of DMC vapors
  - Explosion of the drum with bottom detachment and consequent immediate fire of the whole product, with a limited impact area (about 2 mt.) and a limited duration of the entire event of about 10 min.

- The cause of the fire triggering is reasonably to be found in the accumulation of electrostatic charges on the hose and nozzle, both in plastic material, following the repeated insertion and removal of these same in the drums (final phase of the loading operations)
  - Such material is not compatible with the manipulation and handling of flammable substance (dielectric properties)
- The procedure for handling flammable, in effect at the time of the event, gave general indications about the chemical compatibility and the grounding system and the correct identification of the specific equipment to be used
- According to interviews with some workers, there was not a specific training on the handling procedure

- Using nozzles of stainless steel and conductive pipe that are chemically compatible with the specific loading raw materials
- Loading possibly from the foot valve of the container in order to avoid turbulence
- Do not exceed the loading speed of 100 lt./min (av. speed of 1 m/s)
- Loading possibly by vacuum produced in the container in which the raw material loading is carried out
- Loading the raw material in exact order as described in the manufacturing process
- Checking the correct grounding system in case of conductive equipment (stainless steel nozzle and/or conductive pipe)
- Check regularly the electric continuity of the "nozzle + conductive pipe" equipment (electrical bonding) - every 6 months
- Do not climb on wooden pallets
- Keep the packed containers separated from each other

- Replacement of all nozzles for the flammable transferring with loading nozzles of stainless steel and conductive pipe
- Medical interviews of the workers with psychologists of the department of clinical psychology hospital about Post-Traumatic Stress Disorder (PTSD)
