Ministerie van Sociale Zaken en
Werkgelegenheid

Mutual Joint Visit 2016 - Workshop on Explosives and
Pyrotechnics

S.E. Fireworks

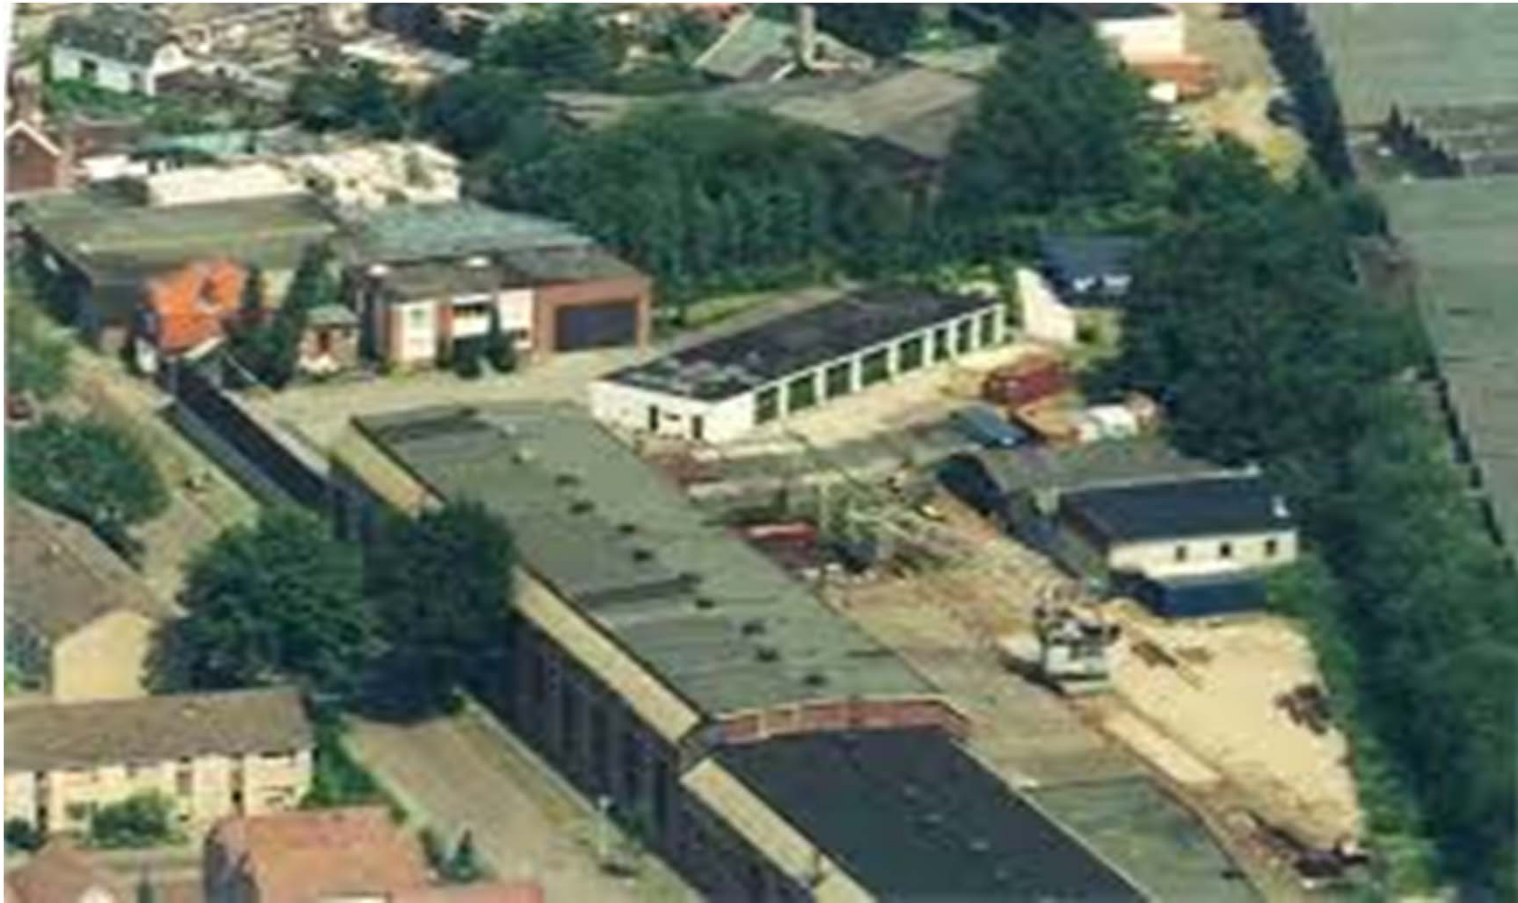
Site before 13 May 2000

- Permit for 158.500 kilo firework
- Permit lasted to 2002 and then the company had to move
- The location had:
 - a bunker with 17 compartments
 - 2 warehouses,
 - 16 containers
 - 7 temporary garage boxes
- Sings of illegal activities since the end 80's

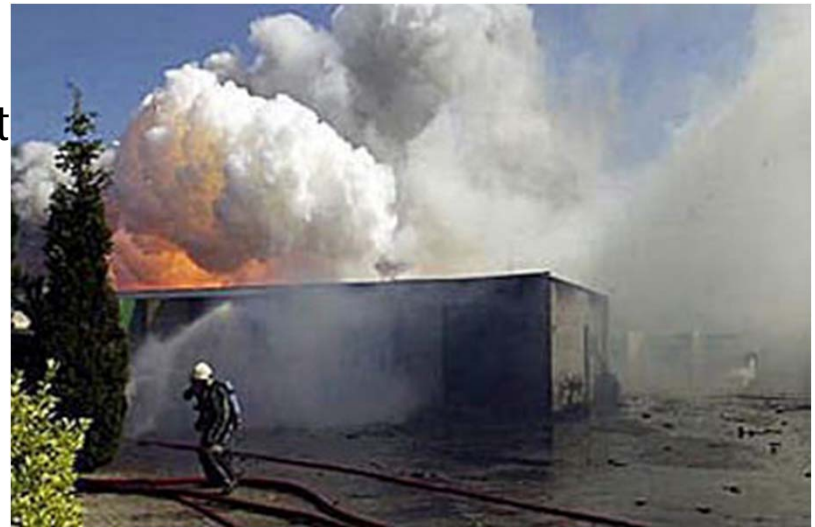
- 15.28 Fire in 2 containers E2 and E15
- 15.30 Fire is several places
- 15.34 1st explosion in container E2 en more fireworks is shot from C4
- 15.34 Garage boxes explode quickly one after another
- 15.35 explosion in C11 followed by the rest of the bunker and other containers
- Fireworks and debris is spread over the area and hundreds offires start
