# **Series of mass explosions in a fireworks plant 25th July 2013 - Città Sant'Angelo (Italy)**

**Eng. Fausta DELLI QUADRI**

**ISPRA – Italian National Institute for Environmental Protection and  
Research Industrial Risk Service**

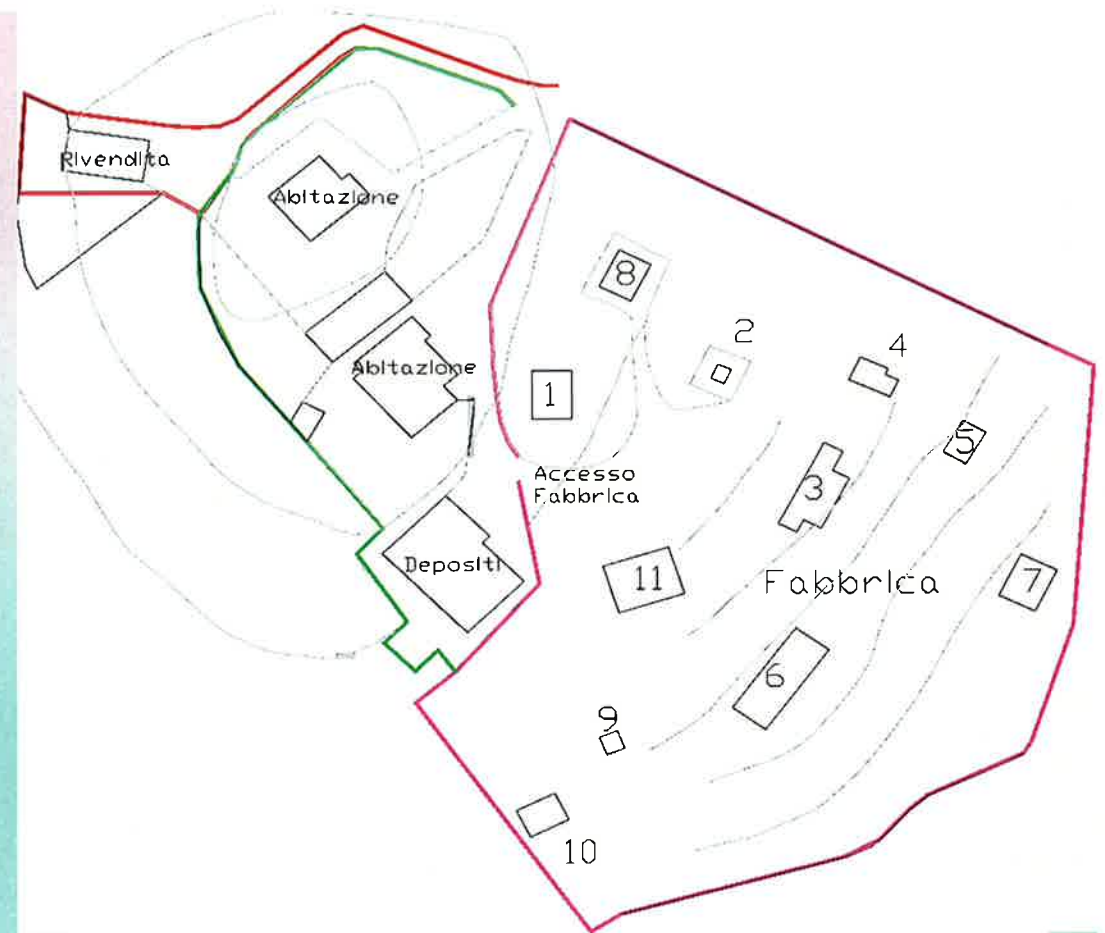
1. Non-pyrotechnic products storage
2. Black powder storage (max 500 kg)
3. Fireworks laboratory
4. Products storage (max 4 t)
5. Products storage (max 9,6 t)
6. Mixing
7. Colours and various material storage
8. Products storage (max 9,6 t)
9. Engines installation
10. Coal crushing
11. Semi-finished products storage (max 7 t) – not yet authorised

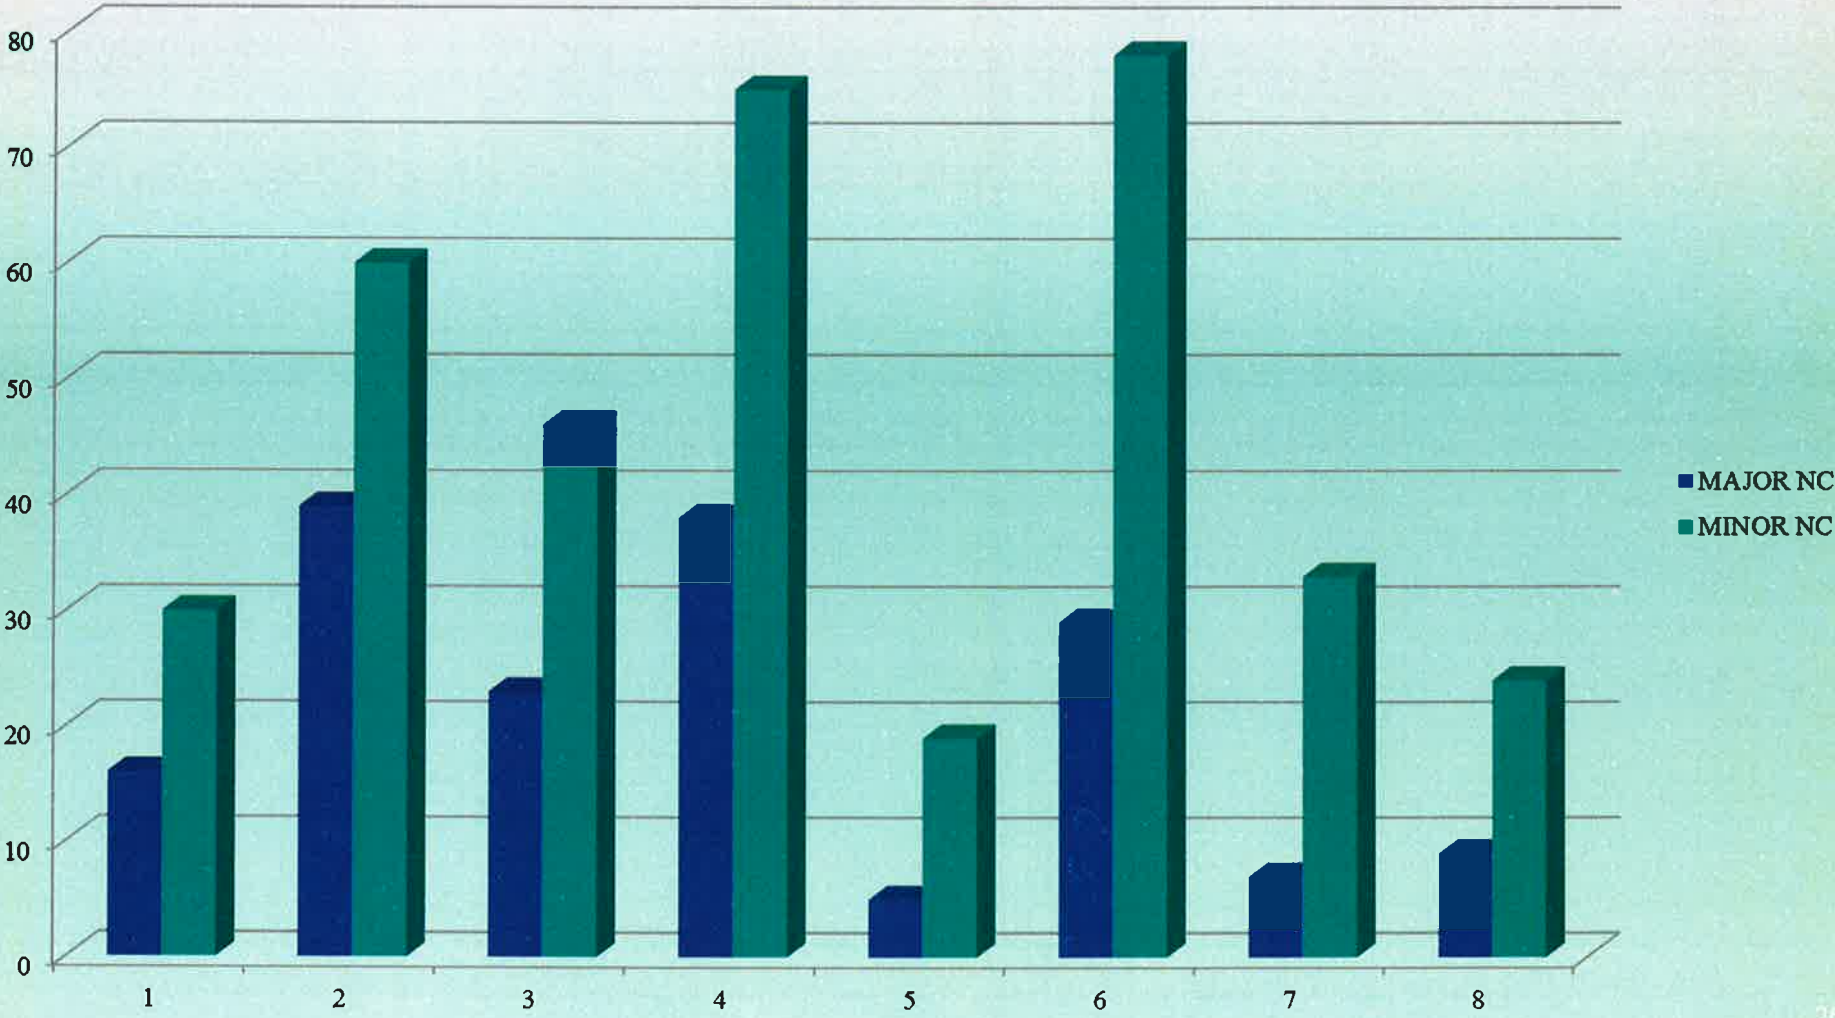
# SMS INSPECTION OUTCOMES: SEVESO EXPLOSIVES ESTABLISHMENTS

- personnel "training" must be improved in many points (especially for family business), starting from the activities plan for internal workers, contractors and visitors, to the evaluation of the results achieved, including a more extensive use of learning tests (points 2.ii and 2.iii)

- need of a full compliance of the planned frequencies for equipments inspection and maintenance. As far as concerning the permit to work procedures, in some cases it has been recommended the improvement of its structure, in terms of the flow of authorizations and the specific definition of its scope and use (point 4.iv)
