WEBINAR ON RISK MANAGEMENT AND ENFORCEMENT ON AGEING HAZARDOUS SITES AND ON MAINTENANCE OF PRIMARY CONTAINMENT SYSTEMS

ISPRA, 8th february 2022

**Inspection experiences on ageing infrastructure and
equipment control: case studies**

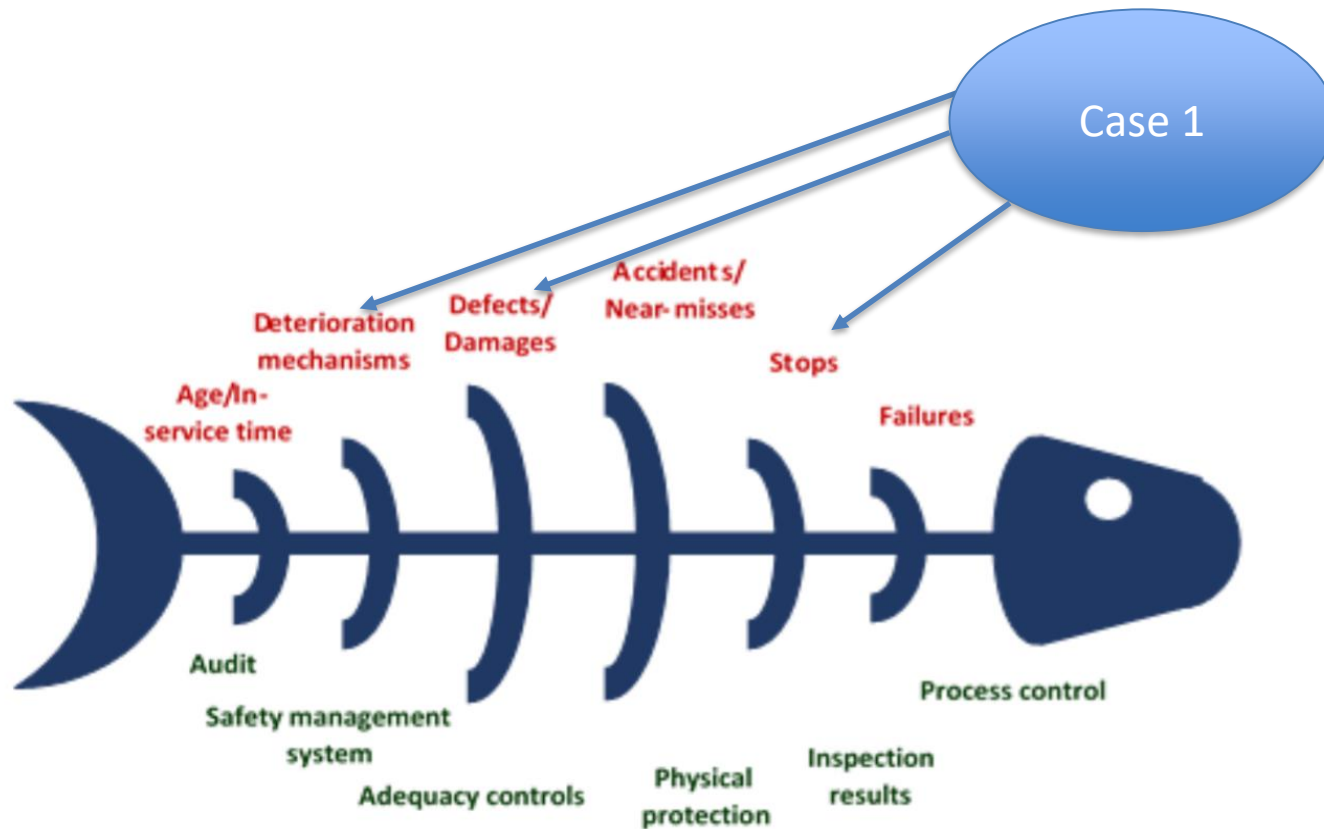
CASE 1: ACCIDENT LINKED TO THE AGING OF OIL STORAGE TANK – ACCELERATION FACTORS

- after analysis and investigation post accident, it seemed that the rapid speed of corrosion in tank D bottom was caused by the **shutdown of the tank** in 2016, when the reduction of the oil level and roof, with stopping the agitation inside, created a discontinuity of operation for the tank: **this could promote the initiation and/or acceleration of localized corrosion phenomena caused by bacteria**, very dangerous since it could progress the corrosive phenomenon through the thickness at particularly high speeds. The rapid localized corrosion would have led to the formation of through-holes in just two years

- accelerated **Microbially Influenced Corrosion (MIC)**, accelerated by the action of microorganisms in the local environment. Facilities where MIC is prevalent include hydrocarbon storage tanks

- failure of the primary protection system of the tank D: damage to the bottom due to a **corrosive phenomenon**, formation of through-holes and LOC from the tank - **deterioration**
- failure of the secondary protection system of the tank D: damage to the asphalt barrier and consequent cracking. The oil vertical migration in the layers below the bottom of the tank was due to the damage of the impermeable layer (bituminous conglomerate barrier) 80 mm thick under the bottom. Cracks might be generated by contact of the less rigid bituminous layer with the annular (rigid) concrete foundation, due to the different behavior of the two materials under stress - **damages**
- failure in the control of the corrosion phenomenon, in the application of the results of the operational experience and in the re-evaluation of the maintenance frequencies of the tanks

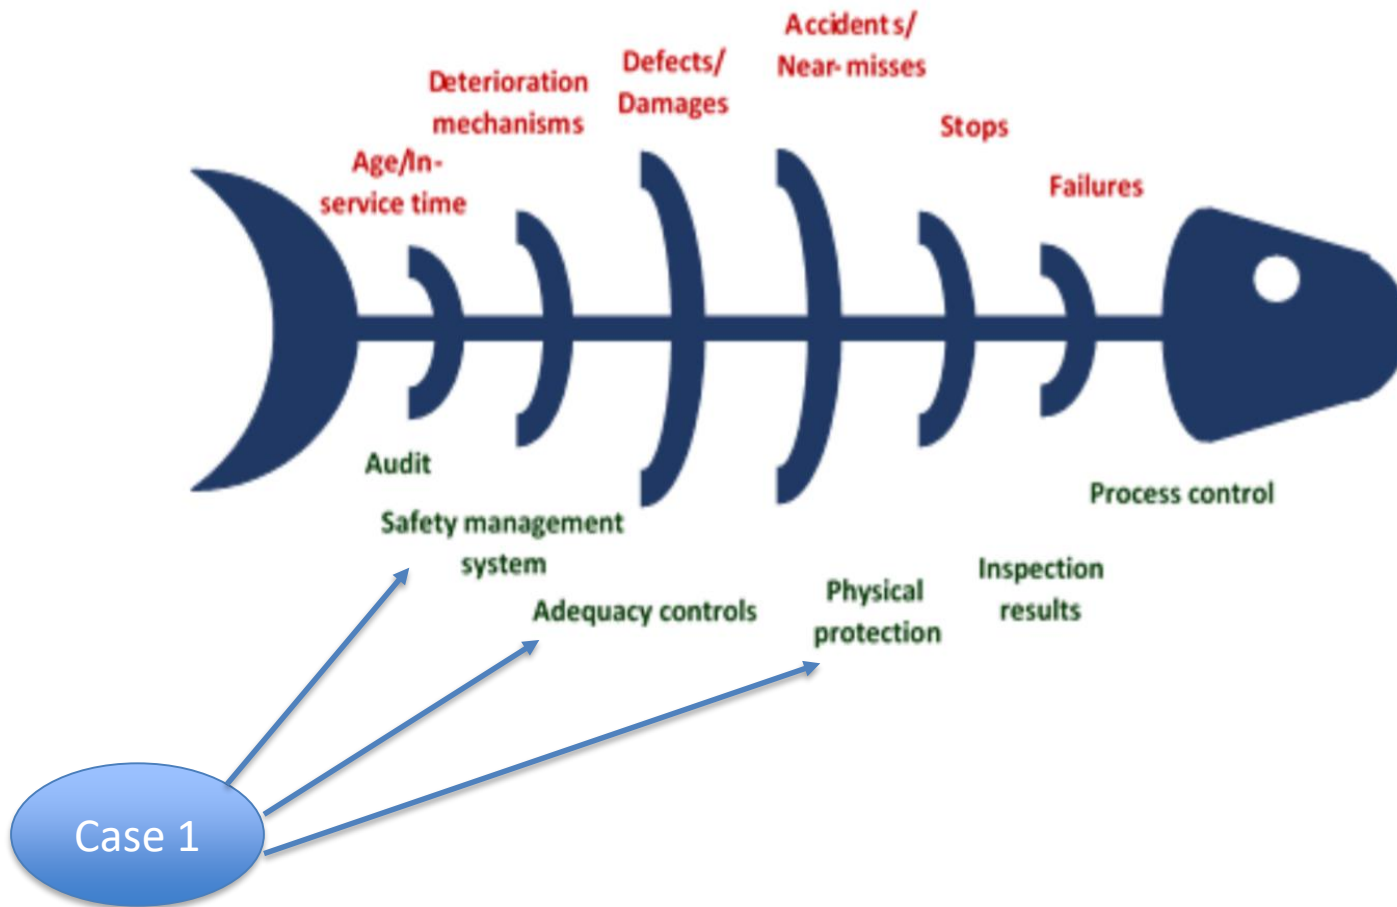
CASE 1: ACCIDENT LINKED TO THE AGING OF OIL STORAGE TANK – FAILURE RETARDING FACTORS

- **SMS – failure in risk analysis:** inadequate consideration of the accident occurred and of all the appropriate safety measures to prevent and mitigate it
- **unadequacy controls:** failure in the control of the corrosion phenomenon, in the application of the results of the operational experience and in the re-evaluation of the maintenance activities of the tanks
- **no physical protection:** failure in the adoption of "compensatory" prevention / protection measures expected from the construction of the double bottom. Lack of in-depth knowledge of the geological situation (composition, structure, risks, etc...) of the area below the plant, resulting in an underestimation of the evolution of any loss of crude-oil in the underground

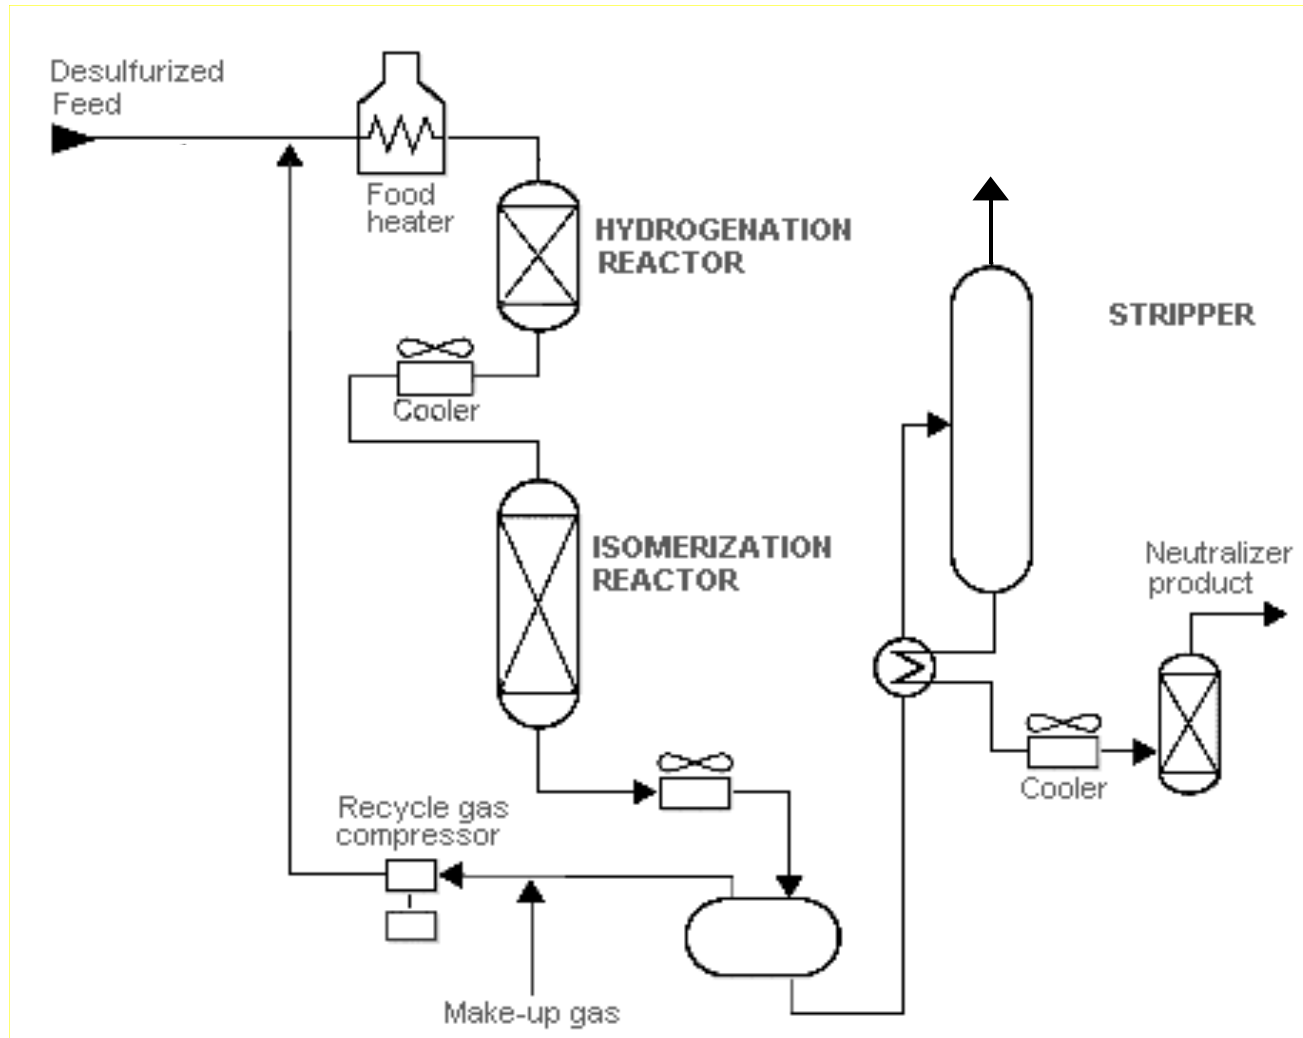
CASE 2: ACCIDENT LINKED TO THE AGEING OF RECIPROCATING COMPRESSOR – TIP UNIT

- Establishment: petroleum refinery
- units involved: isomerisation (TIP) and Bensat (aromatics saturation with catalyst to reduce the benzene contained in the distillate)
- equipment source of LOC: reciprocating compressor B located in TIP unit, used to recycle a gas mixture to TIP and Bensat units. Works in parallel with a twin compressor (A). Works at P from 15 to 21 bar and at T from 40 to 60 °C. Gas mixture recycled: hydrogen (70% vol), methane, ethane, propane and butane (30% vol)
- release of a big quantity of highly flammable gas mixture from the B bottom, that immediately found ignition; strong burst, followed by jet-fire starting from the compressors and impinging the near bensat unit (14 m apart)
- parts of the bensat unit failed causing the release of gasoline and hydrogen, which led to the extension of the fire; strong material damage

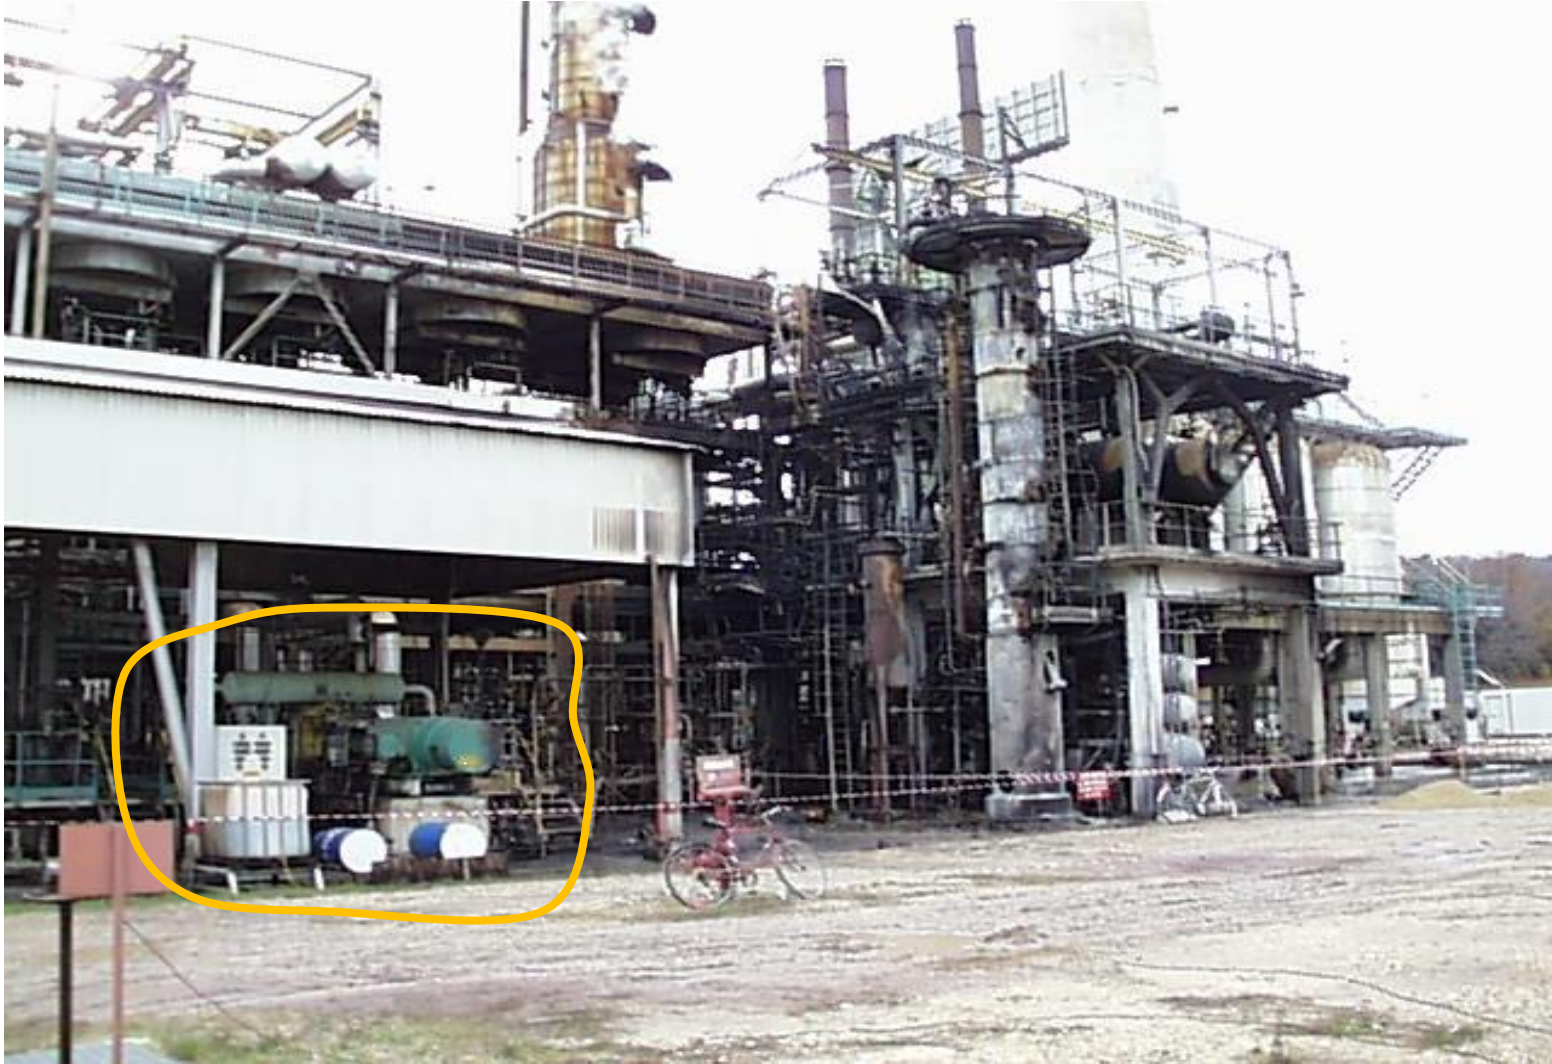
CASE 2: ACCIDENT LINKED TO THE AGEING OF RECIPROCATING COMPRESSOR – TIP AND BENSAT UNIT

- rupture of the crankshaft-rod mechanism in the compressor, consequent hitting action of the piston on the bottom of the cylinder no.2
- the combined effects of hitting-action with the internal pressure (20 bar) led to the failure of the screws, which hold the bottom
- regular controls/maintenance activities on the compressor B since the last 3 years (according to the technical manual and the supplier's indications: pumping part revision (east and west side), valves substitution (east and west side), speedy joint substitution, compressor general revision, substitution of nuts of crank-rod, revision of sealing packages
- leader supplier on the market

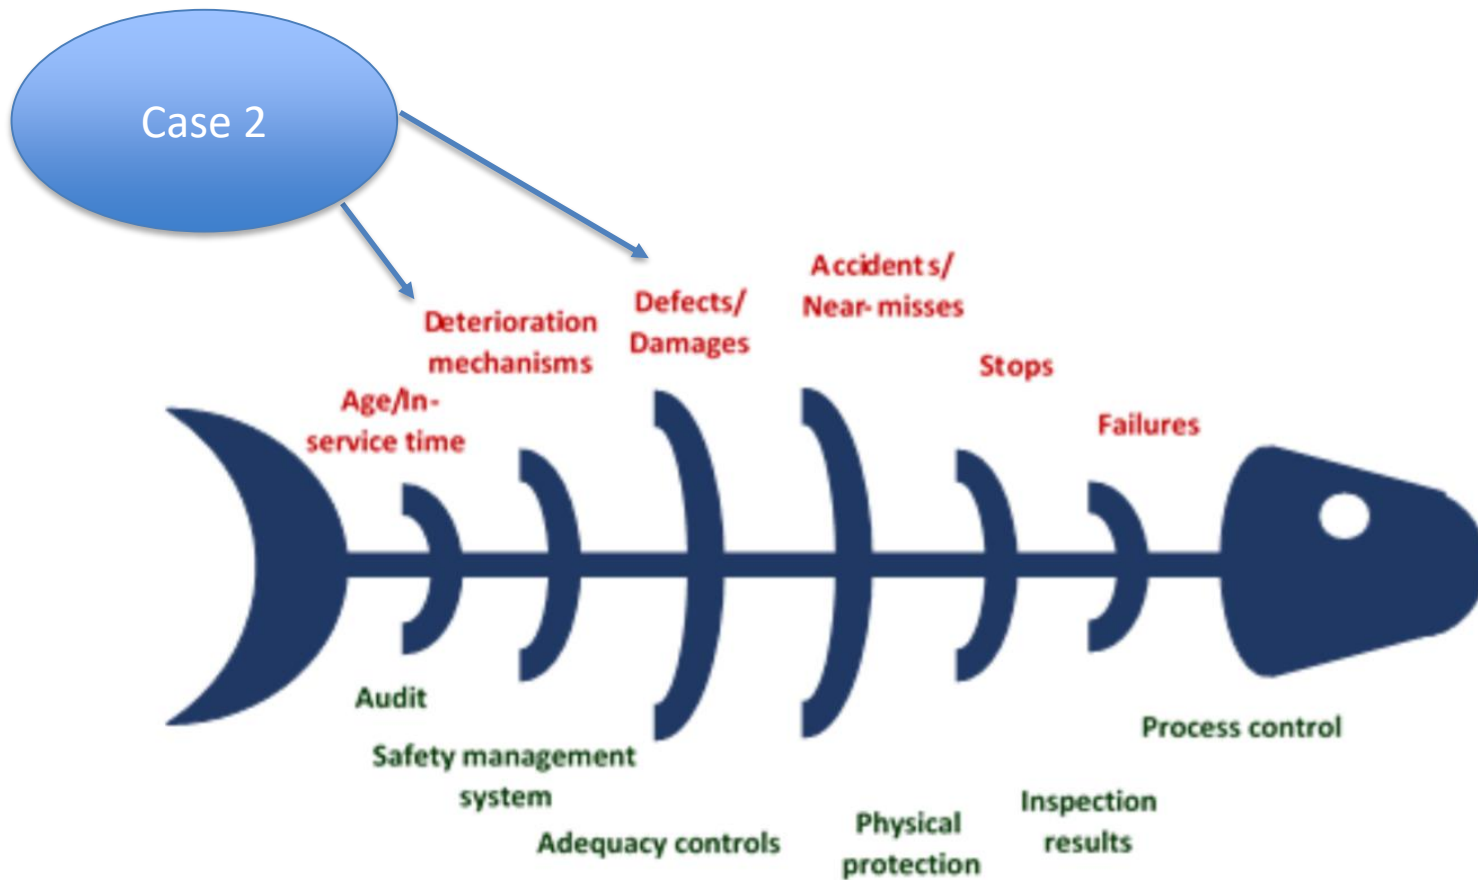
ACCELERATION FACTORS

- **Defects/damages:** mechanical failure of the bottom of compressor; rupture of the crankshaft-rod mechanism: tests and analysis of the materials of the mechanical parts broken showed defects at the origin (production defects, already present at the moment of the supply)
- **Deterioration:** overly stressful conditions of exercise for the kind of compressor; other compressor deficiencies were found: orientation, vibrations detector system, hand stop-valve in suction. A substitution of the two reciprocating compressor by a centrifugal compressor was planned and realized, together with use of interception electro commanded valves in suction lines in order to limit possible gas release

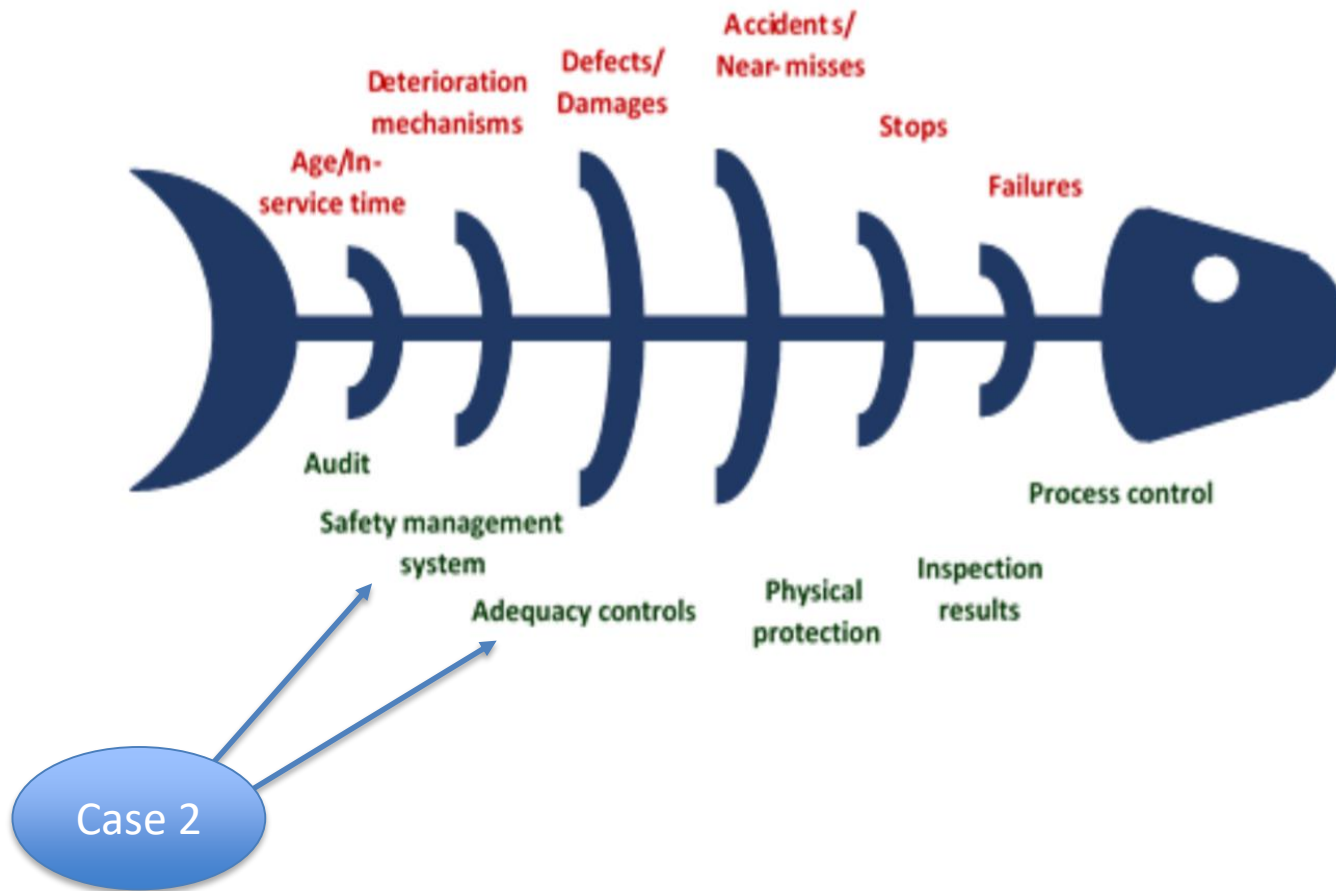
CASE 2: ACCIDENT LINKED TO THE AGING OF OIL STORAGE TANK – FAILURE RETARDING FACTORS

- **SMS – failure in selection and evaluation of suppliers:** excessive trust in the historical supplier (leader on the market) and failure to reevaluate its requirements
- **unadequacy controls:** Excessive delegation of maintenance activities to the supplier; need of a revision of the control, inspection and maintenance procedures for installation, also in consideration of their criticalities
