Loss Prevention Bulletin

Disaster Anniversaries

Issue 251, October 2016

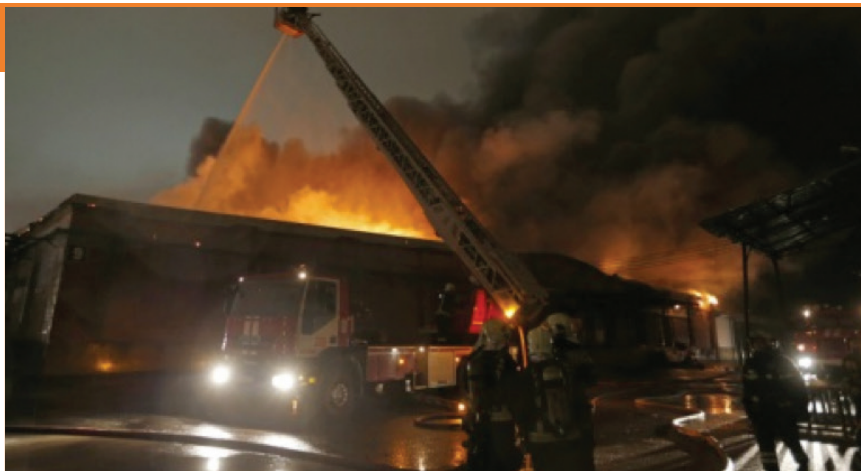
Eight firefighters killed in Moscow warehouse fire

Eight firefighters have lost their lives while extinguishing a fire at a warehouse in Moscow.

Rescuers found the bodies in the remains of a large warehouse that was engulfed by fire late on Thursday 22 September.

The fire covered an area of 4,000 square meters and caused a 1,500 square meter section of the building's roof to collapse. It is understood that the victims had been conducting a search inside the building when its roof collapsed.

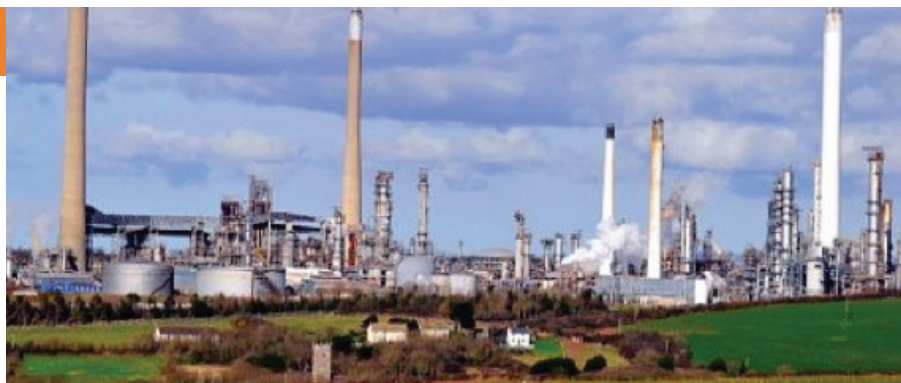
Valero Energy fined following serious accident at Pembroke Refinery

The Court heard how, on 05 March 2012, an access tower walkway that provided gangway access to a stationary tanker vessel had dropped 3.5 metres, causing the operator to be trapped by a slack wire rope. He suffered fractures and lacerations to both legs and a dislocated knee as a result.

The HSE investigation found multiple failings leading up to the incident including:

- failure to carry out a sufficient risk assessment of the use and operation of the access tower, with the result that the dangers of jamming, slack cable, and personnel accessing the walkway without engaging the scotching pin were neither identified or addressed and the hierarchy of risk control was not applied

- failure to provide adequate information, instruction and training to employees as to the safe use and operation of the access tower
- failure to carry out adequate investigations into the previous and related incidents of September 2011, February 2011 and, in particular, August 2010

- failure to review the check-list risk assessment in light of those incidents
- failure to act on the recommendations of their inspection contractor, particularly in respect of the jamming problem and the absence of any access gate interlock and ignored comments on one report that there was a "potential fatal accident waiting to happen".

- failure to install any means of detection or prevention of slack cable in the mechanism
- failure to detect that the access tower was neither CE marked, nor subject to a Declaration of Conformity, as required.

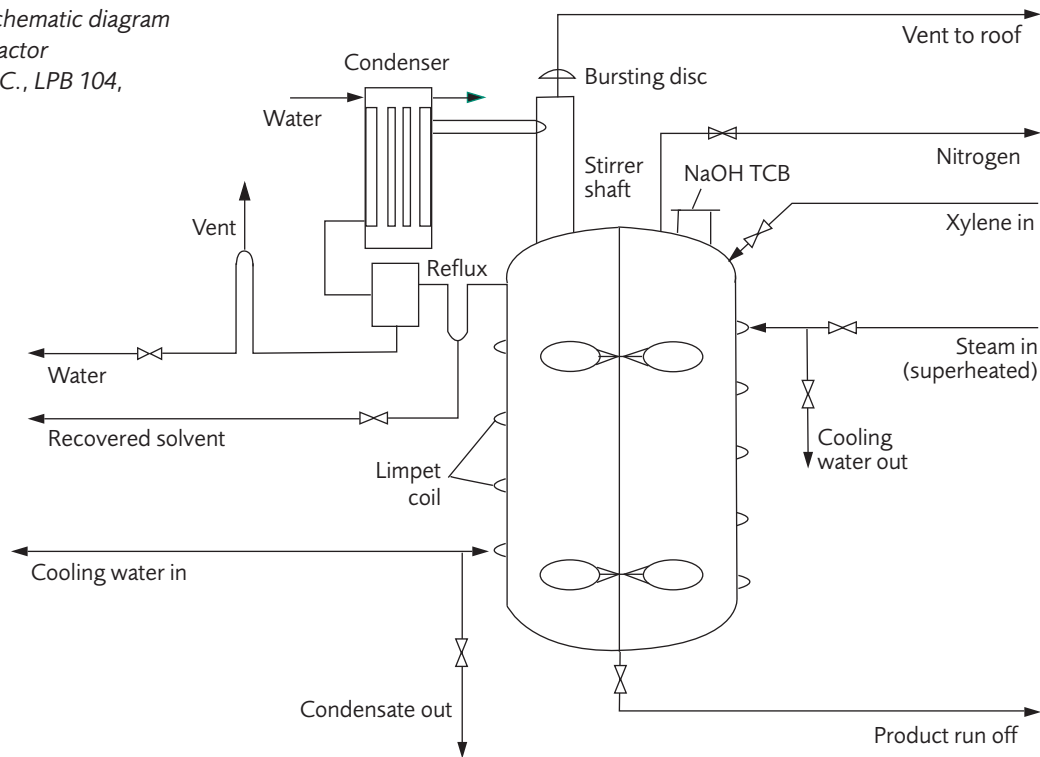
Figure 2 – Schematic diagram of Seveso reactor (Marshall, V.C., LPB 104, April 1992)

ethylene glycol the reaction was quenched by the addition of a large excess of cold water. A schematic representation is shown in Figure 2.

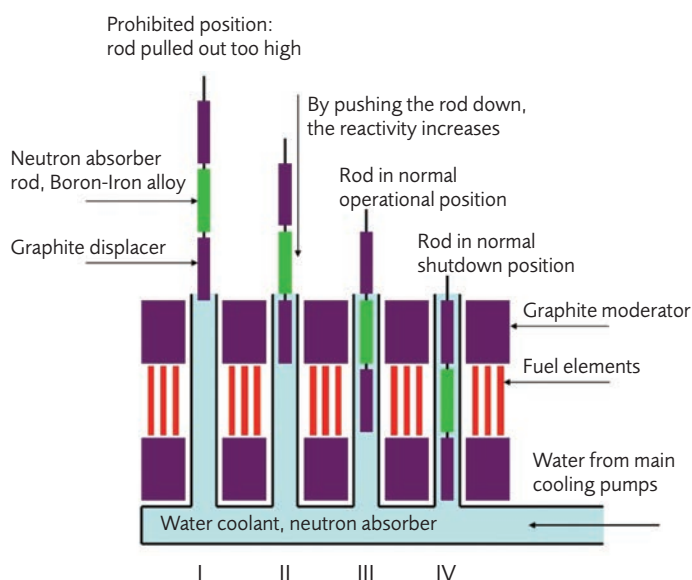
Diagram from http://consumedland.com/page_06_en.html

But there was another problem with the RBMK design that was less well known, a design flaw that was first noticed in December 1983 during the commissioning of Ignalina Unit 1 (Lithuania was then part of the USSR). As the control rods descended into the core, the operators observed a surge in the power. The tip of the control rod was made of graphite. As the control rod descended it displaced water, so instead of

reducing the power of the reactor, the power increased.
