Lessons Learned Bulletin No. 13

Learning from incidents involving liquefied natural gas (LNG) on fixed sites

Number 13 December 2018

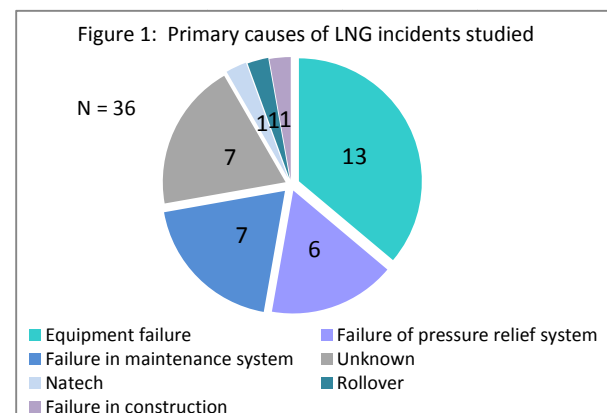
Figure 1: Primary causes of LNG incidents studied

The JRC conducted a review of existing literature on LNG accidents on land-based sites to understand how they might provide evidence for the debate surrounding LNG accident risk. The JRC found documentation of 36 incidents associated with LNG since 1944¹. Prior to 2010, the worst industrial accident recorded was a tank collapse in Cleveland, OH (USA) in 1944 that killed 128 people. The tank was constructed of inferior materials and could not withstand the extreme cryogenic conditions. It is widely believed that substantial changes in LNG equipment standards make this incident very unlikely today. Subsequent accidents are also considered less likely by many experts due to improvements in standards, such as those for secondary containment (Cleveland, OH, 1944 and Canvey Island, UK, 1965), building codes (Montreal, Quebec, Canada, 1972, and Cove Point, Maryland, USA, 1979), and to some extent, LNG rollover (La Spezia, Italy, 1971). Although poor maintenance was probably a significant factor in the 2003 catastrophe at an older facility in Skikda, Algeria, that killed 27 people and injured 74, not enough information is available to conclude that later generation sites could avoid this incident.

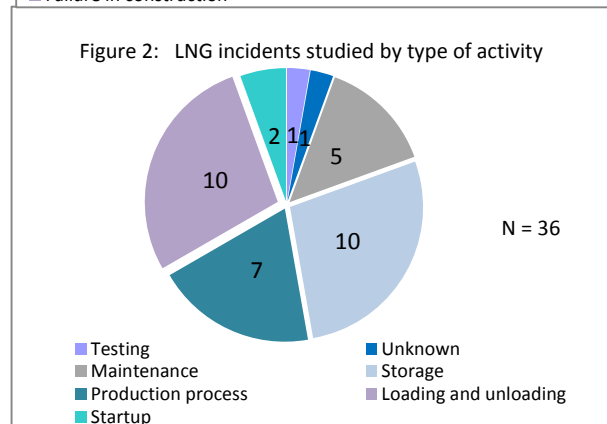
Figure 2: LNG incidents studied by type of activity

Despite advances in safety knowledge, LNG remains a high hazard substance and adequate control is only partially achieved through improvements in technology and standards. A large portion of control measures are dependent on the proper design and execution of safety procedures, a well-functioning safety management system, and a risk assessment that incorporates a full understanding of scenarios and their potential impacts. The JRC study of past incidents identified a number of causal factors as shown in Figure 1. No particular type of process activity seems more prone than others to be the source of an incident (see Figure 2). A cross-comparison of activities and types of incidents highlights the importance of the issues detailed below.

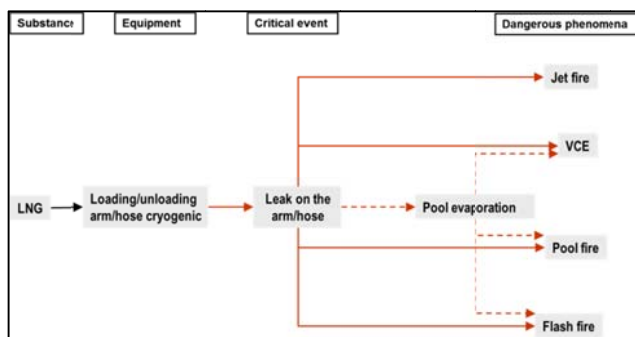
Figure 3: Scenarios for a leak from an LNG loading and unloading associated with the arm or hose (JRC Handbook of Scenarios for Assessing Major Accident Risks, 2017. <https://minerva.jrc.ec.europa.eu>)

In a refueling station liquefied natural gas fuel (Liquid to Compressed Natural Gas refueling or LCNG), a leak is triggered at the start of the piston pump to supply the compressed natural gas (CNG) circuit. This automatic start occurs when the level of gas stored in the CNG cylinders reaches a trigger point after refueling several vehicles in the evening. The leak is detected by a sensor that prevents escalation by triggering the shutdown of the pump. Once the gas pocket was evaporated, the sensor stopped detecting gas and allowed the pump to resume operation. Gas escaped again. In the meantime, an employee from a nearby company heard the noise from the fitting that dropped and saw a cloud forming (due to the condensation of humidity in the air when the gas was released). This person alerted the fire department and on-call staff at the station. Upon arrival, firefighters set up an exclusion zone with a security perimeter and blocked access to the site. Together the station manager and the fire brigade verified that the station was safe and secure, closing all the automatic valves. Half an hour later, maintenance personnel implemented a second layer of security by closing the manually operated valves.
