Chemical explosion in Tarragona, Spain 2020 - key aspects of the DNV investigation

DSB – Norwegian Seveso Conference 2021

21 September 2021

The IQOXE plant in Tarragona, suffered a large explosion on 14th of January 2020 causing multiple fatalities, injuries and major damage:

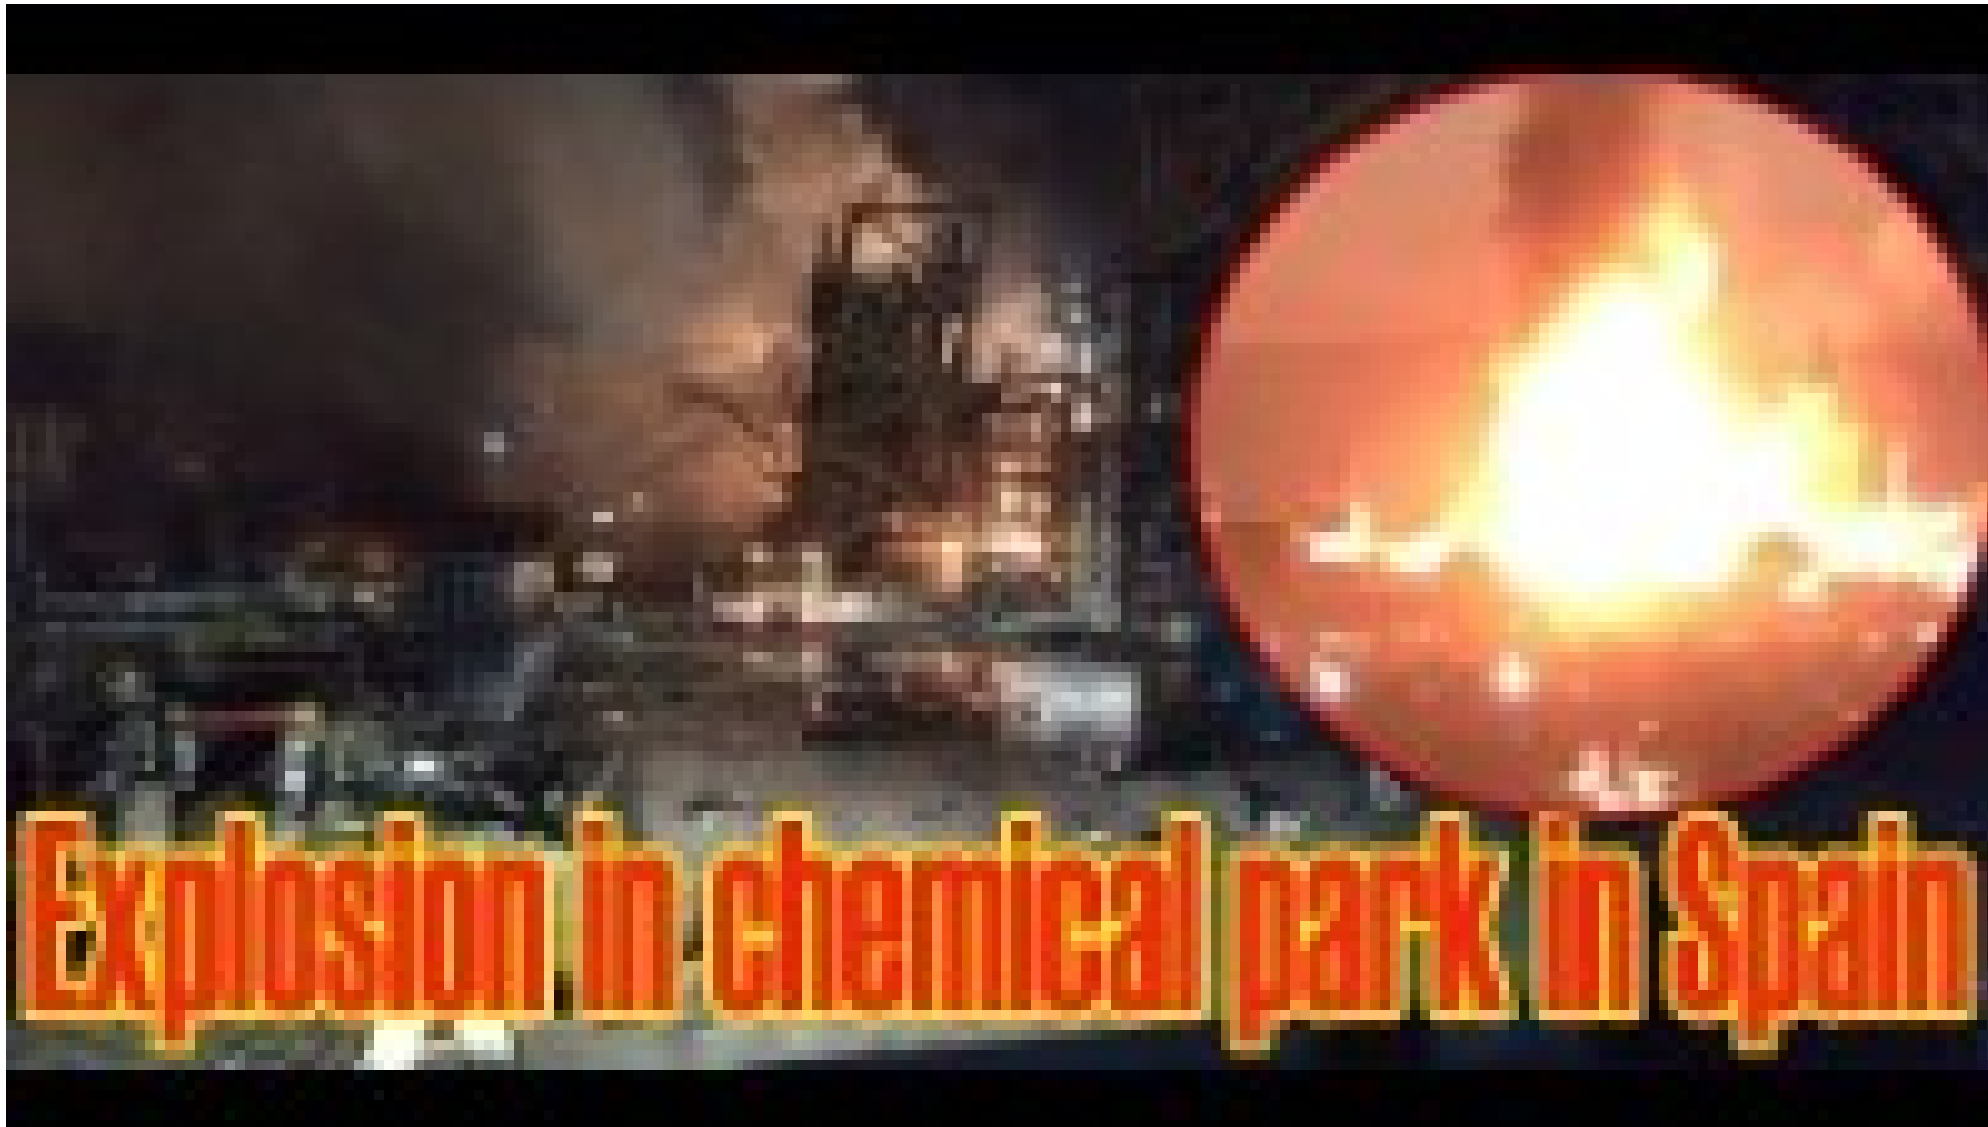
The incident – as in the local media the day after

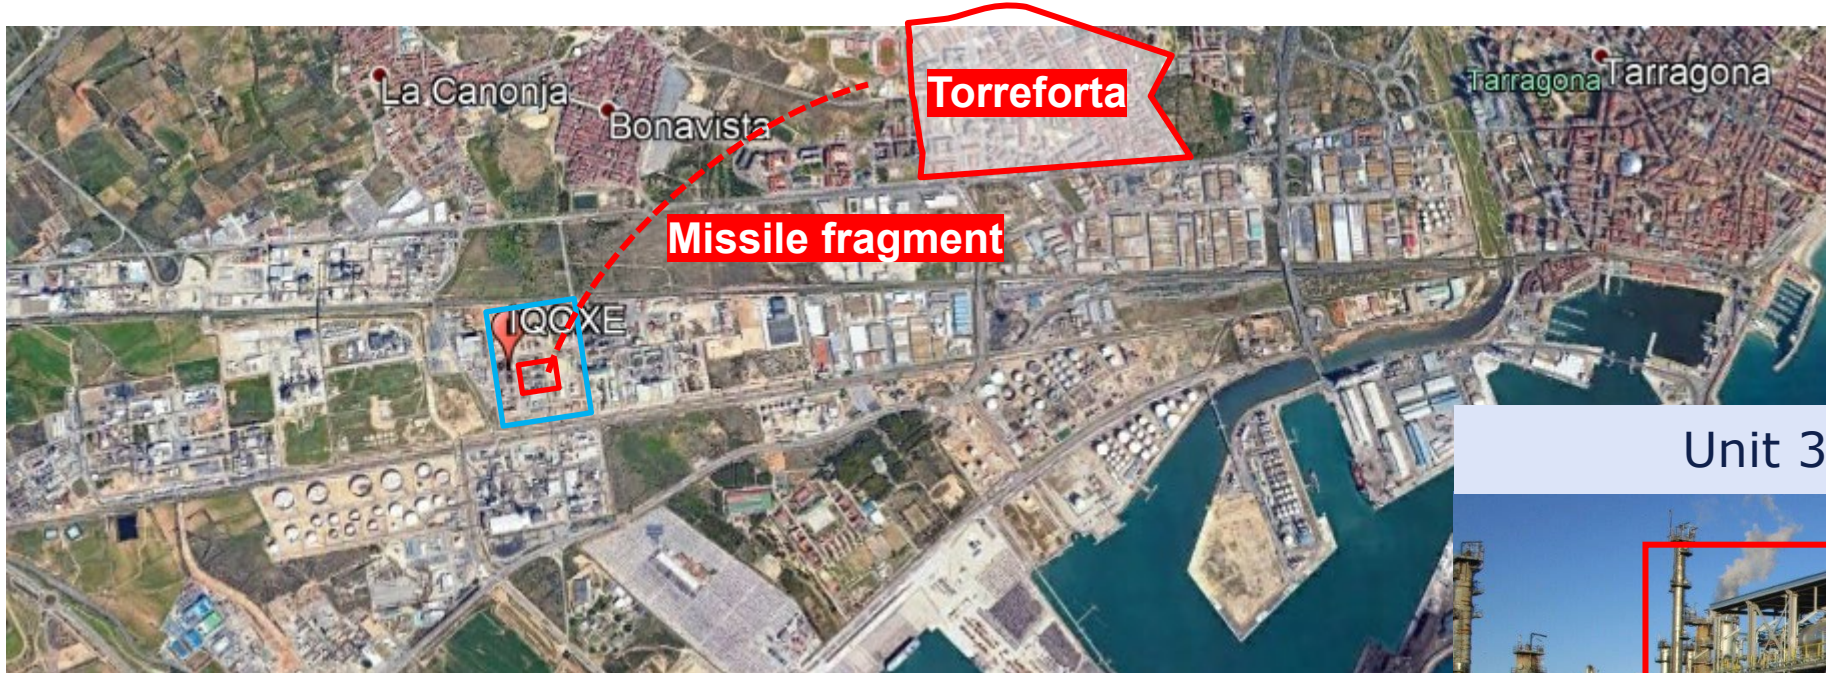
Tarragona area with IQOXE plant location (blue frame) and U3100 (red frame)

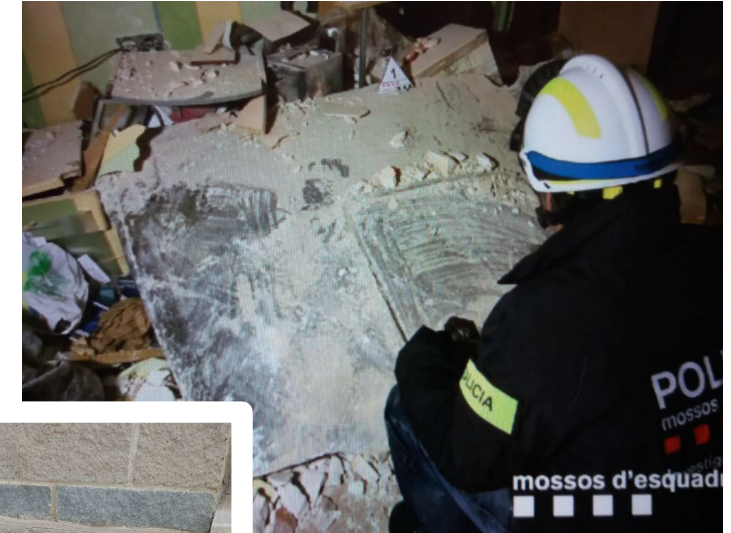
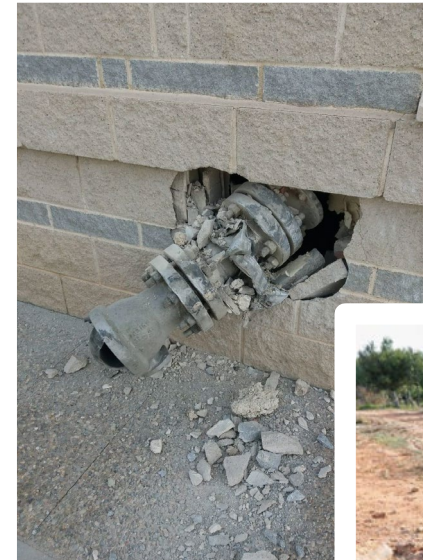
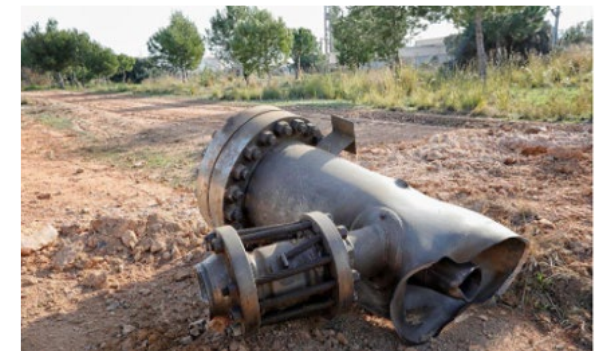
- Observed damage to structures and fragments found were crucial to quantify likely overpressures and energy available in the event.
- In turn, knowing the likely overpressure and energy can help determine the most likely cause of the explosion.
- Research experience has shown the consequences of different levels of overpressure in structures

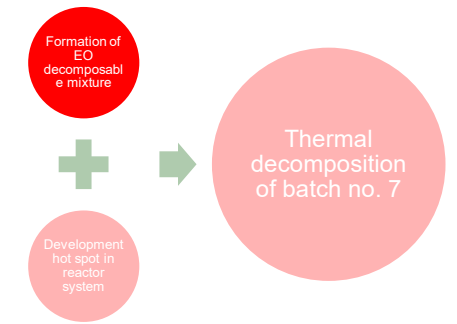
Potential causes for thermal decomposition

Potential cause	Evaluation
A fault in the nitrogen pressure control	High likelihood
An external leak would release a mixture of nitrogen and EO but be replaced by pure EO if addition continued	High likelihood
EO accumulation in the reused nitrogen between batches	High likelihood
Opening, or passing, of the reactor vent valve (31XV332) to the vent header	Medium likelihood
Venting through the pressure relief system would release a mixture of nitrogen and EO but be replaced by pure EO if the feed were continued	Low likelihood
Presence of liquid EO in the reactor	Low likelihood

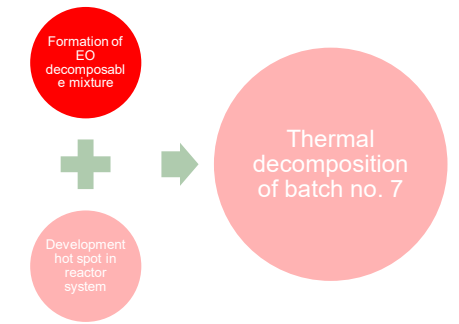
Possible initiation causes of thermal decomposition

Potential cause	Evaluation
A fire impinging on part of the attached process	High likelihood
Runaway reaction reaching the decomposition temperature	Medium likelihood
A fire impinging on the vent system connected to the reactor	Medium likelihood
Heat from unintended reaction catalyzed by contaminant	Medium likelihood
A fire impinging on the reactor vessel	Low likelihood
A mechanical fault in a pump connected to the reactor	Low likelihood
Maloperation of a pump connected to the reactor	Low likelihood
A fault in the electric heat tracing positioned adjacent to some of the pipework connected to the reactor	Low likelihood
Hot work such as welding or cutting on a connected system	Low likelihood

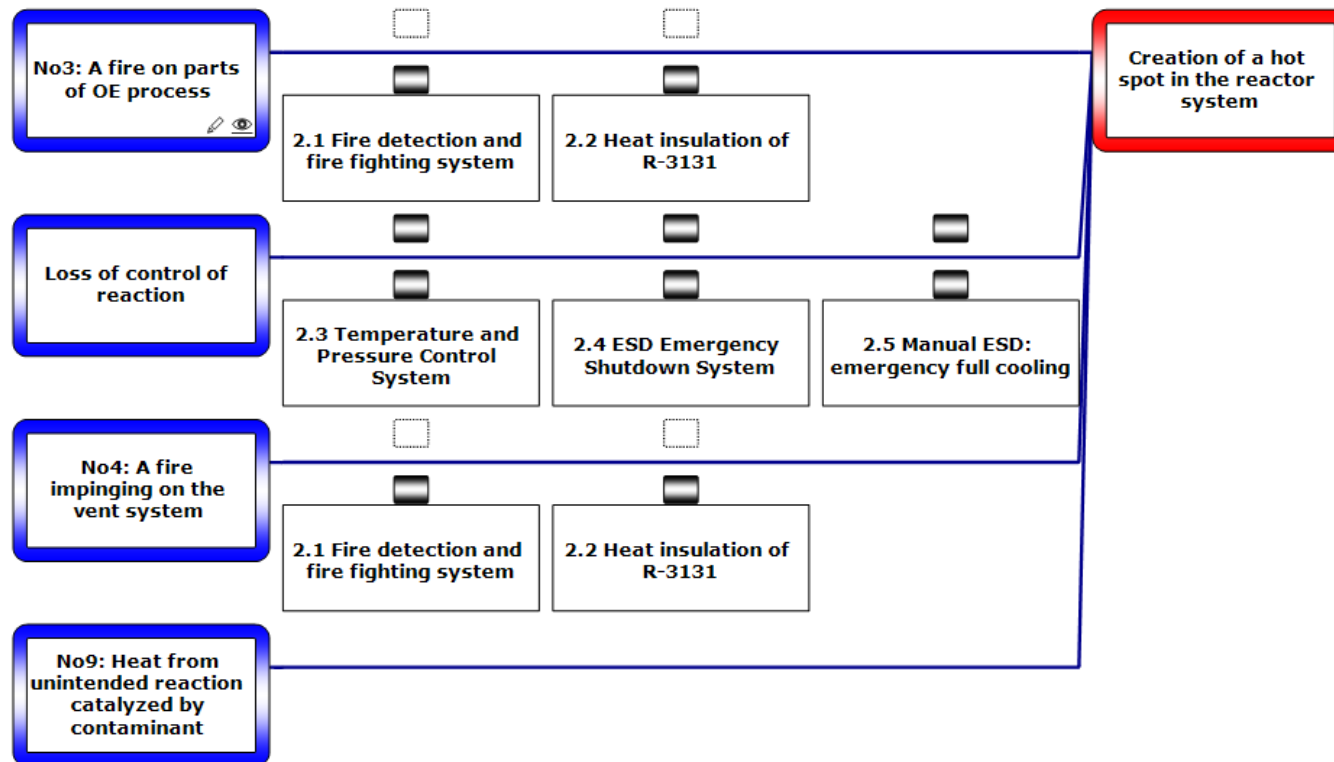
Barrier diagram for 'creation of a hot spot in the reactor system'

Direct cause(s)	<ul style="list-style-type: none">• Insufficient fire detection system• Inadequate firefighting systems
Basic cause(s)	<ul style="list-style-type: none">• The installed sprinkler system only protected the reactor vessel, but not the entire EO connected system in U3100• No evidence was seen of safety studies to identify possible fire sources in U3100, that might affect the EO-connected system, nor was evidence seen of identification of required active or passive fire protection other than a design document based on industrial building regulatory requirements• The EO User Guide suggests applying NFPA 58 and API 2510 and 2510A to the design of fire protection systems for EO storage and processing areas. Moreover, it suggests using process hazards analysis methods that examine the severity of the consequences of a fire scenario for identification areas appropriate for deluge protection• Furthermore, the basic design documents specify that gas and fire detection in the neighbourhood of sources of possible leakage shall be installed. Dilution of leakage and control of fire will result if automatic operation of a water spray system

Improvement area in management system	Determination of risks and needs and location for fire detection and types of firefighting systems

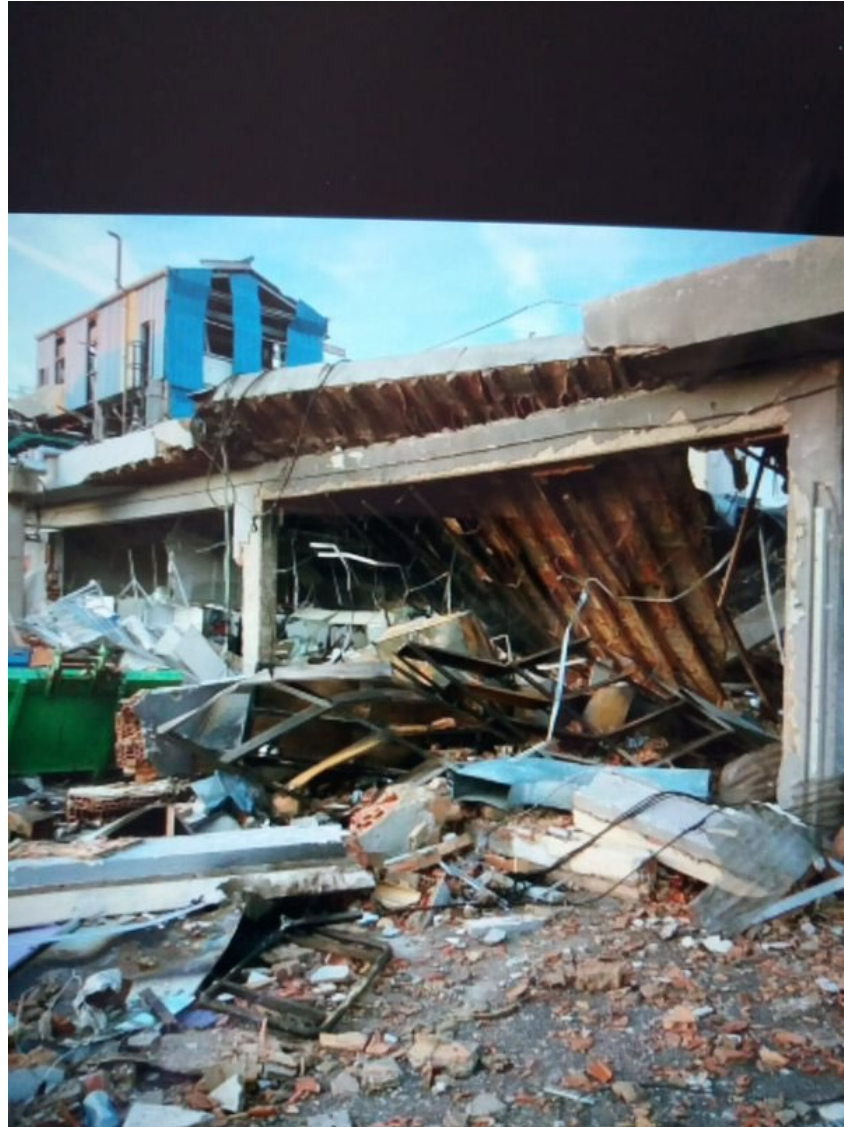
3. Ensure safe control room or occupied buildings

- Predicted over pressure,
- Likelihood,
- How many people?
- Distance,
- Reinforcement

Recommendation details:
Existing and new control rooms and occupied buildings should be assessed to ensure safety of people within them

Assessment should include consideration of building survivability, control systems, safety shutdown systems or use of the control system for managing emergency
