Accident initiated by Power Failure

TWG 2- meeting 2018
The Hague

Yara Porsgrunn

Ammonia Factory Layout

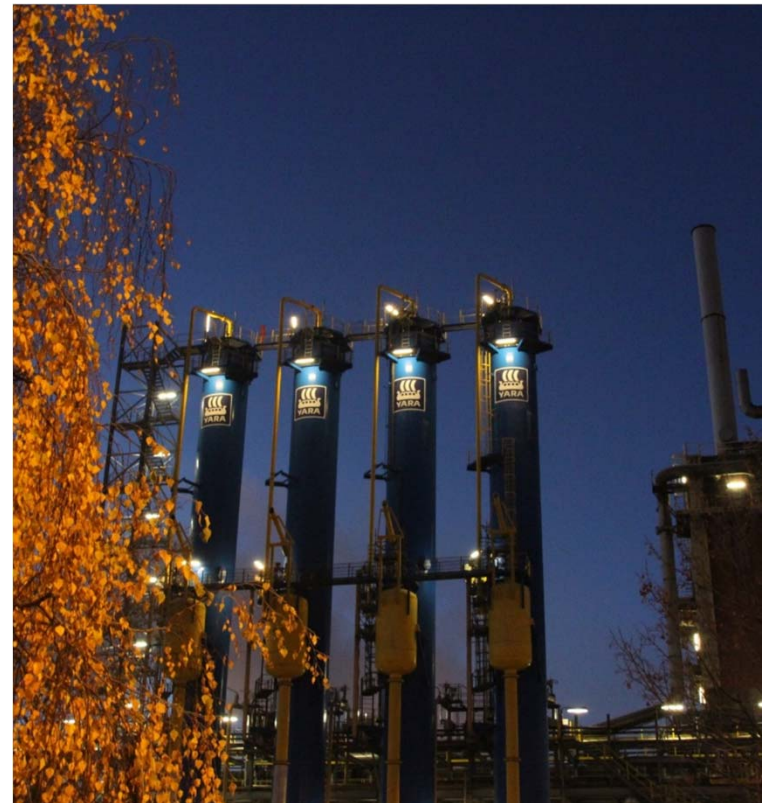
Restart followed by explosion and fire

- Preparations are made for restart of the factory
- Operators follow restart procedures, all seems to be normal
- 03:15 an explosion occurs, followed by an intense oil fire in the compressor hall.
- Two operators that are present, evacuate without physical injuries
- Internal and external fireservices are on site shortly after, and 45 minutes later the fire is extinguished.
- Soon after they can see that the main syngas oiltank (lubricant oil) has «torn» and the fire is localized to this tank.

- The initial power fluctuation did not cause the accident, but initiated the shut down.
- The direct cause is the generation of an explosive and highly sensitive atmosphere in the vapour phase of the oil tank.
- Oxygen enriched air came into the nitrogen purging system from the Air Separation Unit.
