Lessons learned from LPG/LNG Accidents

Maureen Heraty Wood
Major Accident Hazards Bureau

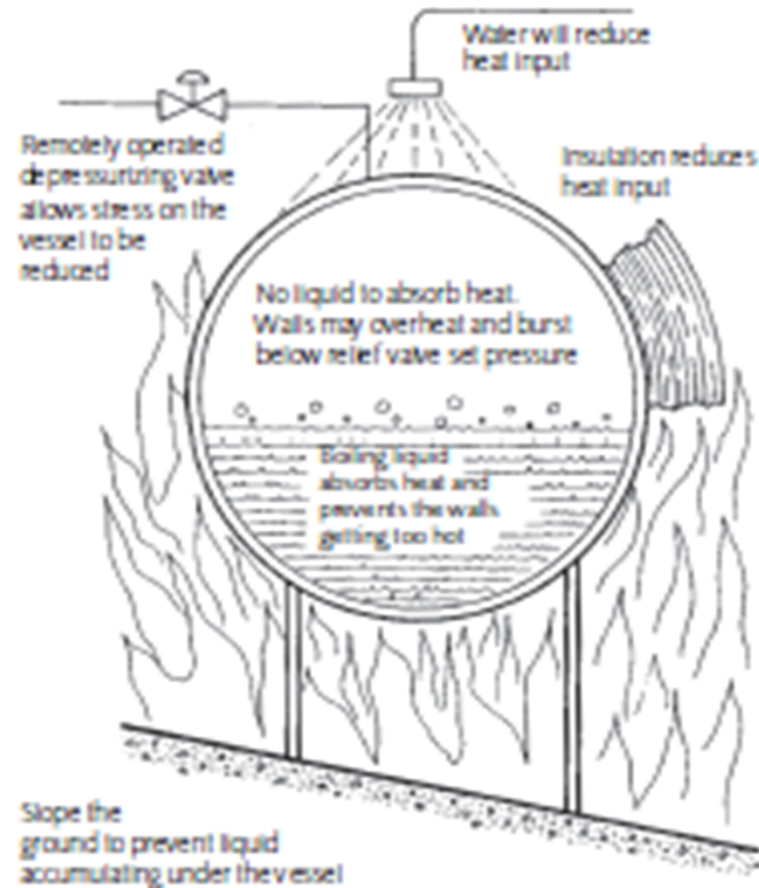
Figure 1.7: Preventing BLEVES in LPG vessels

If it is not practicable to install a closed draining system then consider the use of a dewatering pot isolated from the main vessel during the draining operation.

This should minimise the quantity of LPG accidentally released.

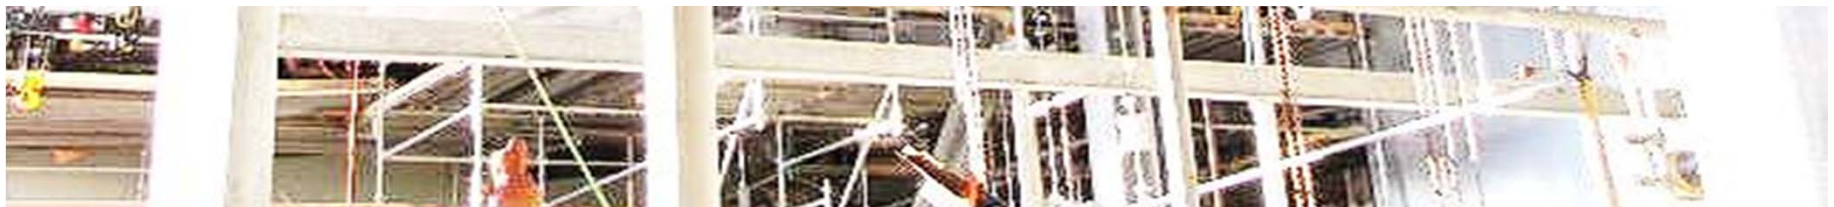
Photo from CSB report - <http://76.227.217.14/UserFiles/file/FINAL%20Urgent%20Recommendation.pdf>

The U.S. Chemical Safety Board (CSB) cites a number of explosions dating back to 1997 caused by improper purging - practices that were in most cases allowable under prevailing regulations

Make sure that gas supply lines contain nothing but gas before the equipment they feed is started

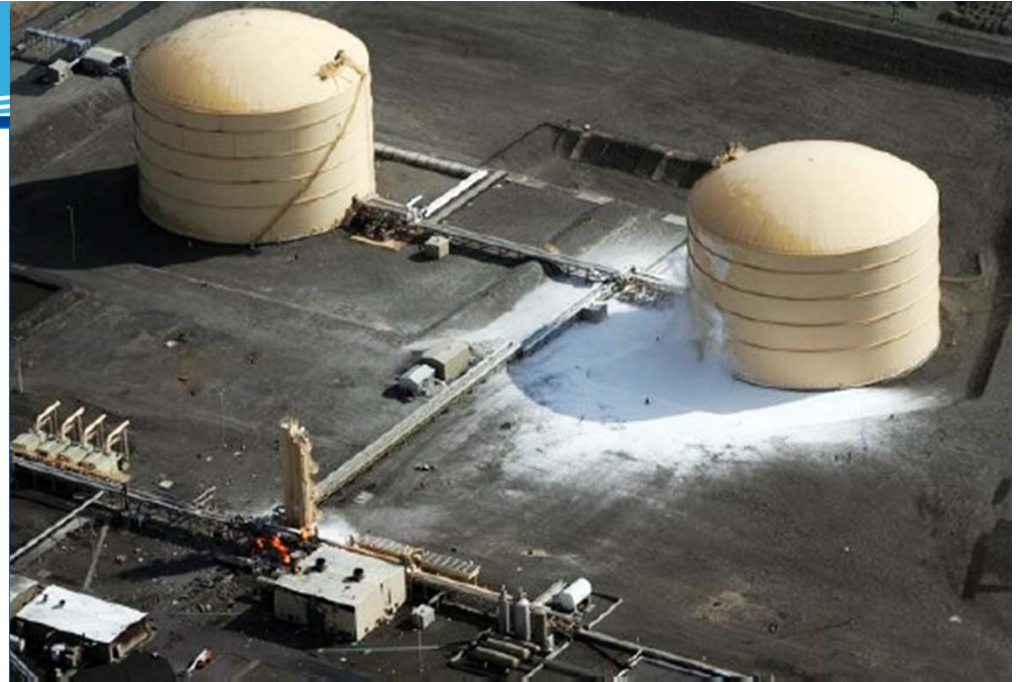
An **emergency shutdown** was activated and plant personnel were evacuated.

The **nearby town was evacuated** due to concerns that the outer tank shell was penetrated from flying debris
