Evaluation of the ESReDA Cube Method for the Aviation Sector

First analysis of the method's applicability by applying it on 3 aviation cases

Delft University of Technology

Master of Science
in Aerospace Engineering

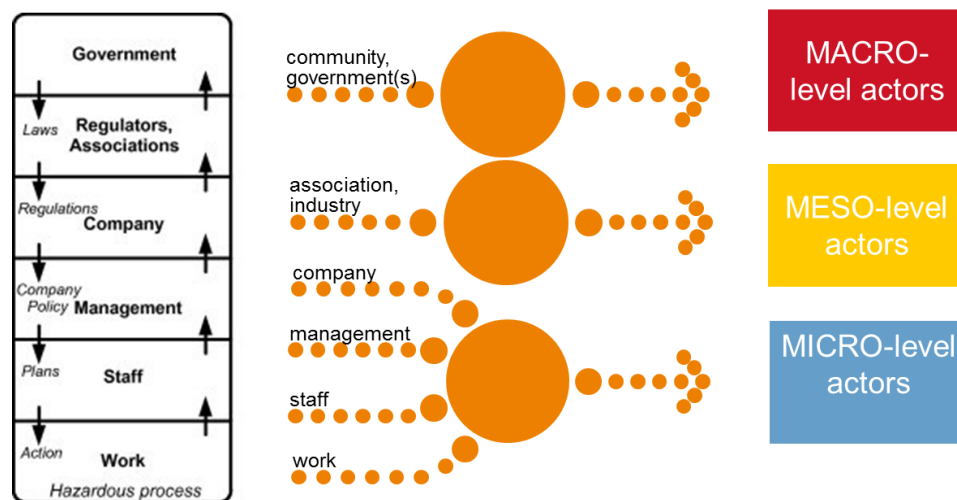
The second question and dimension focus on the stakeholders affected by the lessons learned. The stakeholders can be divided in three groups: the macro level (the highest level which contains society and the European Union), the meso level (the holding branch of the industry and the safety authorities) and the micro level (the lowest level, this can be an individual or the entire company or organization) (see figure 2-1). Every recommendation/action can be addressed to one of these three stakeholders. This dimension represents the system level in the ESReDA Cube.

Figure 2-1: Stakeholders of a process

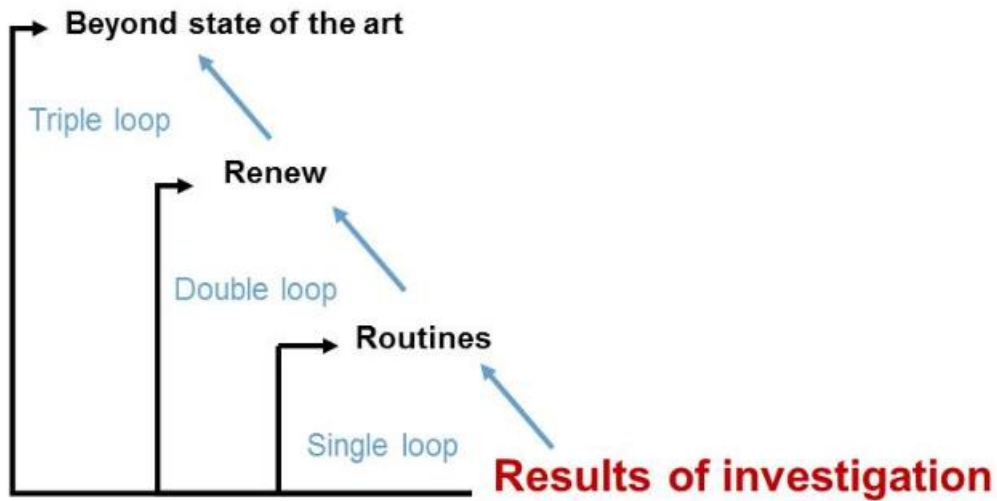
The last question and third dimension focus on the degree of renewal caused by the lessons learned. Lessons can be learned in one of the three levels of the learning process. These levels are the triple, double or single loop. The depth of learning or degree of renewal depends on the level of the learning process where lessons are learned. When learning happens in the triple loop the principle is changed which means the whole concept

of operations is innovated beyond the state of the art. When the lesson is learned in the second loop the insights are changed/renewed which causes an adaptation of the existing operations. At last, when the single loop is touched it means the rules/routines are changed/improved to optimize the operations. This can all be seen in figure 2-2 and 2-3.

Figure 2-2: Levels of the learning process

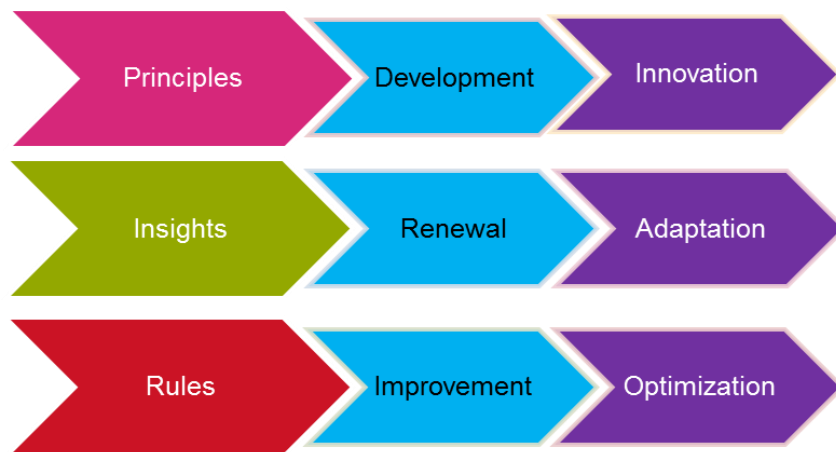
Figure 2-3: Depth of learning

Every recommendation/action can be addressed to one of the three aspects: optimization, adaptation or innovation. This dimension represents the depth of learning level in the ESReDA Cube.

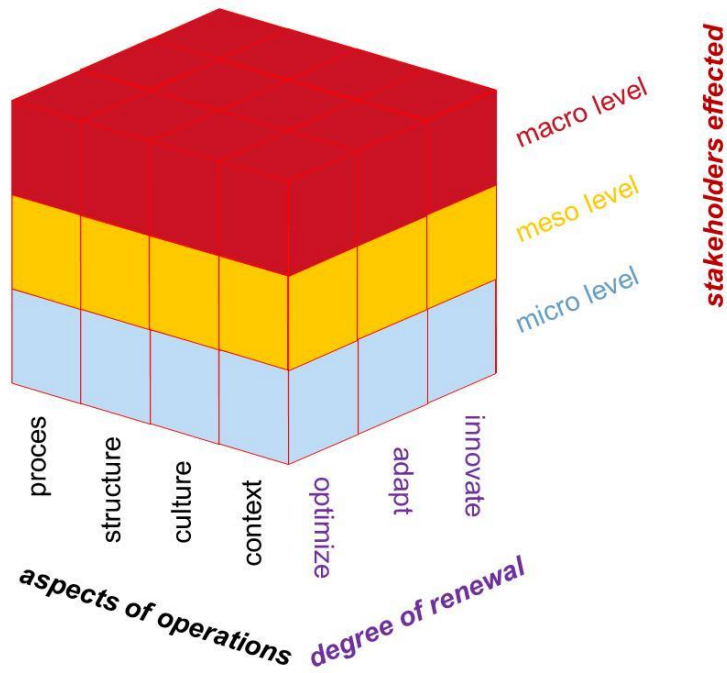
As mentioned, these three questions represent the three dimensions which form the ESReDA Cube (see figure 2-4). This cube is a Cartesian coordinate system. On the X axis of this system “aspects of operations” (operation level) can be found, on the Y axis “stakeholders effected” (system level) and on the Z axis “degree of renewal” (depth of learning level).

Figure 2-4: Visual display of the ESReDA Cube

With this new lay-out the operation level will exist out of three aspects and not four, as in the past. As seen in figure 2-4, the cube exists out of small cubes. Every small cube is a location where a recommendation/action can be categorized. With the new lay-out, every level's axis will exist out of three small cubes. This means that the ESReDA Cube will become a regular cube. Since there is one row deleted, the total number of locations where a recommendation or action can be categorized in the cube is reduced from 36 to 27. This means if a location is empty, it has a much bigger impact then in the previous lay-out of the cube because of the reduced total number. One empty location in the old lay-out meant one cube on 36 is empty. Now it means one on 27 is empty. In this way conclusions and new learning suggestions made concerning one empty location become more strong. For the cases analysed here the ratio does not change. The whole aspect of innovation is empty for the analysed cases, meaning 12 out of 36 locations are empty. In the new lay-out this is 9 out of 27, so also one third.

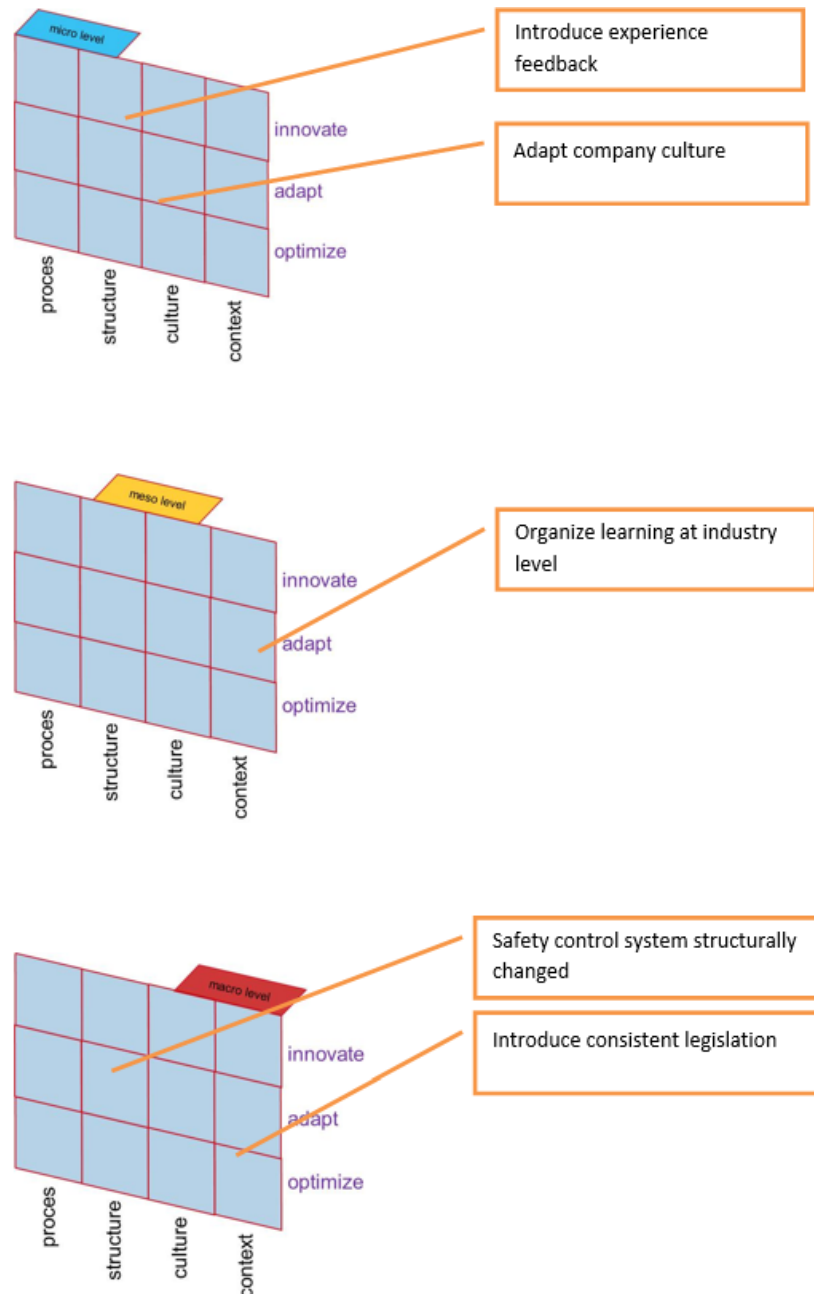
With these coordinates all items from the template can be plotted in the ESReDA Cube. In this way it can be clearly checked how, what and where lessons are learned (see figure 2-5).

Figure 2-5: Example of recommendations/actions plotted in the cube

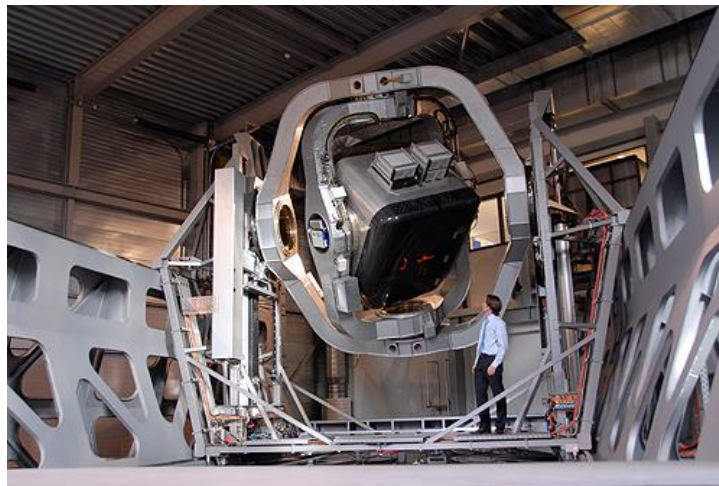
The Desdemona (DESorientatie DEMONstrator Amst) simulator (see figure 5-1) is part of a European project called SUPRA (Simulation UPset Recovery in Aviation). During flight it is possible that a loss of control situation happens due to which an aircraft can get into an upset situation like stall. An adequate and quick reaction of the pilots is very important in such situation to ensure recovery and flight's safety. For this it is important that pilots are able to train on upset situations and on handling corresponding G-forces. One of the project's purposes is to develop new simulator concepts to prepare pilots better for these kind of situations. Current simulators have a limited motion envelope because they make use of a hexapod (six legs) platform. These platforms suffice for most aircraft maneuvers which have to be performed by commercial aircraft but not for upset situations and the corresponding G-forces. That is why the Desdemona simulator is developed. The Desdemona simulator combines the possibilities of a hexapod platform with a centrifuge. In this way complex situations which can happen during flight can be simulated, including their G-forces. The cabin of the Desdemona simulator can rotate around any conceivable axis and can generate up to 3G. With this simulator pilots can be better prepared for upset situations.

Figure 5-1: Desdemona simulator^[108]

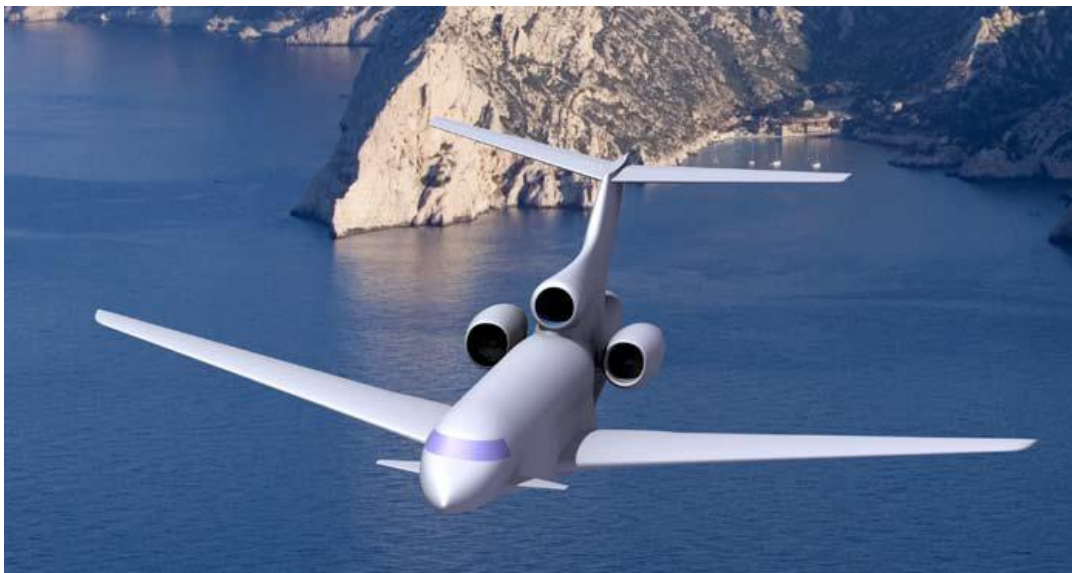
Stall shield devices (see figure 5-2) are a new innovative concept to prevent stall accidents in the future. It can be used in both general and commercial aviation to prevent an aircraft from stalling or if necessary, to improve its recovery. It is still being researched for the moment. It was suggested in a paper written by J.A. Stoop and J.L. de Kroes.

The stall shield device consists of several adjustable control surfaces which are mounted on the aircraft's fuselage at the nose and tail section. Because they are positioned near the nose and tail the moment arm is quite long which makes it possible to minimize the size of these surfaces. These surfaces have two positions. The neutral one where they are incorporated in the fuselage structure and the operating position where they are deployed into the fuselage's free air flow. They are deployed in case of a (near) stall situation and during a 1G unstable flight. The size and angle of attack of these surfaces is adjustable. It can be adjusted automatically or manually to meet the required aerodynamic forces necessary to control the dynamic behavior of the aircraft during (near) stall. Several working modes for these shields are available: nose and tail separately or combined. The mode depends on the flight phase, the stall situation, the operating conditions and the aircraft configuration. The control system of the stall shield device is integrated in the flight management system. The control system should also make use of GPS data like speed, positioning and altitude. In this way redundant data (next to the pitot static data) is available. Also a direct angle of attack indicator will be used.

Figure 5-2: Nose stall shield devices deployed^[54]

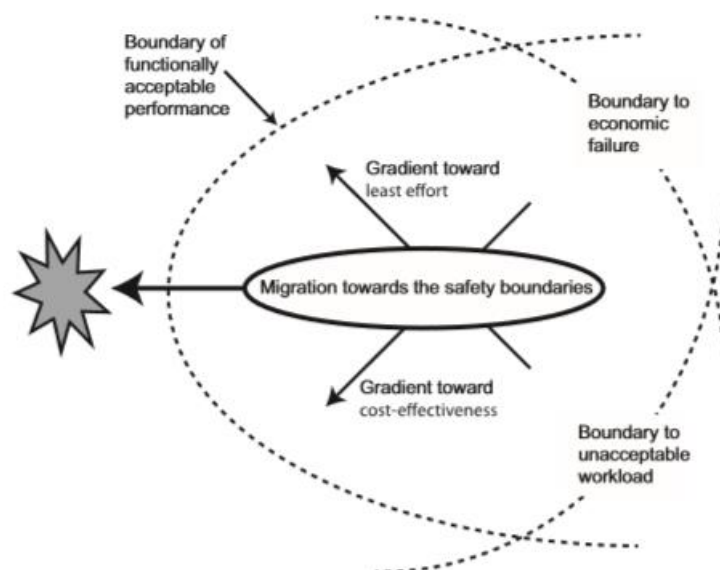
In this ACCIMAP model accidents happen because a lot of these hazardous processes can be found in really competitive environments. In such environments there is a lot of pressure to work as cost-effective as possible. Due to this cost effective way of working or cost-gradient, the hazardous process moves from the boundary of economic failure to the side of more efficiency. The workload or effort gradient also moves from unacceptable to more easy with less effort. The process balances itself between economic failure/unacceptable workload and the boundary of functionally acceptable performance. When the boundary of functionally acceptable performance is crossed an accident is possible (see figure A-1).

Figure A-1: Migration towards safety boundaries

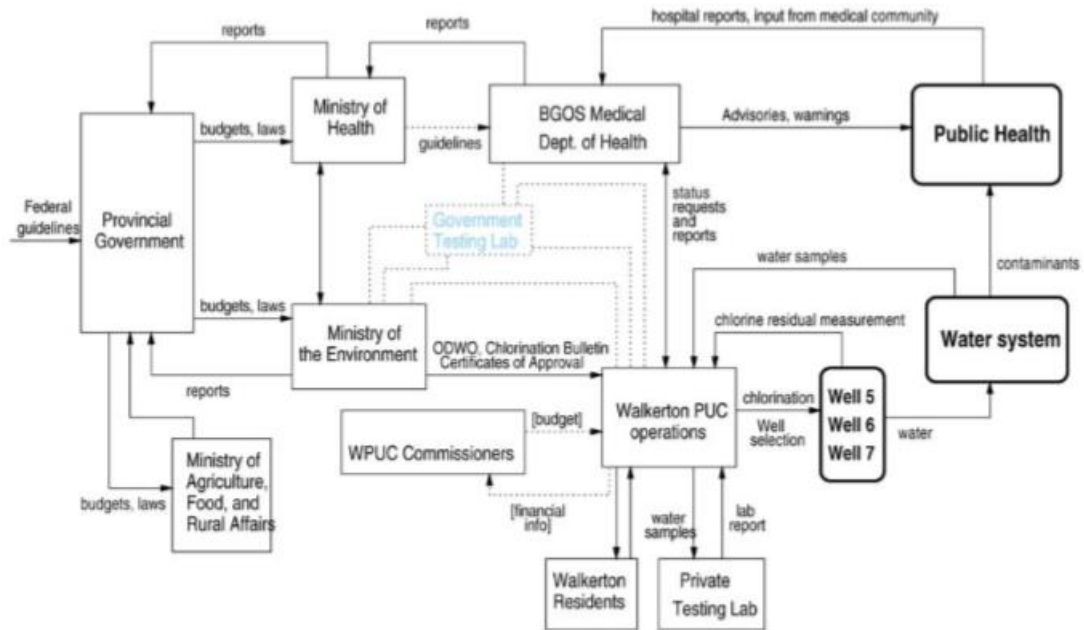
The second model shows (figure B-3) the system at the time of the accident. With these snapshots and its text, the changes in safety of the hierarchical structure can be found. In figure B-3 the lines have the same meaning as in figure B-2, although the dotted lines are new. They represent feedback, communication or control lines which have become inoperative or ineffective.

Figure B-3: Safety control structure at the time of the accident

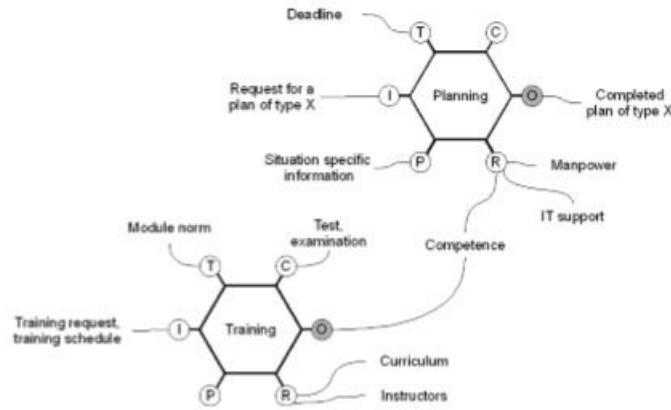
Next, the couplings between the several functions are checked. These couplings are shown graphically and are based on the description of the functions in the tables. In this representation only the couplings between the functions are shown. The position of the hexagons is unimportant, no cause-effect relation or any causal flow is shown by this. In figure C-2 a small example is presented, the two functions are training and planning.

Figure C-2: Example of small system
