MINISTÈRE DE LA TRANSITION ÉCOLOGIQUE

Ageing and maintenance of industrial equipment

Feedback from France

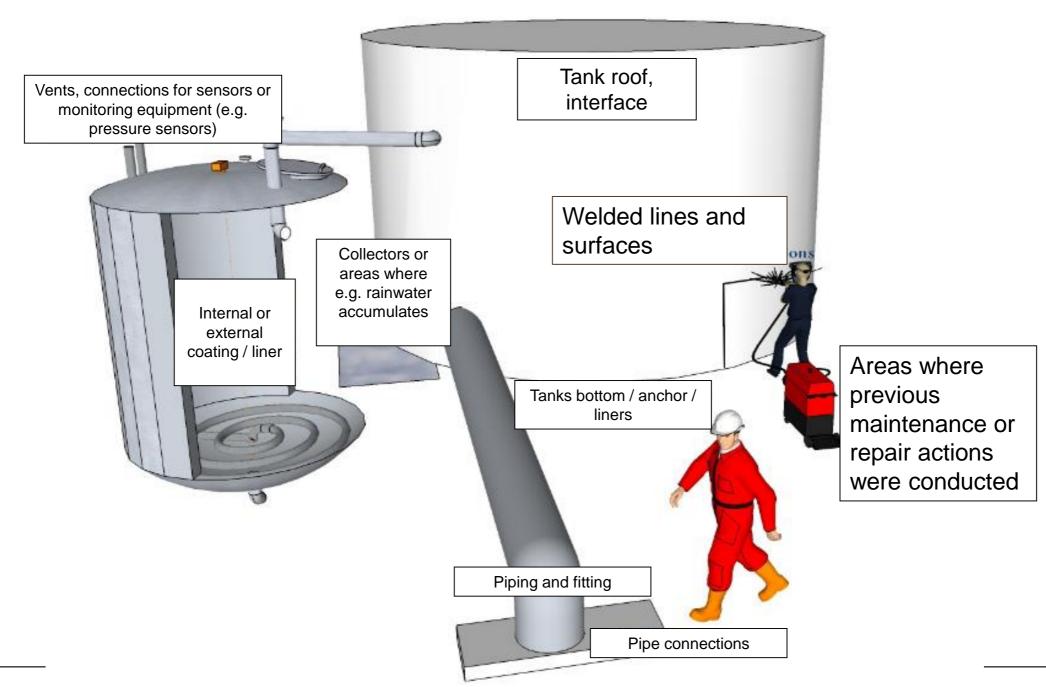
Example for storage tanks

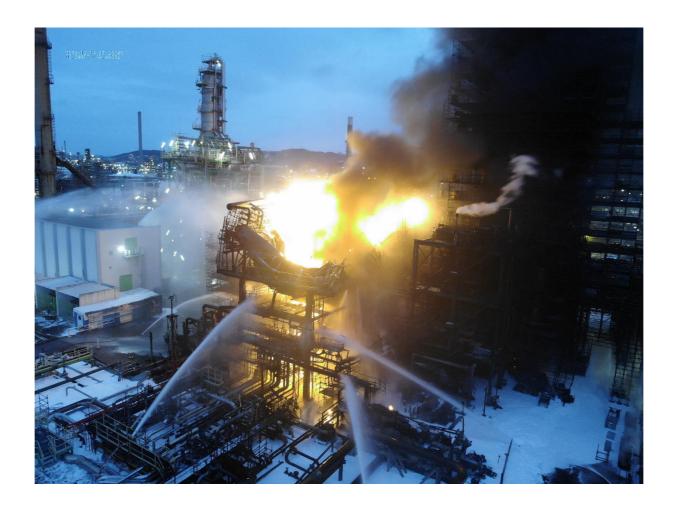
Fire in the distilling unit of a refinery ARIA 54828 (in 2019)

despite the French regulation « modernisation plan for industrial facilities »

Gasoline leak and fire in the distillation unit at around 4 am on Saturday

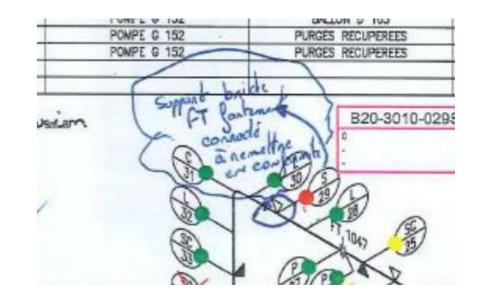
Corrosion of a pipe at a support

Support found to be visually **corroded but no inspection** of the pipe at the support due to:

- Incorrect identification of the type of support in the document base and on the isometric, leading to an inappropriate thickness measurement
- The various people working in the field do not realise that the measurement carried out (by ultrasound) is not the one that should have been carried out according to the procedure in force (gammagraphy)
- Failure to replace the corroded support
- Confusion between two substrates in the definition of the work required of the intervening company: the work is carried out on the wrong substrate
- No formal validation stage for the preparation of the work
- Acceptance of the work does not allow these errors to be corrected

- Survey of pipe supports in unit D11 and update of isometrics
- 61 493 items inspected
- 506 pipe supports identified in the unit
 (3 supports were not identified, 6 were incorrectly identified)
- Checking and quantifying the damage to the piping at the identified supports
 - 1 pipe shows a significant loss of thickness
 - 38 others show losses in thickness that need to be analysed
 - Replacement of pipes and supports
 - Modification of the work management and acceptance tool

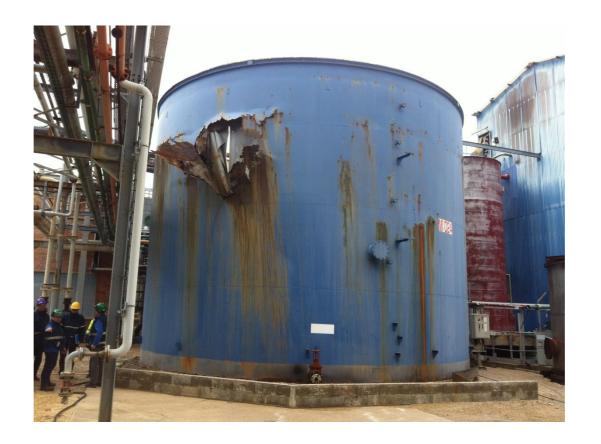
Mercury rainwater tank rupture at a chemical plant ARIA 51102 (in 2018)

NO subject to the French regulation « modernisation plan for industrial facilities »

- Tank used for the recovery of mercury-contaminated rainwater (628 m³ capacity, steel, lined)
- Stoppage of mercury water treatment due to a reagent delivery failure
- AND heavy rainfall
- Use of a tank known degraded (since a precedent inspection)
- Internal instruction limits the filling to 60 % of its capacity
- Use of the tank to store beyond the maximum filling instruction

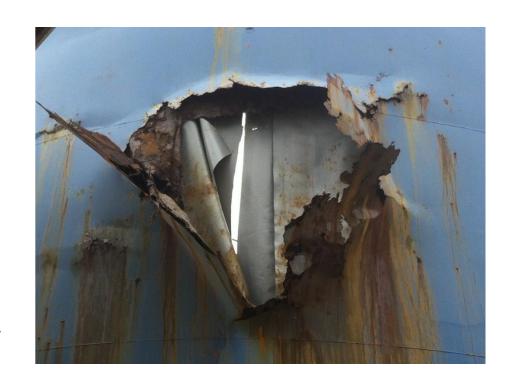
Lack of anticipation of degraded situations, resulting in an inappropriate overfilling decision.

134 m³ flowed into the River (a flow of 65 g with a concentration of 0.49 mg/l of mercury).
