Incident

Risk and safety management of ammonium nitrate fertilizers: keeping the memory of disasters alive

Dr. Zsuzsanna Gyenes, EC Joint Research Centre, Italy;
Nicolas Dechy, CHAOS association, France

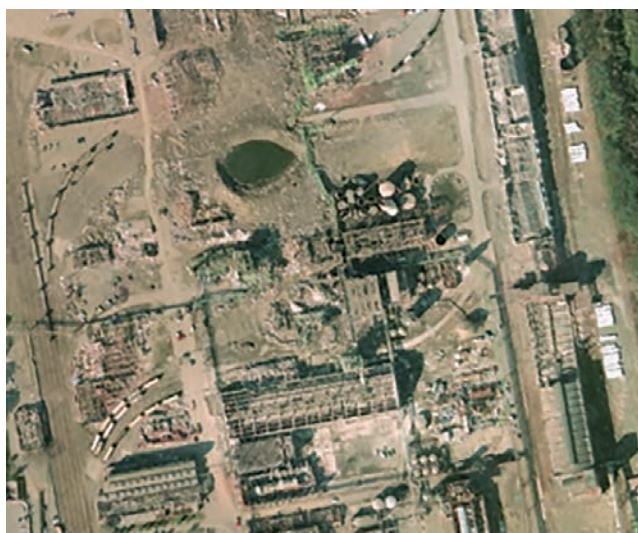
Figure 2: The area affected by the explosion (Source: Archives Grande Paroisse¹⁷)

Exactly 80 years to the day after Oppau, a severe explosion occurred in a temporary storage for off-specification and downgraded ammonium nitrates at 10.17 a.m. on 21 September in 2001 at the AZF industrial site in Toulouse, France. The detonation, felt several kilometres away, corresponded to a magnitude of 3.4 on the Richter scale. A 7m deep crater (65x45m) was observed outside the plant and a large cloud of dust and red smoke drifted to the north-west. The accident resulted in 30 fatalities, with up to 10,000 people injured and 14,000 people receiving therapy for acute post-traumatic stress. The cost was estimated by insurers to be in the region of 1.5 billion Euro³.
