Chemical Accident Prevention & Preparedness

Learning from emergency response failures and successes

Emergency response

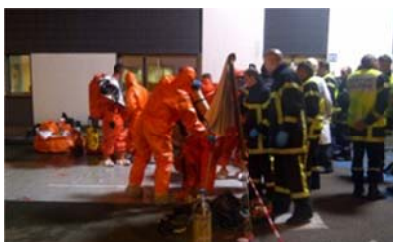
Figure 1: Intervention of responders at the site (SDIS 56, 2011)

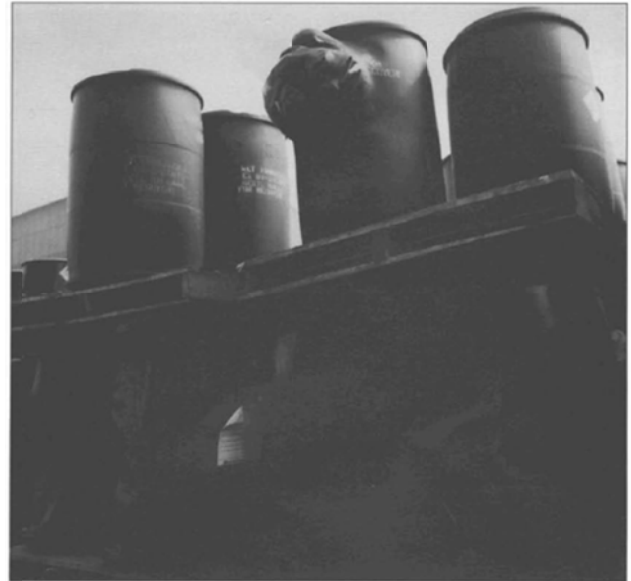
Figure 3: Plastic drums on the fire block flammable liquid storage area showing heat radiation damage and effects of pressurisation. (HSE, 1992)

The serious potential for escalation of the incident was evidenced by numerous plastic drums on the fire block which were damaged by radiant heat. The fire service made a considerable effort to cool these containers of flammable liquids during the course of the fire and successfully prevented their ignition.
